FACILITY CONDITION ASSESSMENT

Camp Naumkeag
85 Memorial Drive
Salem, Massachusetts 01970

130200.18R000-014.322

April 2, 2018

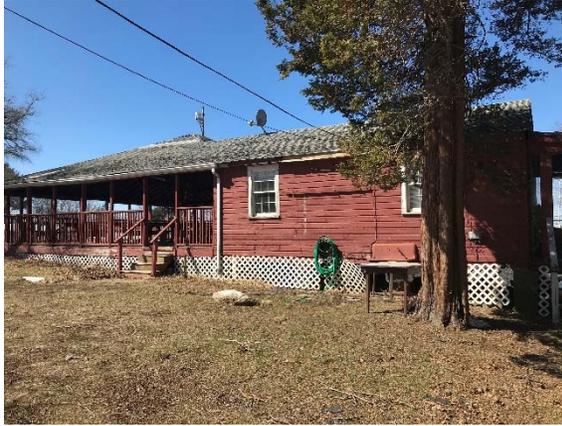
PHOTO #1:	CARETAKERS RESIDENCE
-----------	----------------------

- The Caretakers Residence roof is leaking and there are decayed wood boards at the eaves. Recommend replacing affected sheathing in conjunction with roof shingles replacement.

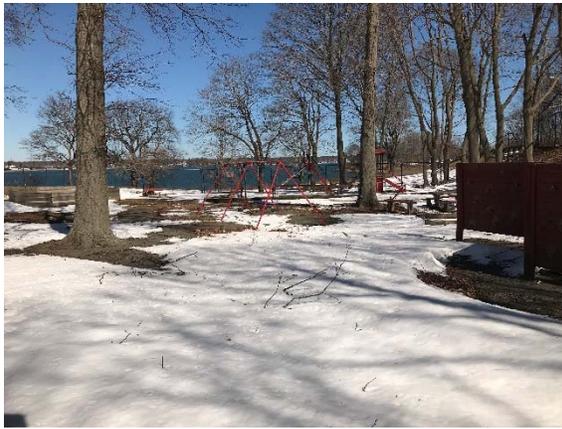
PHOTO #9:	PLAYGROUND
-----------	------------

- Drinking fountain at playground is not working and is recommend for replacement.

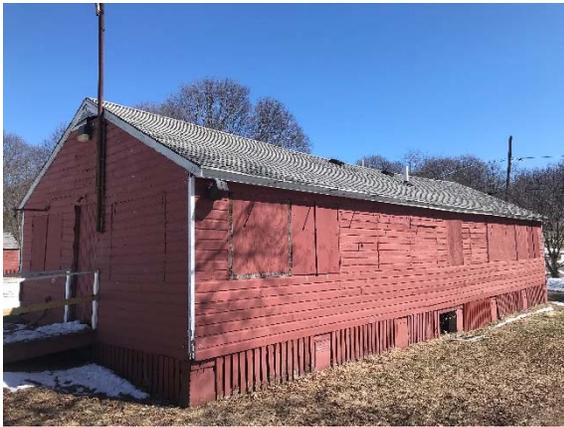
PHOTO #21: FOUNDATION PIERS

- Four of the five Camp buildings are built on loose block piers. The buildings have settled, and the structures have been affected. It is recommended to jack the structures, straighten floors and install code compliant footings.

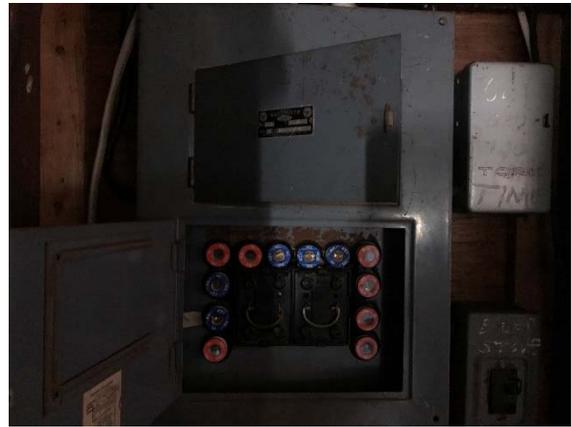
PHOTO #22: MAIN BUILDING ELECTRICAL

- ADA accessibility upgrades
- Drinking fountain replacement
- Foundation improvements stabilization of buildings
- Install backflow preventer
- Replace fuse type electrical distribution panel at Main Building
