FACILITY CONDITION ASSESSMENT

Pioneer Village
98 West Avenue
Salem, Massachusetts 01970

EMG Project Number:
130200.18R000-009.322

Date of Report:
March 26, 2018

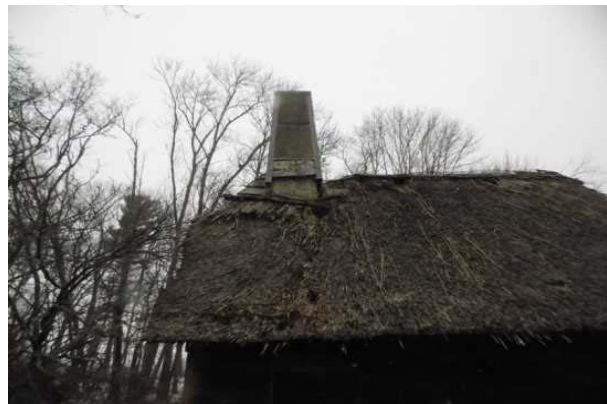
THATCH ROOF DETAIL

- The roof finishes vary in age. The roofs are maintained by an outside contractor and due to the nature of the materials, the thatch is replaced in the spring by a group of volunteers.
- According to the POC, there are no active roof leaks. There is no evidence of active roof leaks.
- The field of the roofs have isolated areas of missing thatch, damaged decking and weathered wood shakes. Portions of the roof finishes require replacement. The damaged portions of the decking or roofing material should be must be repaired.
