March 31, 2017

## **PURPOSE:**

MDA conducted on-site building evaluations of the five structures located at Camp Naumkeag in Salem, MA in November of 2016 for the purpose of determining the structures suitability for adaptive reuse and or continued operation as a day camp sub-let by the City for recreational activities.

## BUILDING SURVEY REPORT

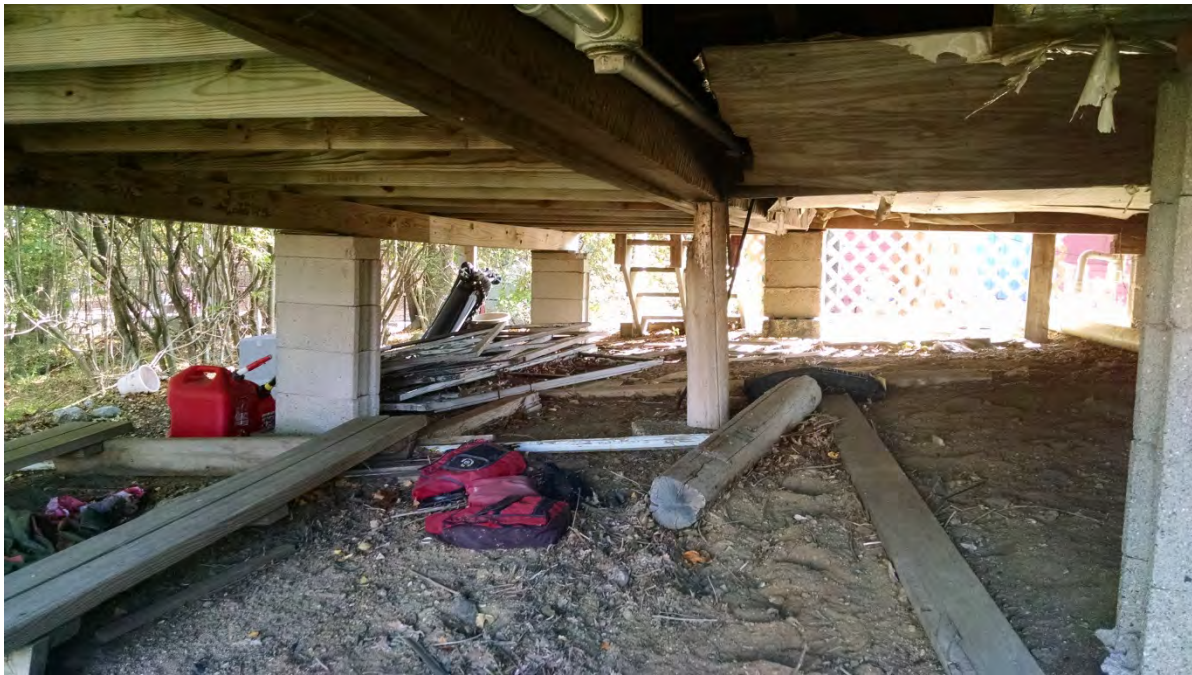
Typical pier construction

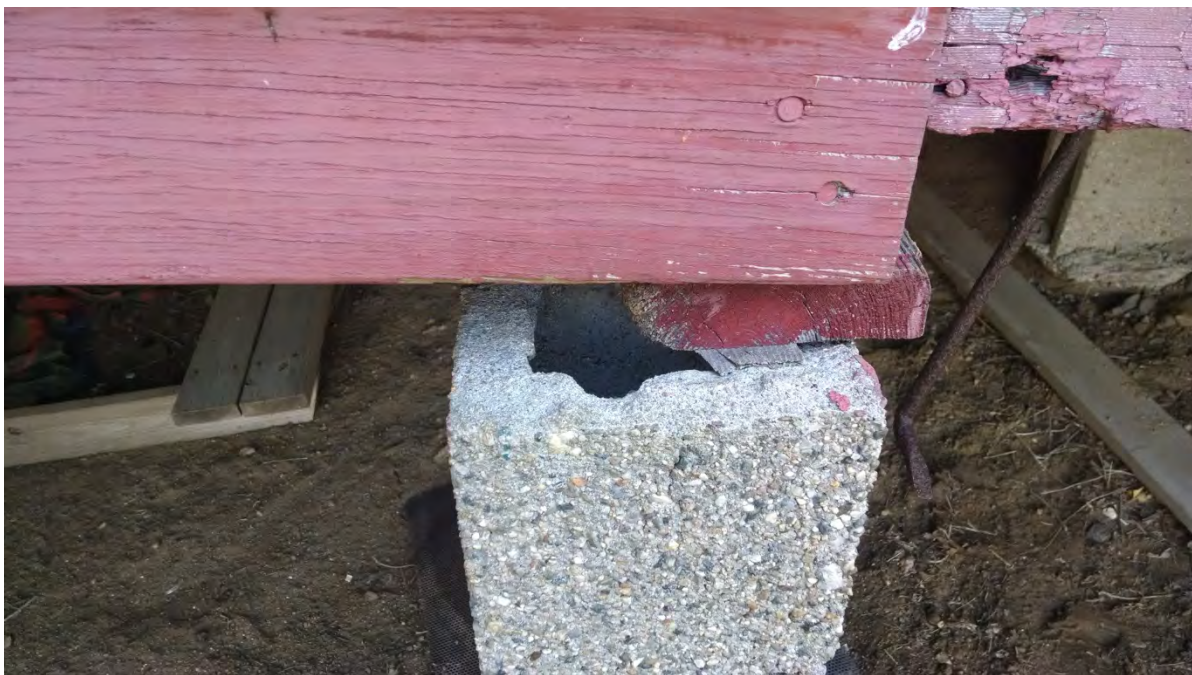
With limited or no physical connections tying the structure to the piers these buildings lack the basic hold down anchoring requirements of a common residence. As they are elevated on piers and adjacent to the coast these buildings are subject to a higher probability of damage in a severe wind event.

Typical unrestrained pier to beam connections

Any meaningful undertaking to improve the buildings would require the foundations be replaced in order to meet current codes.

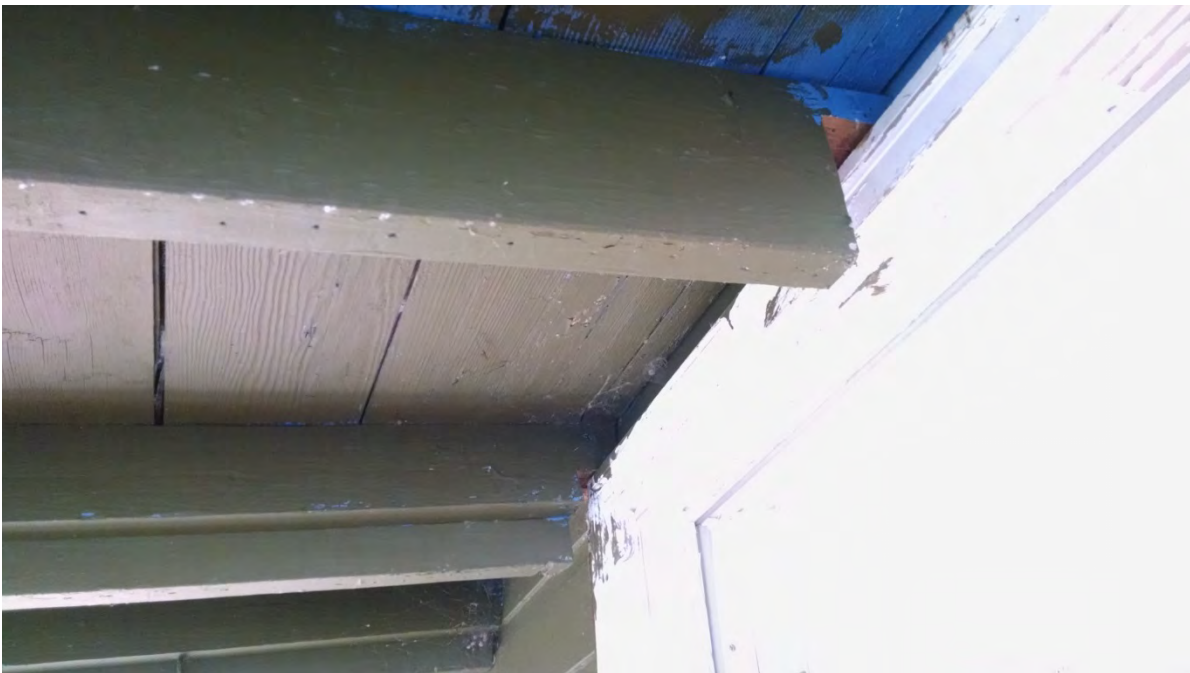
Notched rafters over doorway into caretaker's building

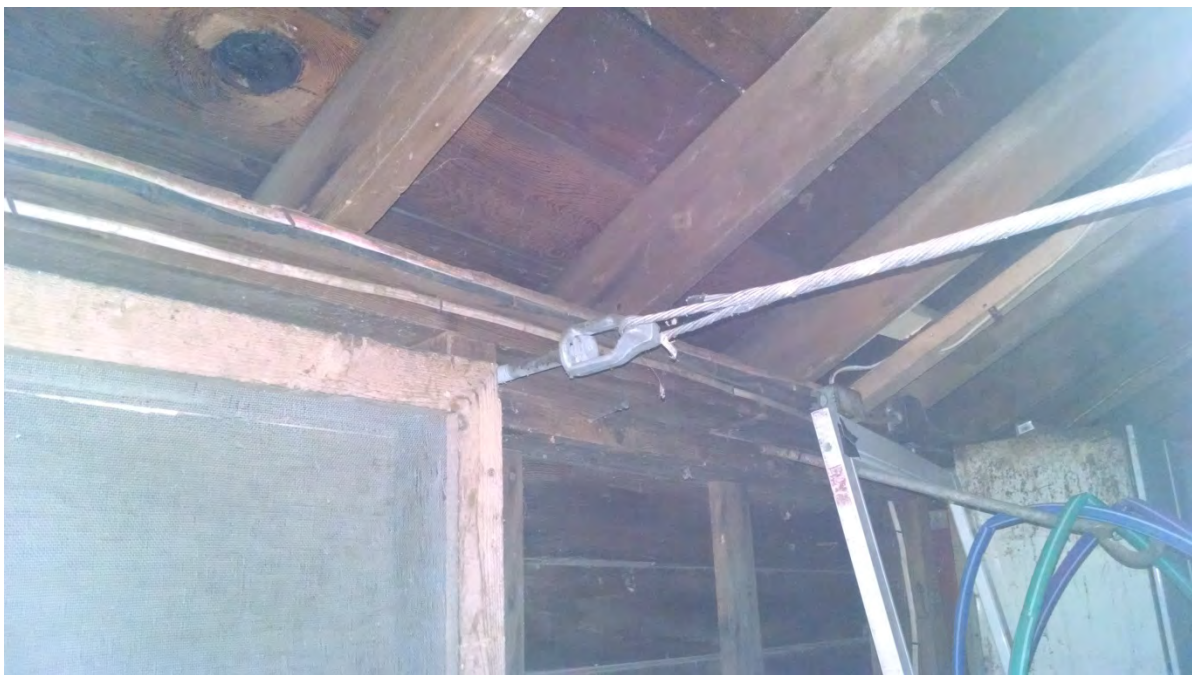
*Overall condition of the structure is fair. The wood framing and siding of the structure is in limited contact with grade at the south west corner of the building. There is no discernible differential settlement. The ceiling joists have been reinforced with cables and the exterior walls of the building appear plumb.*

Steel cables added to prevent outward roof thrust.

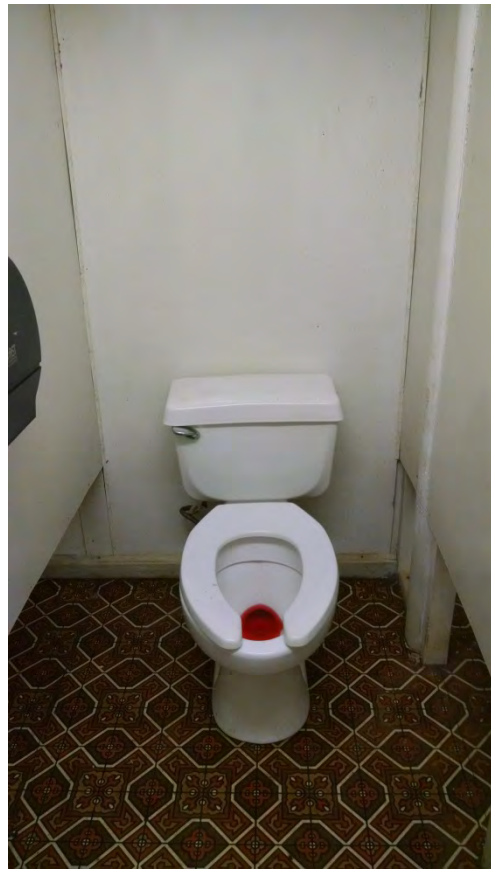
Interior finishes are either nonexistent or dated and in poor condition. Restrooms have painted porous baseboards and toilet partitions. Mold was evident on the drywall in one restroom.

Standard toilet stall  
Note porous wood base

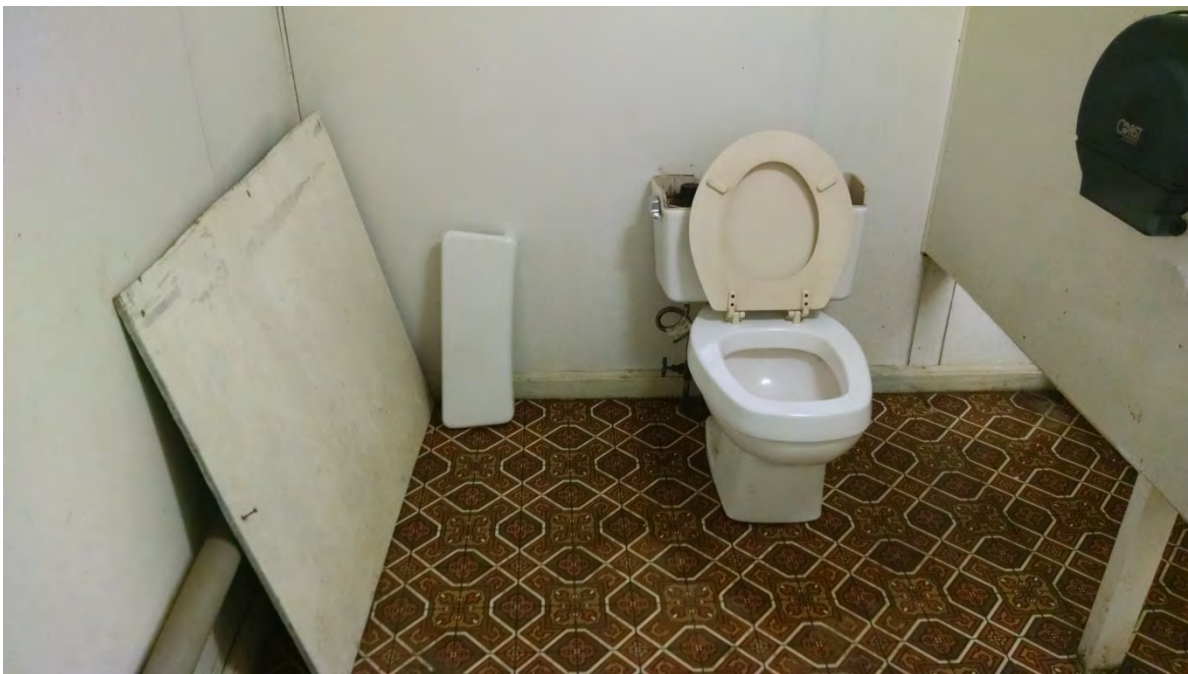
Non-compliant accessible stall.  
Note Caretakers building electrical conduit feed to the left.

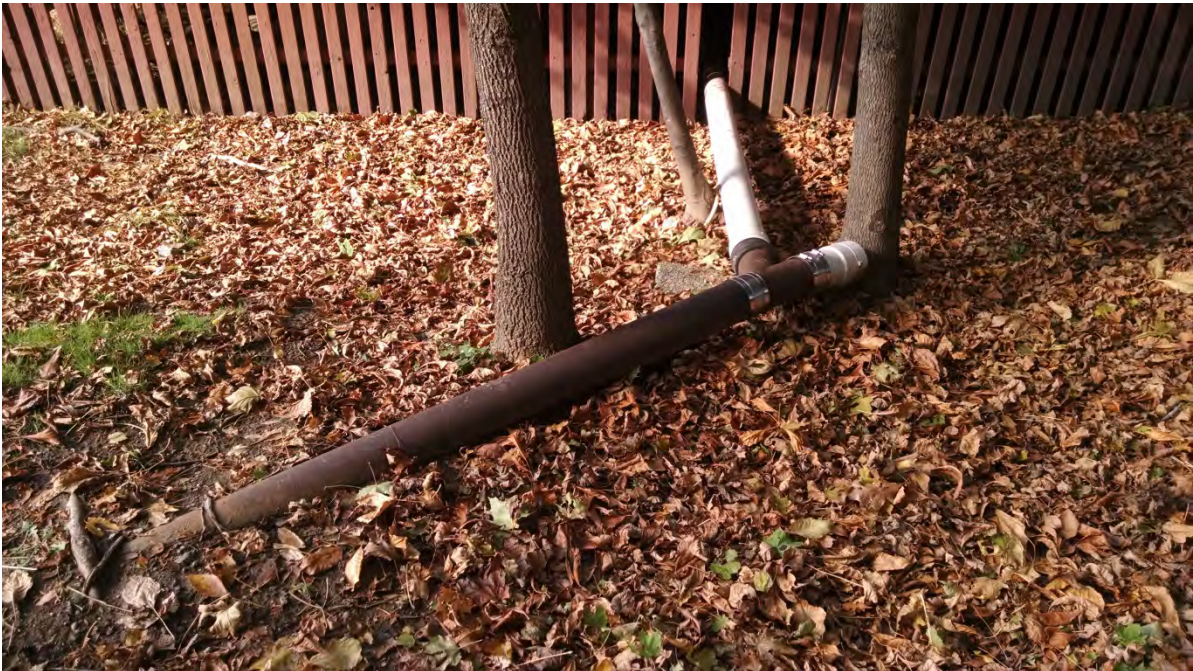
Sanitary service runs above grade in several areas and is subject to frost heaving. Potable water and toilets must be drained seasonally as the nature of a raised structure offers no protection from pipe freezing. The two wooden framed structures that have public restrooms do not have a means to provide hot water.

Exposed sanitary line.

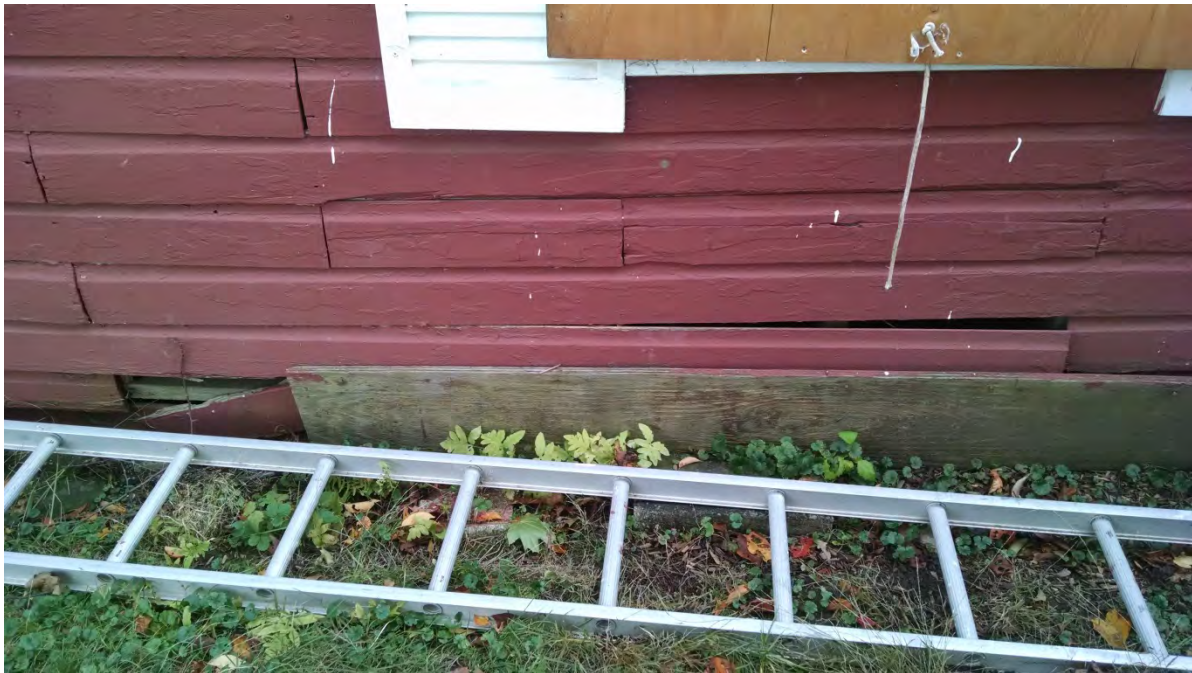
*Sill and siding rot is evident along the south and west sides of the building and there is ample opportunity for rodents and animals to occupy the space under the structure. There are numerous areas where siding has split and or rotted through.*

Siding deficiencies

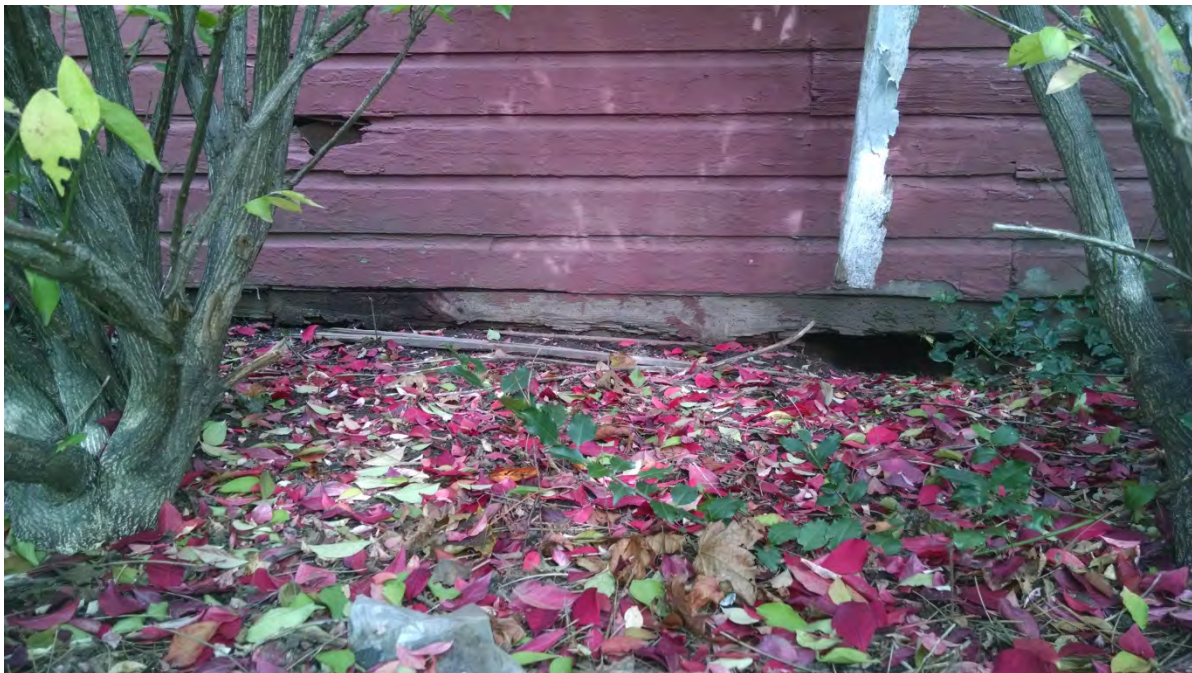
*Overall condition of the structure is poor. The wood framing and siding of the structure is very close to, and in some instances, in contact with grade. There is excessive differential settlement in the south end of the building resulting in a greater than 2% floor slope at several areas inside the building. The lack of collar ties and improperly spaced ceiling joists have resulted in the roof ridge sagging. At two points the ridge has split and the roof rafters have pulled away from it.*

Siding in contact with ground

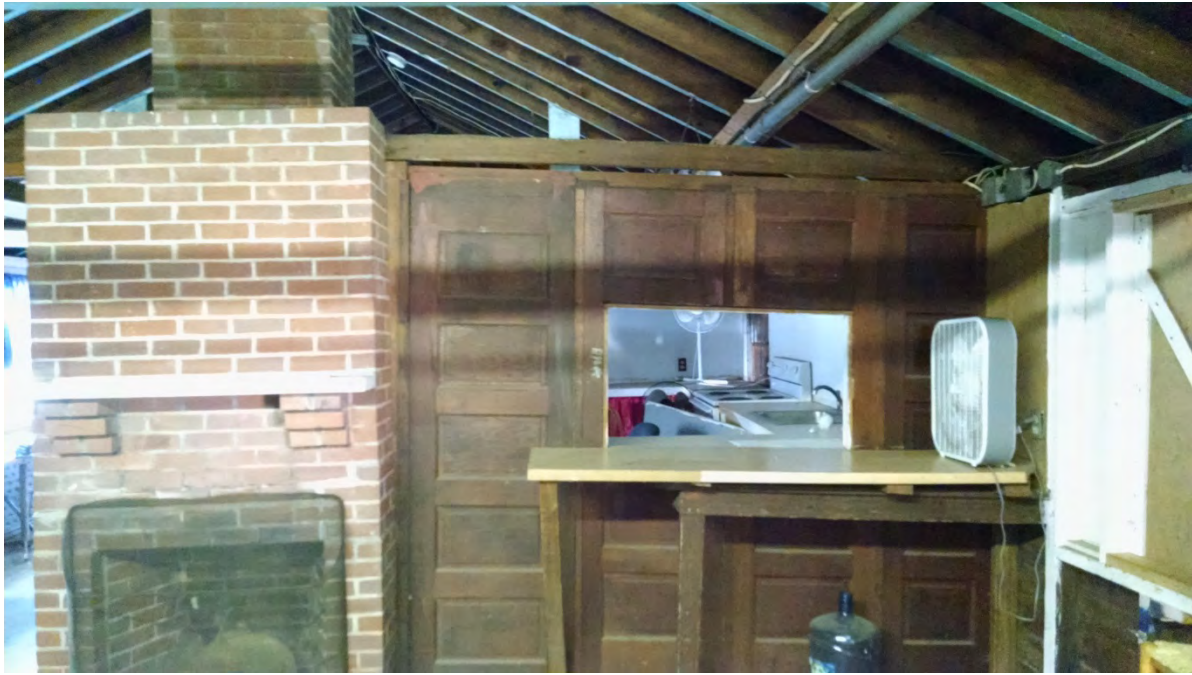
Settlement of the east side of building (3.2 degree floor slope)

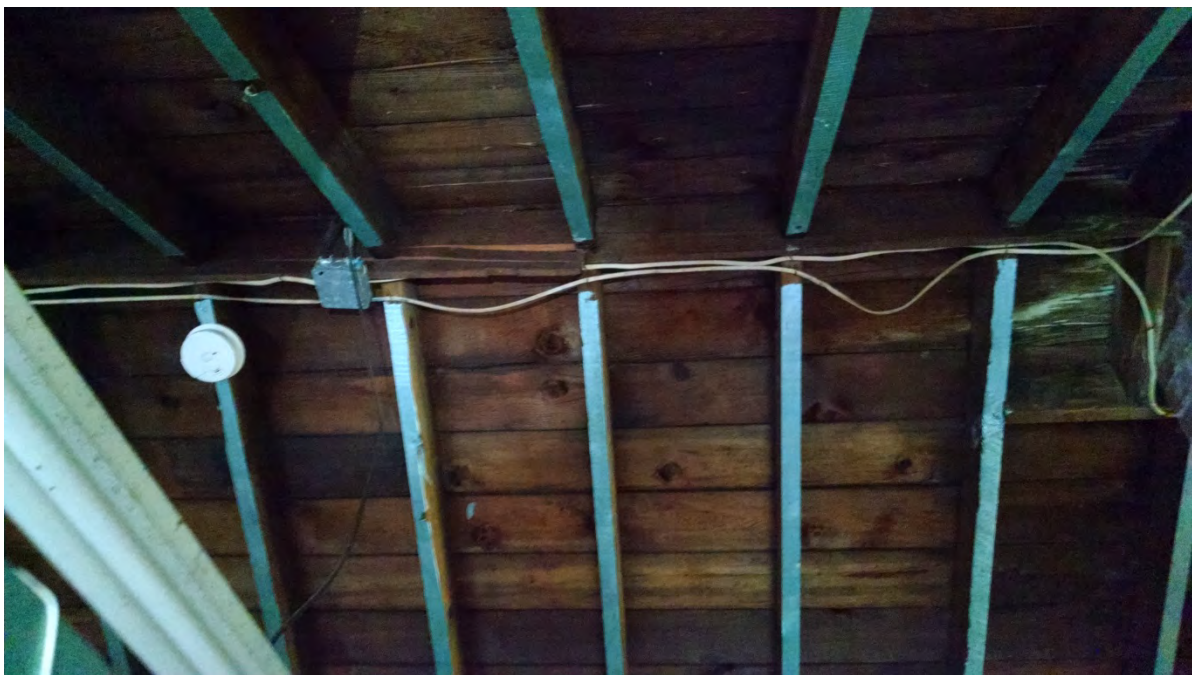
Split ridge beam at area of roof deflection

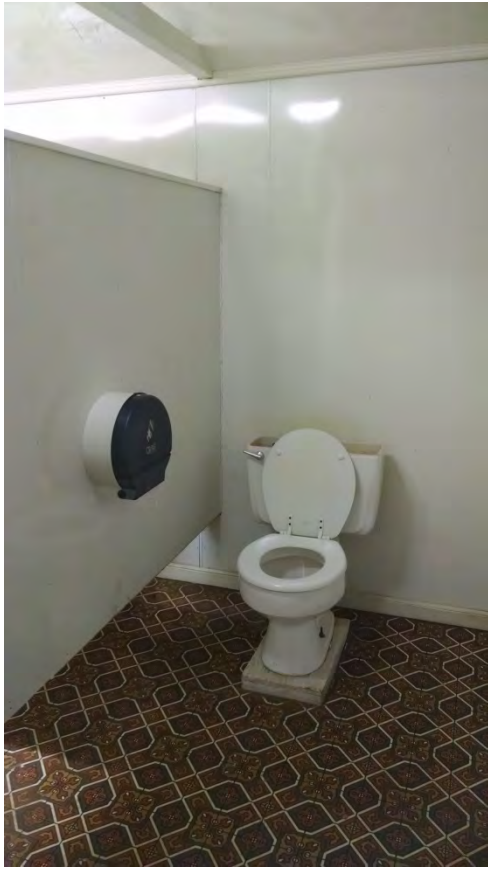
Accessible toilets	<i>*</i>		Accessible lavs	<i>*</i>	
<b>Men's Room</b>		Cond. <i>*</i>			
Number of toilets / urinals	<i>*</i>		Number of lavs	<i>*</i>	
Accessible toilets / urinals	<i>*</i>		Accessible lavs	<i>*</i>	
<b>Comments:</b> <i>The building has dedicated restrooms for girls only. An attempt has been made to address accessibility in the form of a 5'-0" wide stall, however the restroom has numerous deficiencies including, no grab bars, incorrect fixture height, location and sizes and is not considered accessible.</i>

Non-compliant accessible  
toilet stall

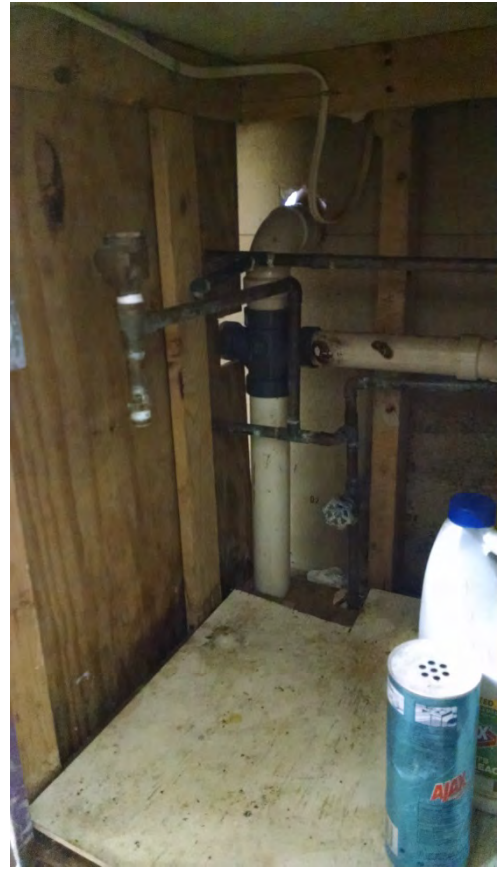
Water heater location  
(Removed)
