29 November 2022

Reference: Pioneer Village Evaluation Reference: Pioneer Village Conditions Assessment

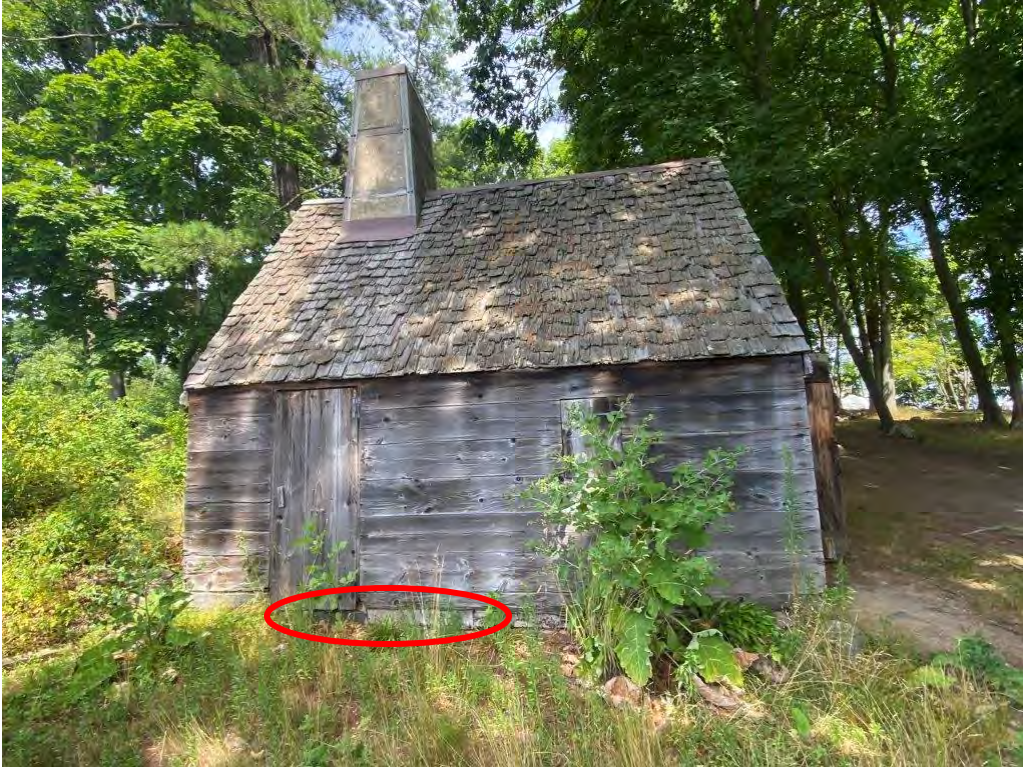
The south elevation has a wooden door and window opening that is currently boarded up. We found the base of the lowest siding board to be rotted, which is partially exposing some of the plywood and concrete slab behind it. This is due to wood's constant contact with the exterior grade and water exposure. Environmental factors such as these can rapidly deteriorate the wood material, especially if there is no maintenance done (Photo 1).

Photo 1: Structure (1), south facing exterior elevation conditions

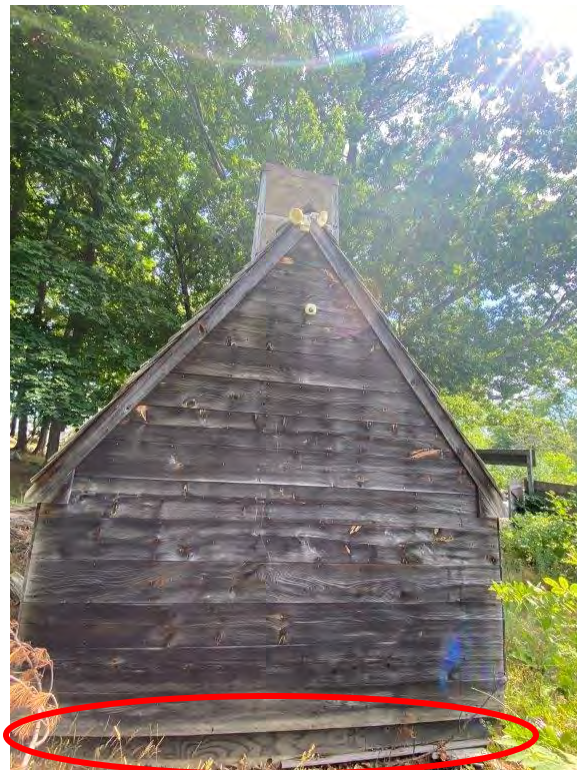
This elevation is the back of the structure, with neither doors nor windows for use. The bottom horizontal siding board is missing in its entirety, allowing the potential for rot to attack the interior plywood. The condition is similar to the south face, occurring from the exposure to water and soil (Photo 2).

Photo 2: Structure (1), west facing exterior elevation conditions

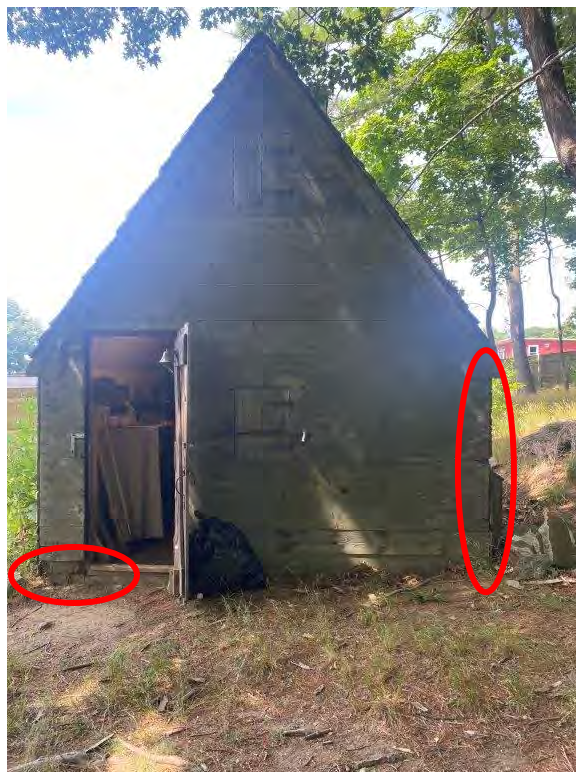
The east elevation is the front entrance to the cottage, with a door and two windows, one at the main level and the other at the peak of the gable. Similar to the other two elevations, there is missing siding board, however, at this face the board is missing below the doorway at the southeast corner. We also found signs of rot, at the northeast corner, in the ends of the face boards.

Photo 3: Structure (1), east facing exterior elevation conditions

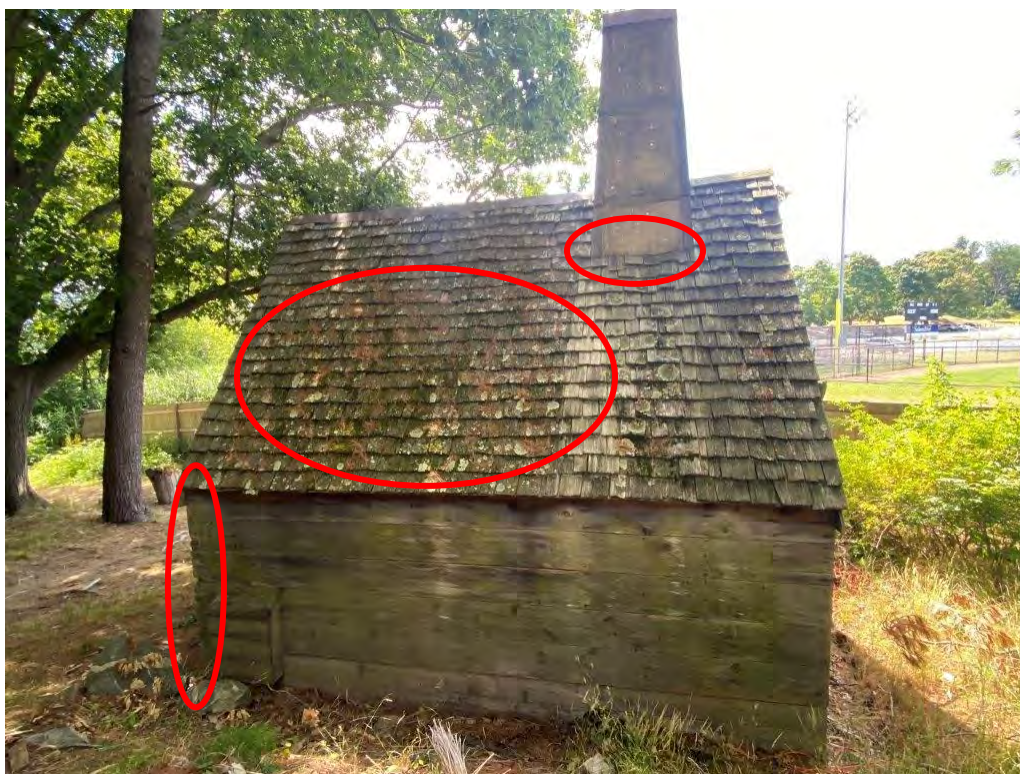
At the base of the chimney, above the roof, no flashing is present. This means that water can enter the gaps where the chimney penetrates the shingles. If water traps itself in the roofing system, it can encourage deterioration and weakening of the wooden materials (Photo 4).

Photo 4: Structure (1) north facing exterior elevation conditions

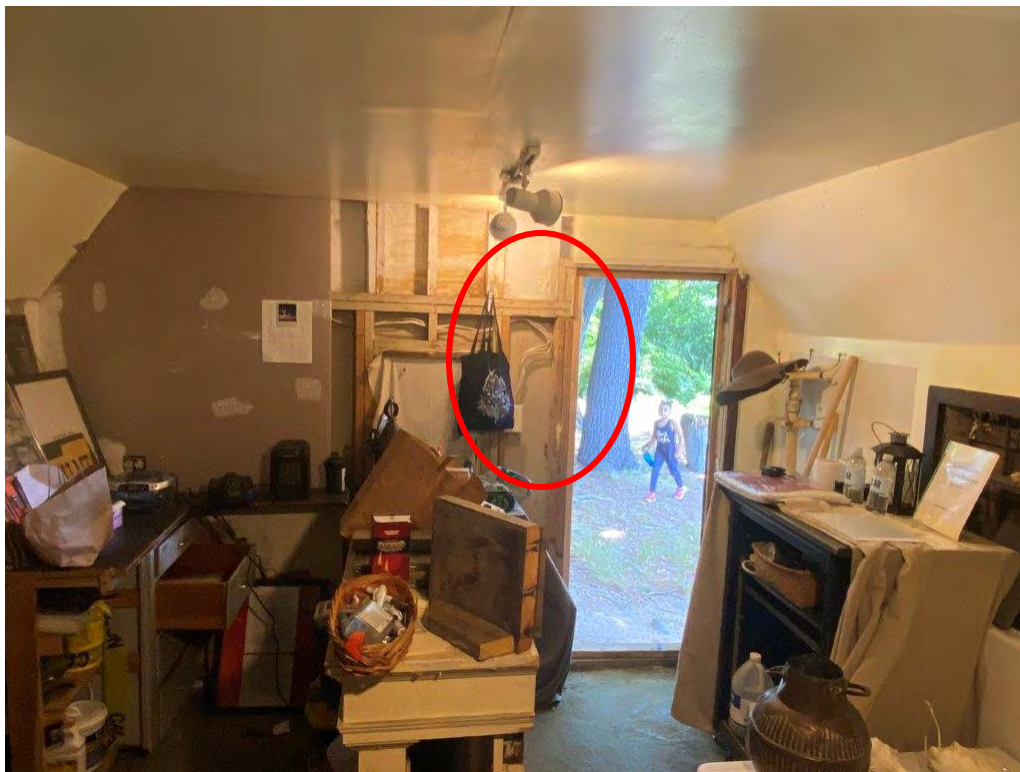
The two most concerning conditions we found are at the east facing elevation. The door interrupts the framing of the wall, and most critically the wall plate of the roof. The wall plate ends at the door jamb, which can potentially allow for spreading of the roof eaves. There is also gypsum board missing next to the doorway, exposing the electrical wiring of the cottage. This can be a safety hazard if water or even unsupervised children find their way to this area (Photo 5).

Photo 5: Structure (1), modern framing and interior with break at wall plate, facing east

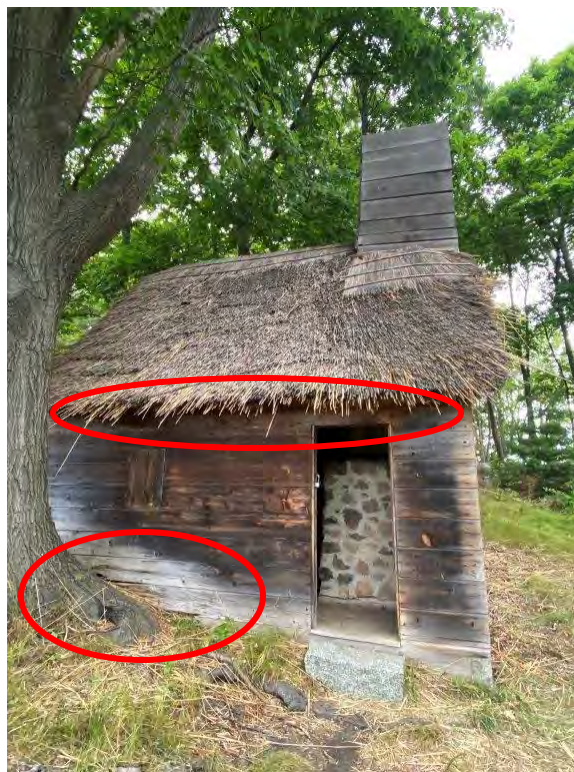
This elevation is the point of entry and maintains a wooden door and window at its face. At the base of the southeast corner of the cottage, there is extensive tree root growth, which is pushing up the soil and cottage, covering the base of the wall. From the prolonged exposure to grade, the siding boards at this location are deteriorated and missing, exposing the interior framing.

Photo 6: Structure (6), south facing exterior elevation conditions

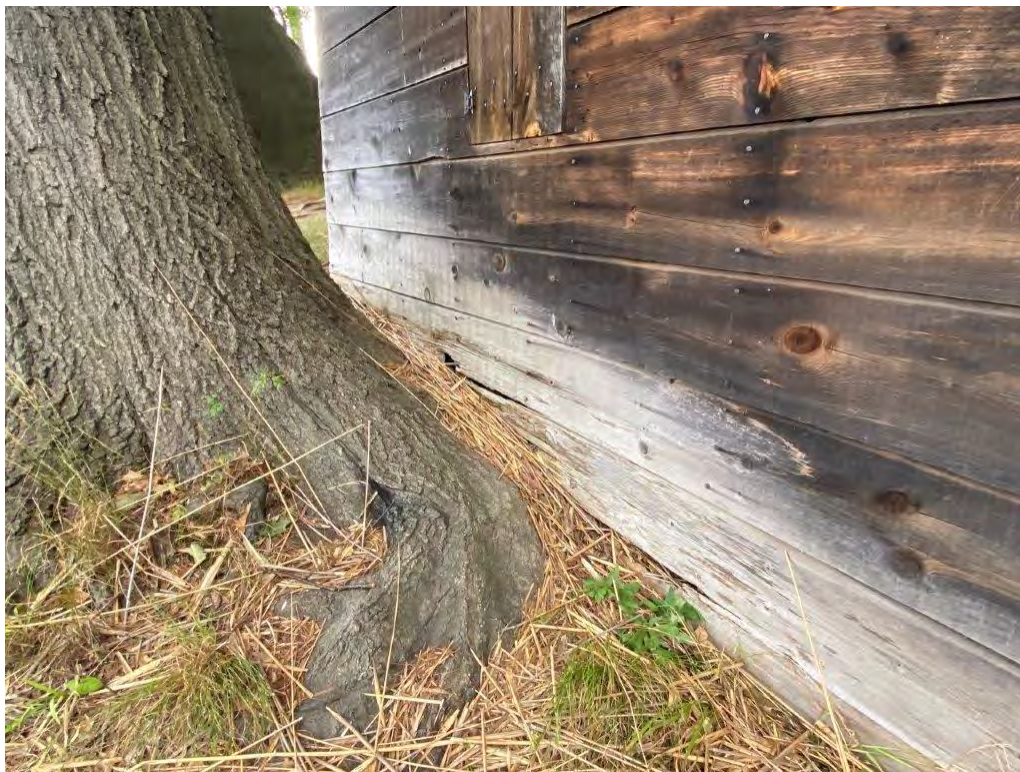
Photo 7: Structure (6), severe rot and material loss at southwest corner

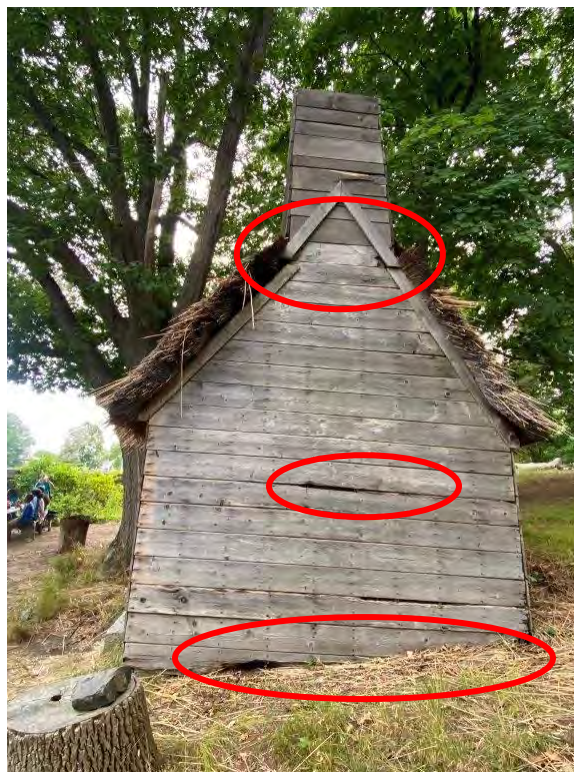
We found several of the siding boards rotting at their top and bottom edges, exposing the internal framing to environmental factors. This is especially present at the northeast corner where the boards are shifting into the north end grade (Photo 8).

Photo 8: Structure (6), east facing exterior elevation conditions

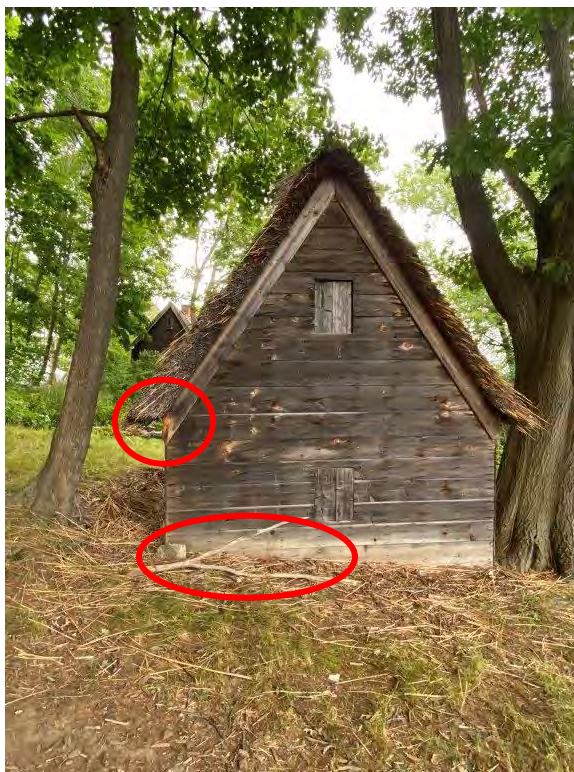
The west face has two windows, one at the main level and one at mid-height of the interior loft space. The northwest corner of the wall leans down into the grade and is covered by soil. From constantly being covered by soil and kept in a moist environment, the boards the lower portion of the wall is being aggressively consumed by rot (Photo 9).

Photo 9: Structure (6), west facing exterior elevation conditions

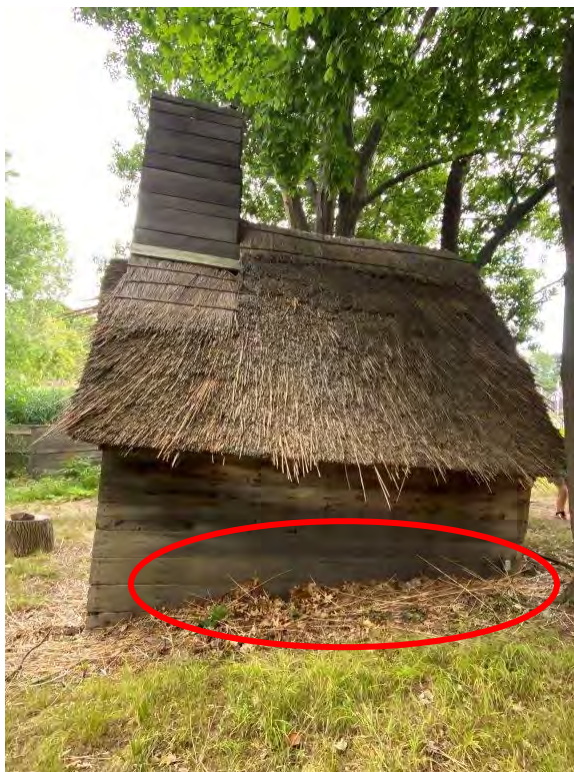
This elevation leans the most into grade, as this is the opposite side from where the tree is pushing the structure over. There are starting signs of rot in the base siding boards, exposing the interior posts which are badly deteriorating as well (Photo 10).

Photo 10: Structure (6), north facing exterior elevation conditions

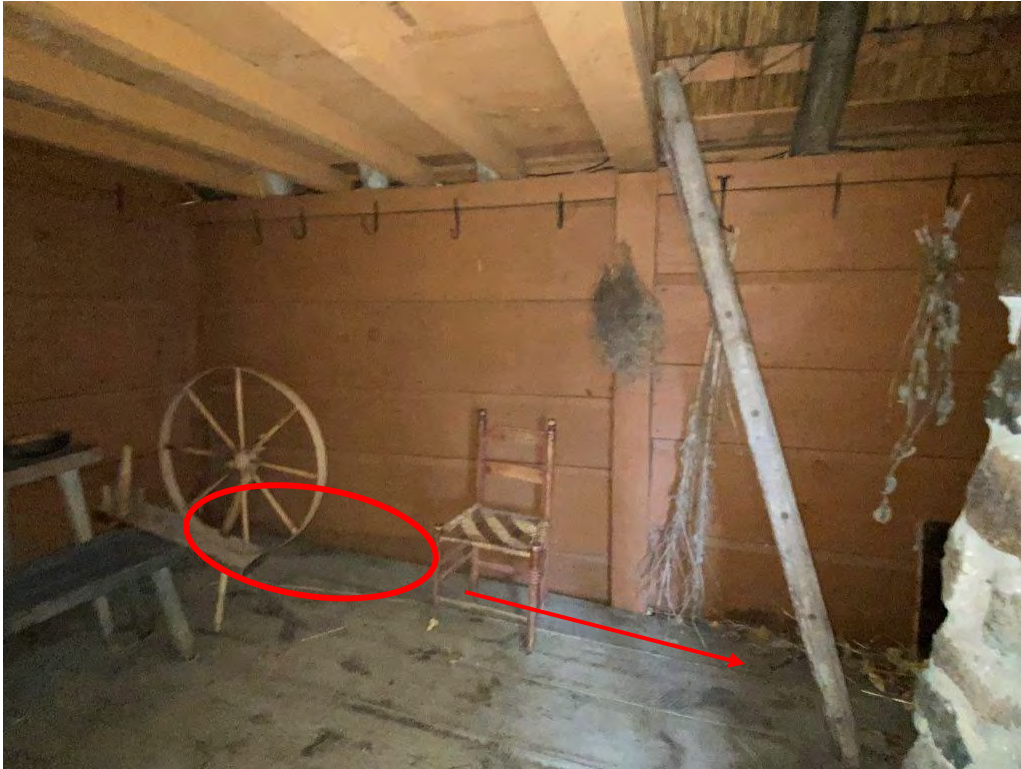
Due to the overturning that the structure is experiencing, the interior wood panels are overlapping one another at the northwest corner and have moved below the floor plank level. At the northeast corner, the bottom of the corner post was visible and severely rotted at its end, to the point that the interior of the member has started to hollow out. Considering the severe signs of rot and movement, we performed several resistance drill tests in the two north corner posts. The results showed severe deterioration of the northeast post from its base to about 3' above the ground. Meanwhile, at the northwest corner, the post was found to be rotted about a foot above the base to the bottom. From being buried in the soil for an extended period of time, the posts are badly rotted and have weakened, and ultimately have become vulnerable to the overturning behavior of the overall frame. The floor planks at the northeast corner sag and bounce when walked on, indicating weakening of the material in this area and/ or loss of support from beneath (Photos 11 & 12).

Photo 11: Structure (6), downward shift in NW corner wall and rise in NW floor

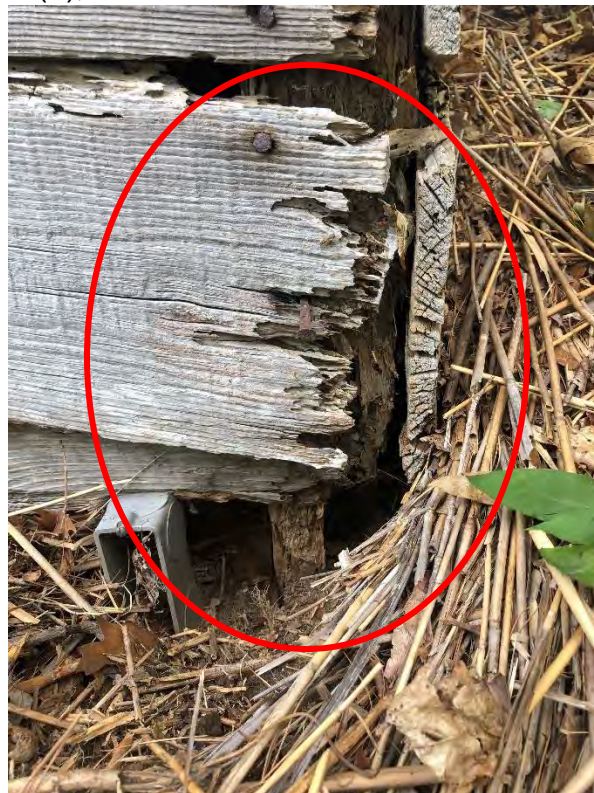
Photo 12: Structure (6), badly rotted post end at northeast corner

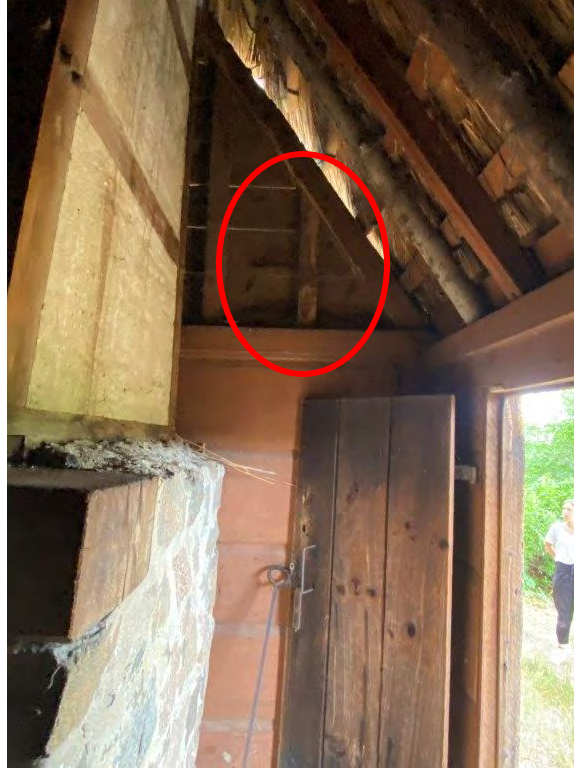
There are several areas of rot at this frame because of the exposed opening between the stone chimney and its surrounding wooden "box." The gable end rafters, and wall plate are deteriorating as well as the vertical wall studs supporting the exterior sheathing (Photo 13). This part of the frame is experiencing water penetration, and it remains in a dark and shaded environment, ultimately prolonging its water exposure, encouraging rot.

Photo 13: Structure (6), rot and openings on the east interior wall

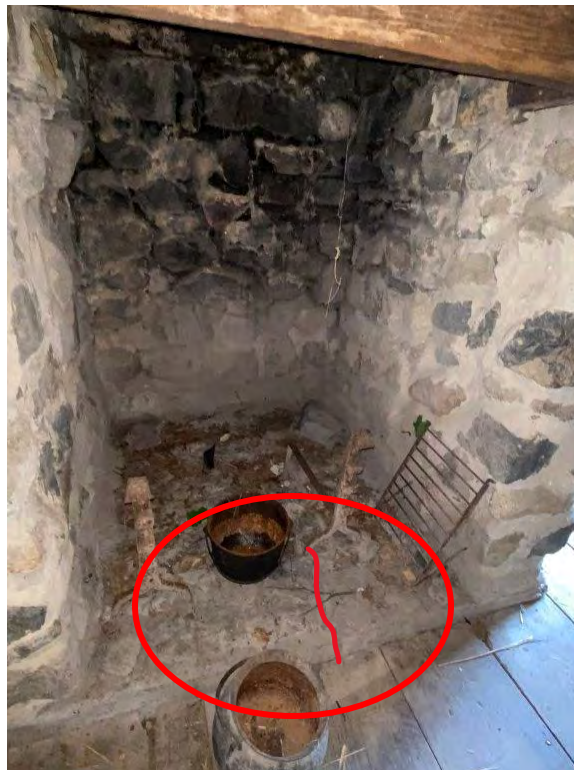
The concrete slab of the hearth is cracked and lifting at its midspan, likely from the unresolved overturning of the structure which is exerting an unbalanced load onto the chimney and its fireplace (Photo 14) as well as the possibility of frost heaving. Another side effect of the leaning structure is the shifting floorboards to the northeast corner of the cottage.

Photo 14: Structure (6), crack in concrete hearth slab

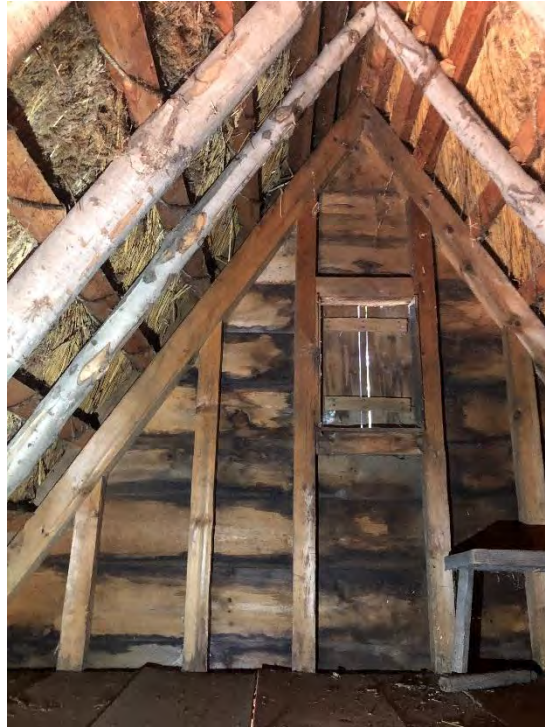
At the loft space level, several of the siding boards are darkened along their edges, stained from water exposure and will have the propensity to rot (Photo 15). Additionally, the floor framing at the main floor leans down towards the northwest corner of the cottage.

Photo 15: Structure (6), water-stained boards of west interior façade

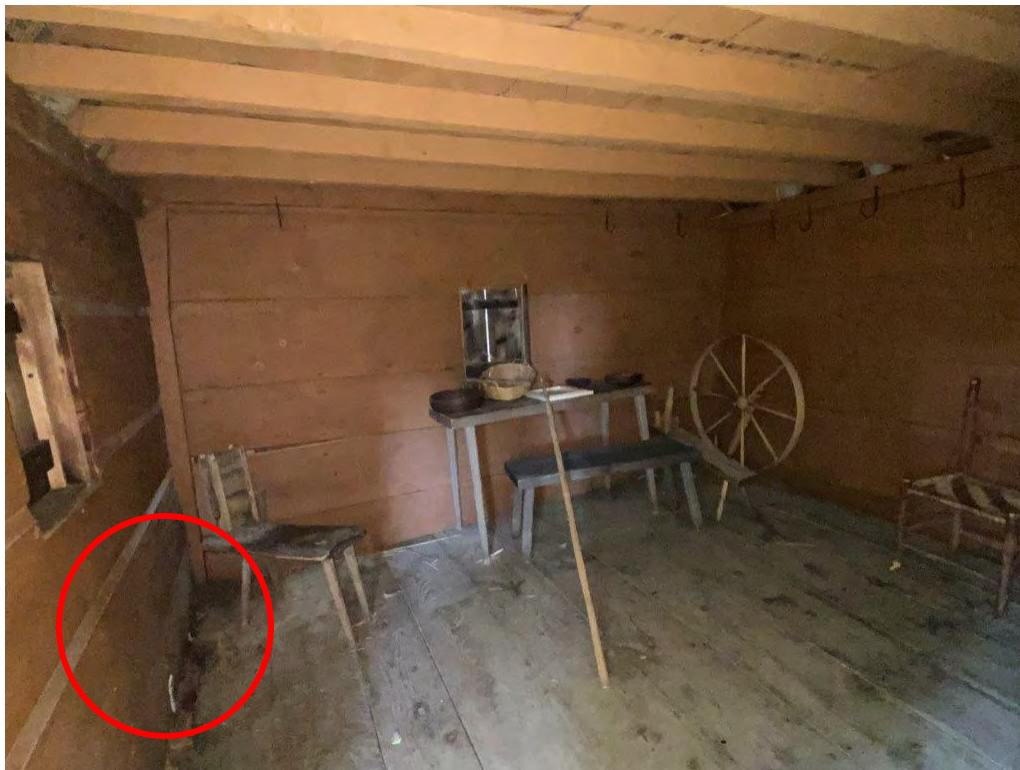
At the southwest corner of the cottage, the floorboards have uprooted and started to decay while the interior siding board is rotting away as well. The upward force of the tree roots at this location brought the grade up to the base of the cottage, promoting decay and movement (Photo 16).

Photo 16: Structure (6), deteriorating bead board at SW interior wall

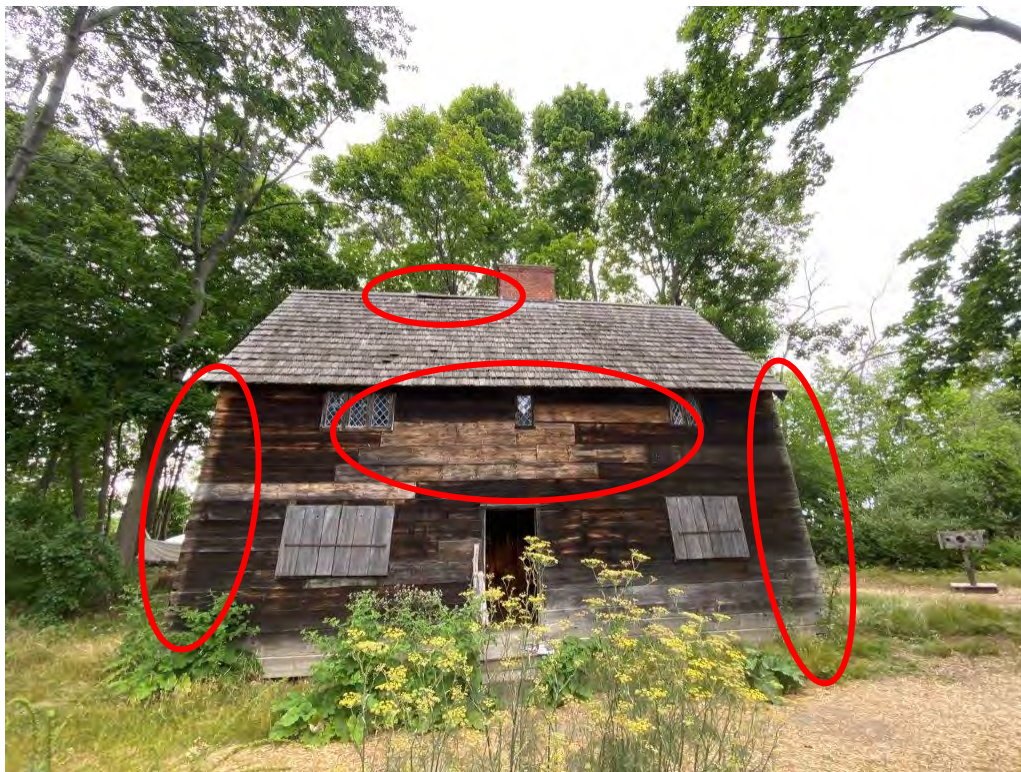
At the roof level, the ridge cap, west of the chimney, is starting to loosen. This gap in the construction creates an easy pathway for water to penetrate the structure (Photo 17).

Photo 17: Structure (7), south facing exterior elevation conditions

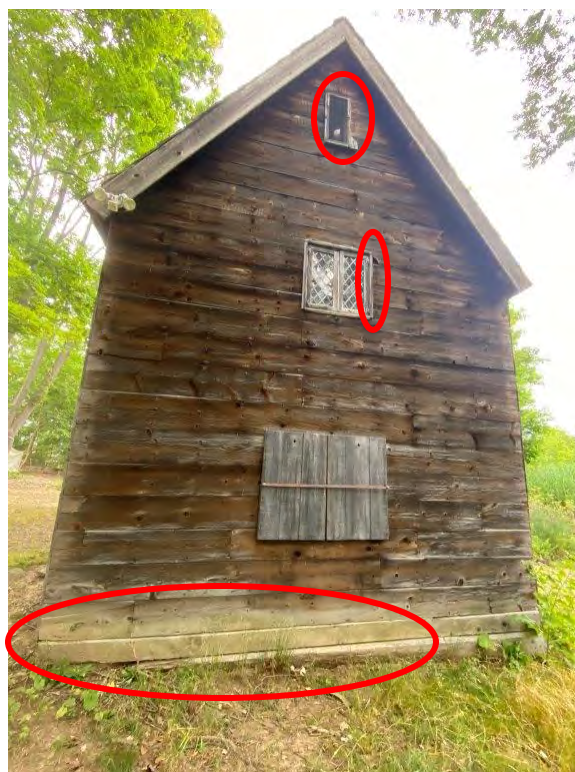
At the northwest corner of the house, the sill is completely rotted, causing the bottom edge of the siding boards to start deteriorating as well. The grade slopes up towards the north direction, covering the sill at this location, creating a moist environment for the wood members (Photo 18).

Photo 18: Structure (7), west facing exterior elevation conditions

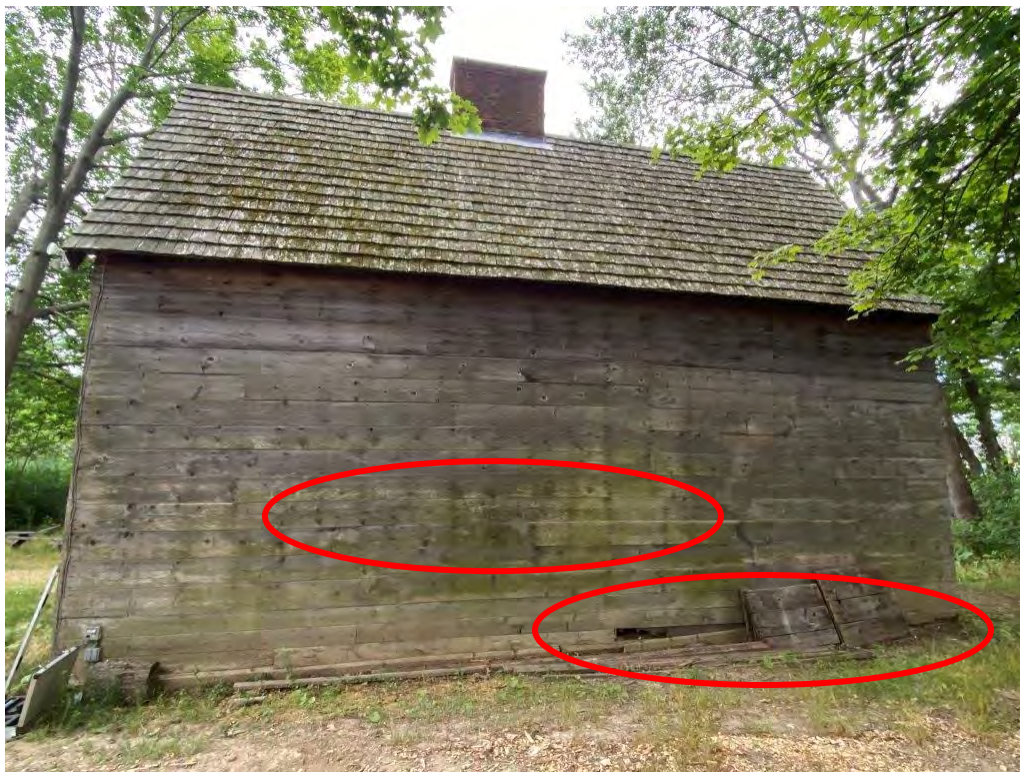
The north elevation is entirely covered by wood siding, without any openings or access points. In conjunction with some slight rotting at the base boards, there are entire siding members that are loose or missing, exposing the floor framing and sill behind. At about mid-height of the elevation, the siding is covered in algae, which if not cleaned and maintained, will lead to deterioration of the wood (Photo 19).

Photo 19: Structure (7), north exterior elevation conditions

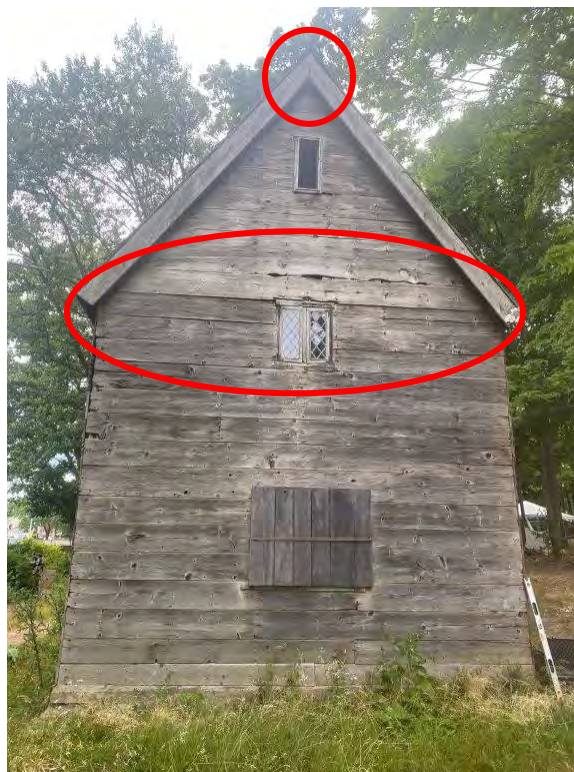
At the roof level, the wood shingles are starting to pull away from the rake board, indicating that that shingles may be starting to wear away in this area (Photo 20).

Photo 20: Structure (7), east facing exterior elevation conditions

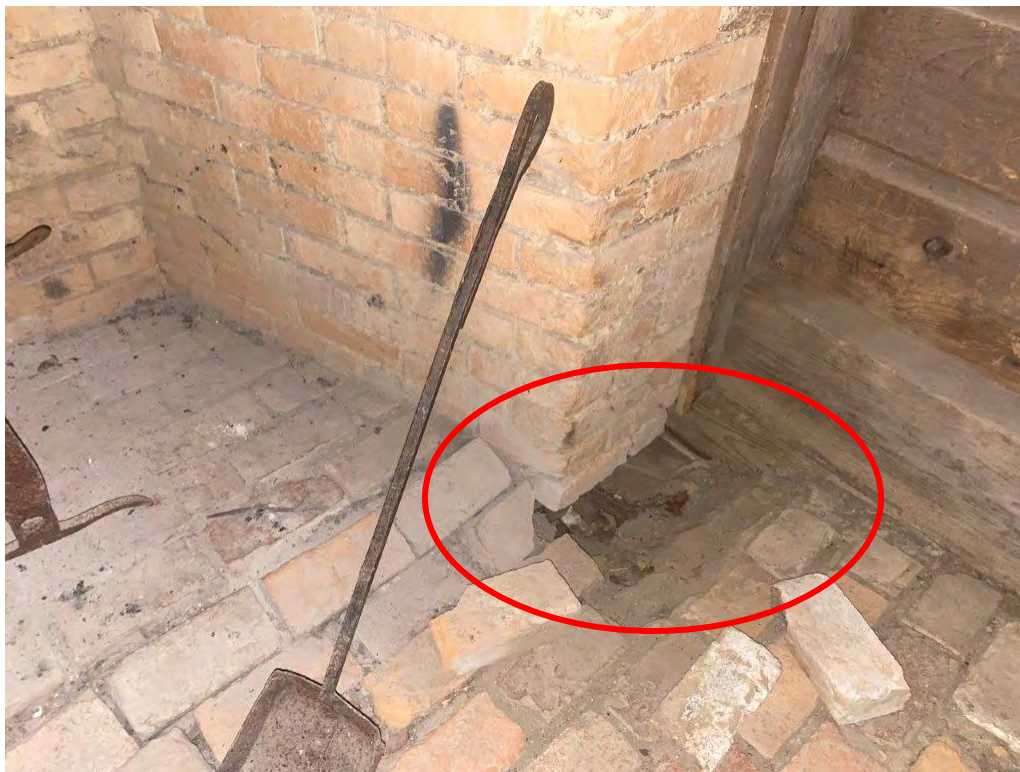
There is a hole beneath the hearth at its north corner, east facing side. The presence of this hole can potentially undermine the chimney creating an unstable condition (Photo 21).

Photo 21: Structure (7), northeast corner of hearth with missing grade

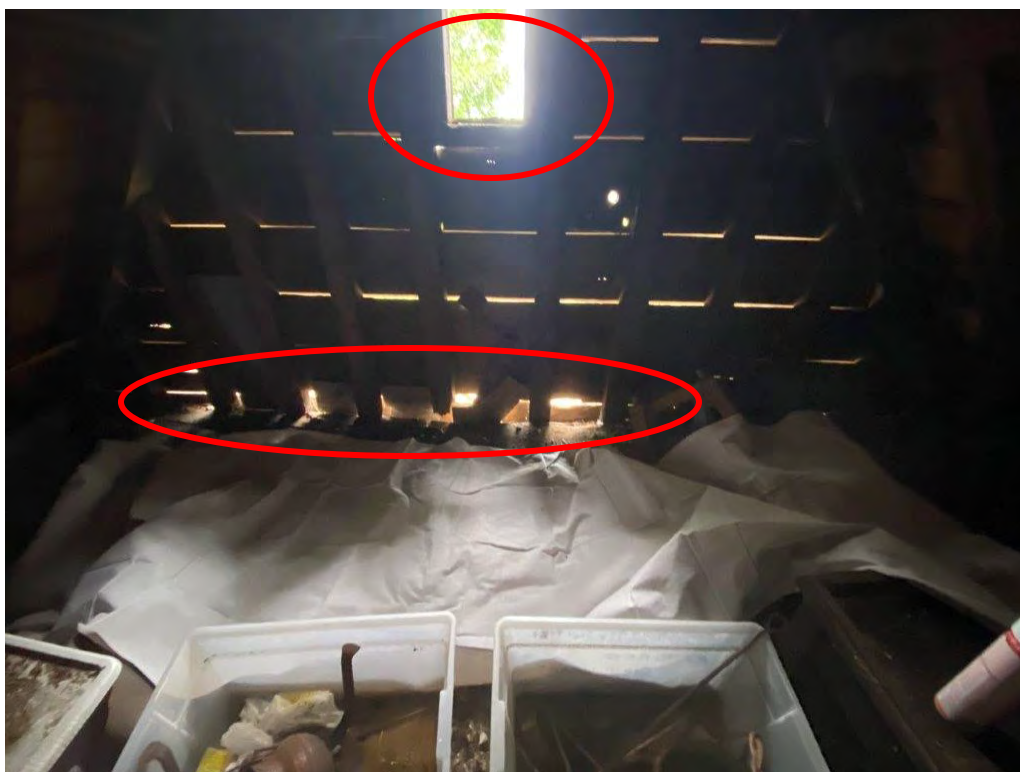
The most serious damage in the house is found at the attic level. At the east end, there is extensive water related rot damage that has caused the east gable wall to loosen, and detach (Photo 22) from the floor, which is rotted as well. The wall boards and floor planks are all stained from the prolonged water exposure this space has been vulnerable to. Much of the gable wall needs to be rebuilt.

Photo 22: Structure (7), east interior wall at attic level with openings at siding and window

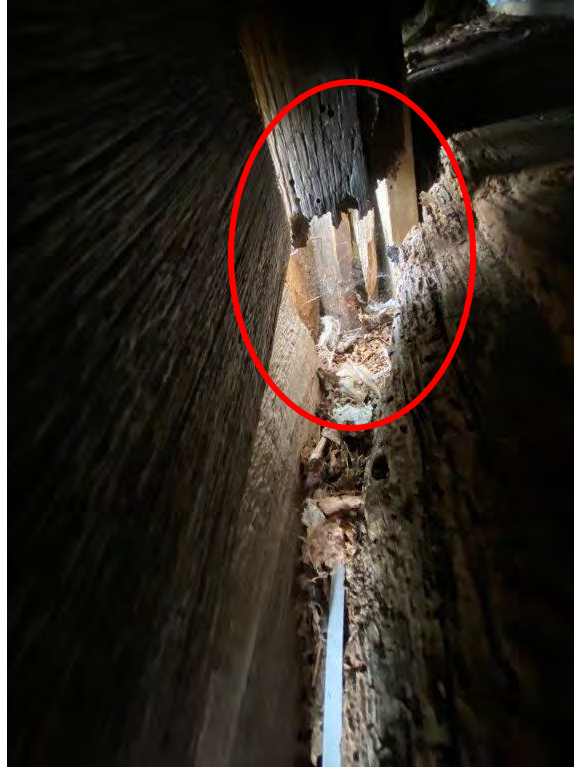
Some of the floor planks at the west end are seeing rot as well, caused by the same exterior exposure that the east side is suffering from (Photo 23).

Photo 23: Structure (7), rotted floor planks at attic level

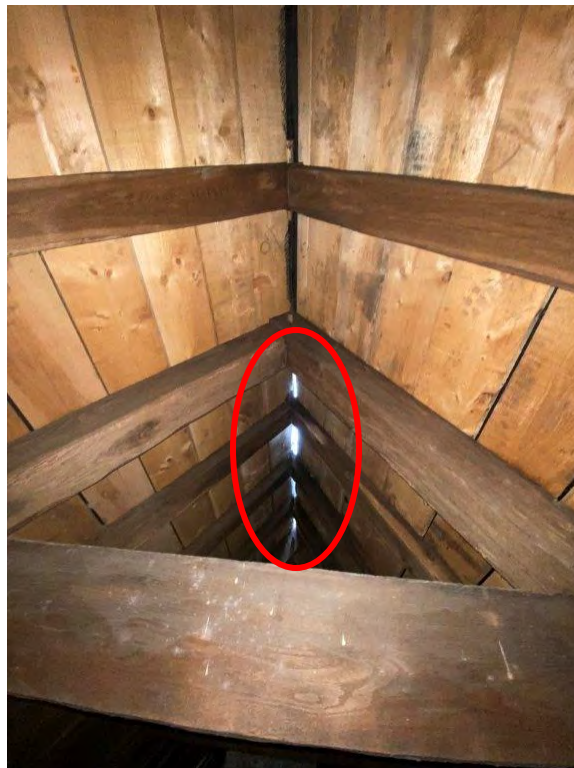
The roof ridge that runs east to west has a gap at the very peak where the shingling and sheathing boards appear to have rotted away (Photo 24) and must be replaced.

Photo 24: Structure (7), gap in roof ridge

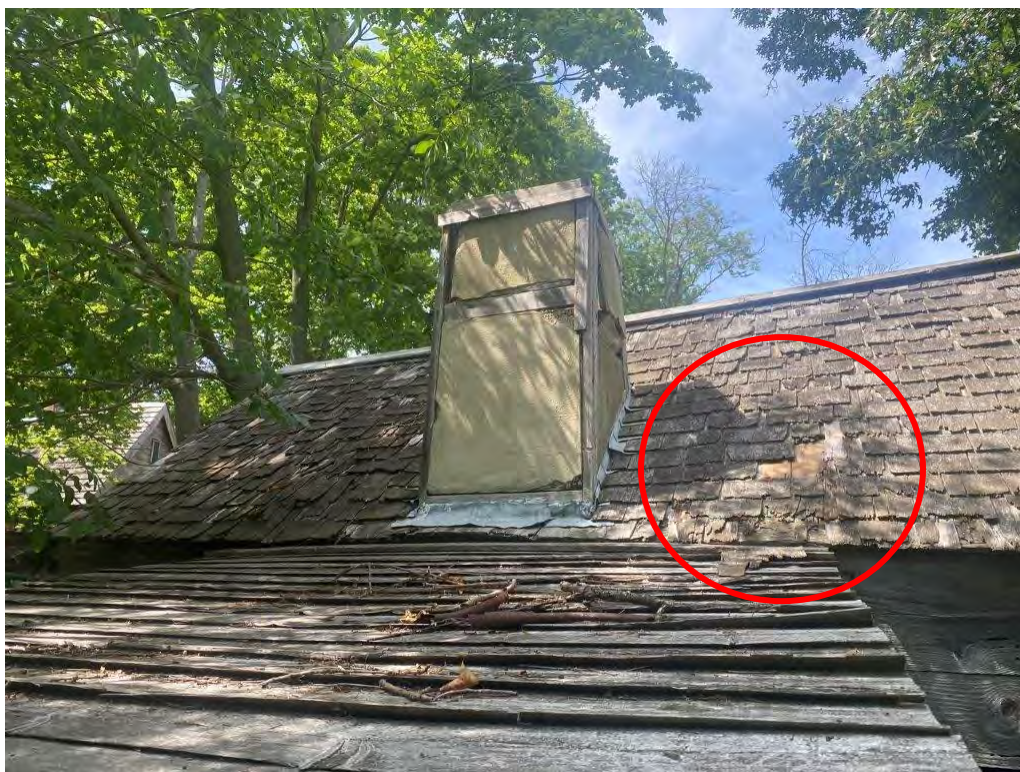
Photo 33: Structure (8), south facing roof with missing shingles

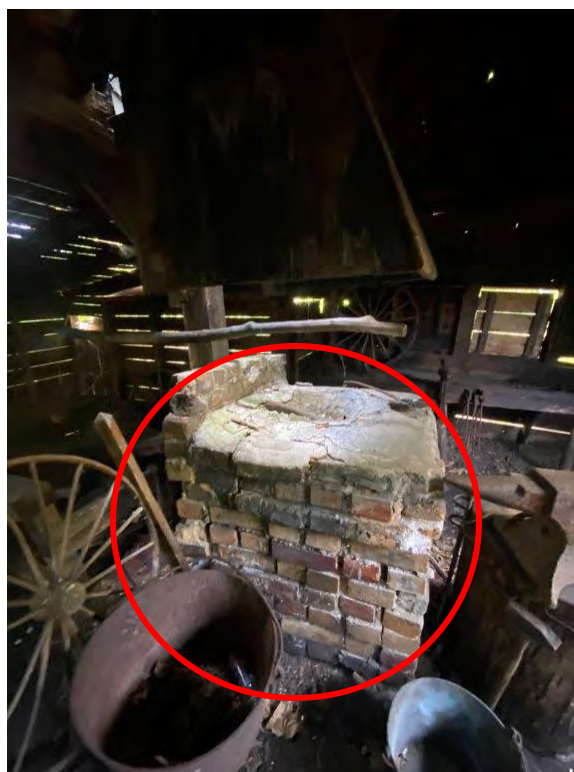
Photo 34: Structure (8), deterioration of interior brick hearth

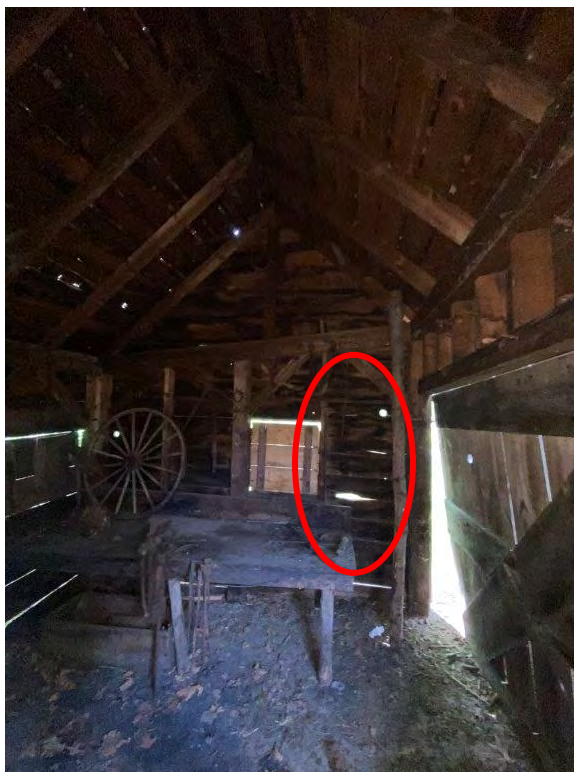
Photo 35: Structure (8), gaps in rotting wood panels of west interior wall

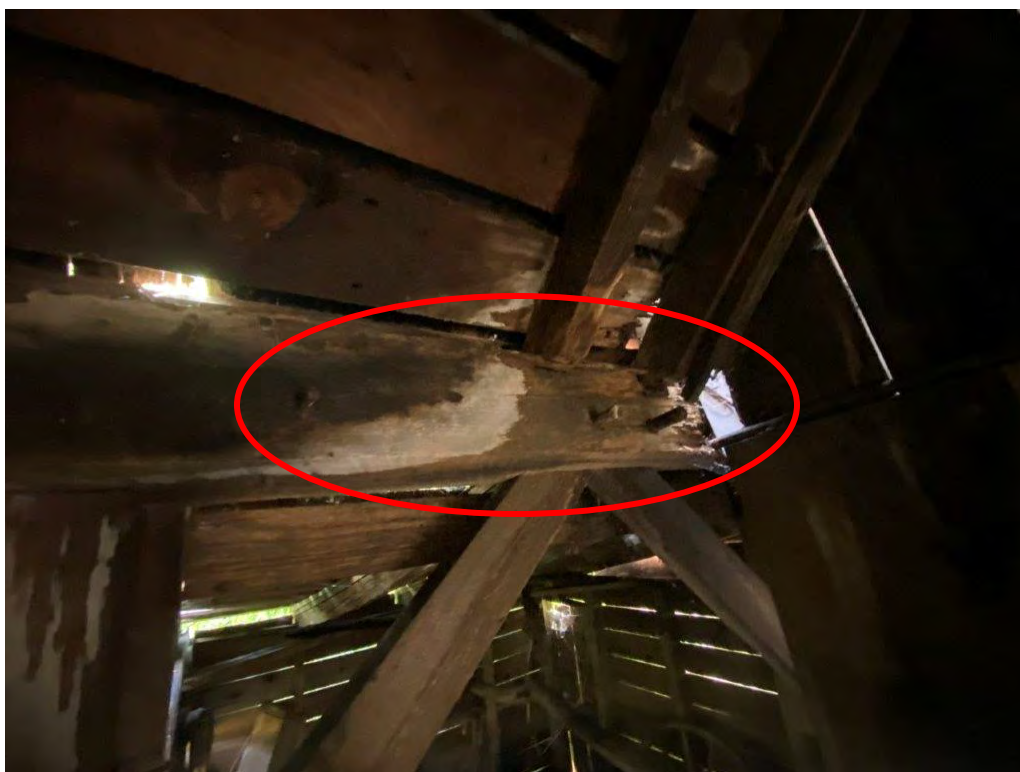
Photo 36: Structure (8), rotting on southeast side wall plate near chimney shaft

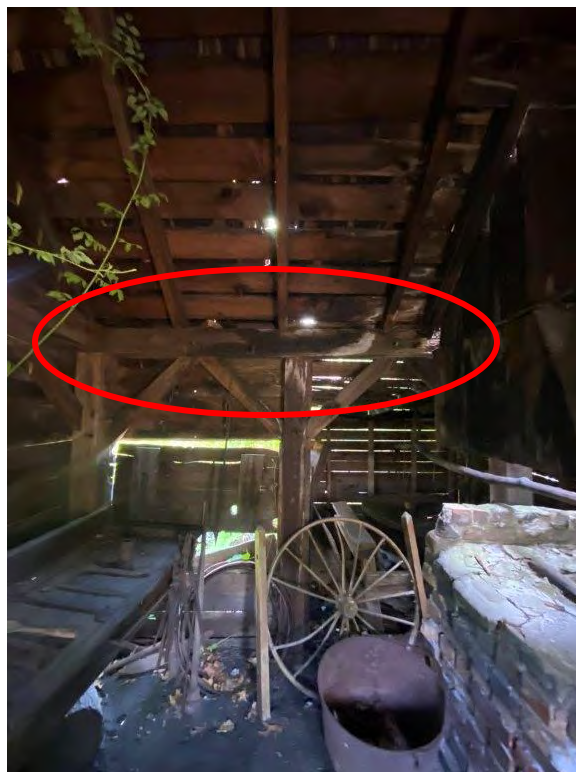
Photo 37: Structure (8), rotting post and wall plate at southeast wall with missing boards

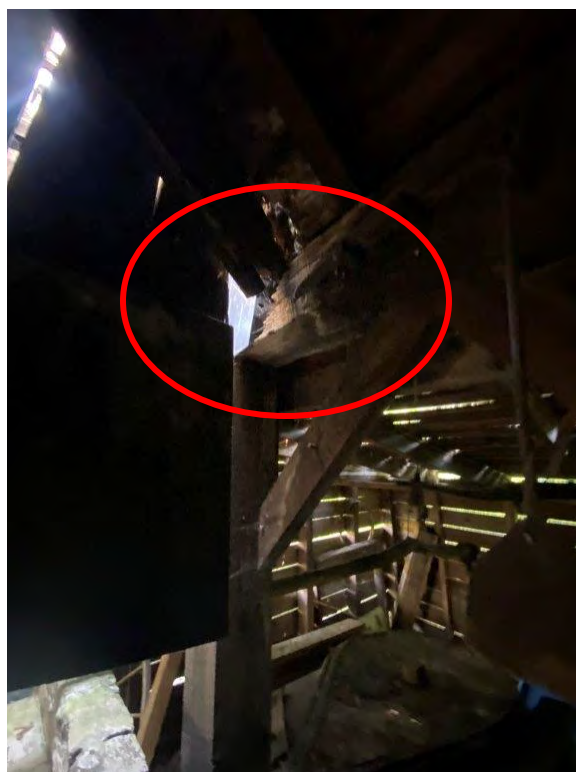
Photo 38: Structure (8), rotting on southwest side of wall plate near chimney shaft

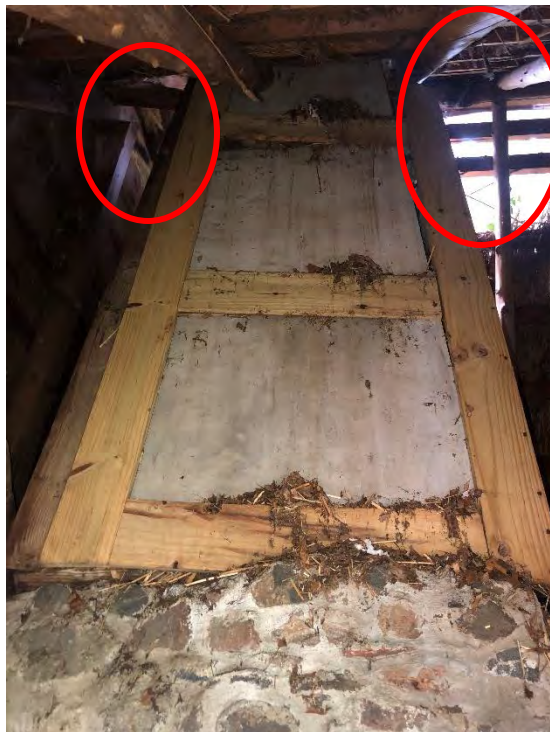
Photo 47: Structure (10), south side of chimney showing missing roof

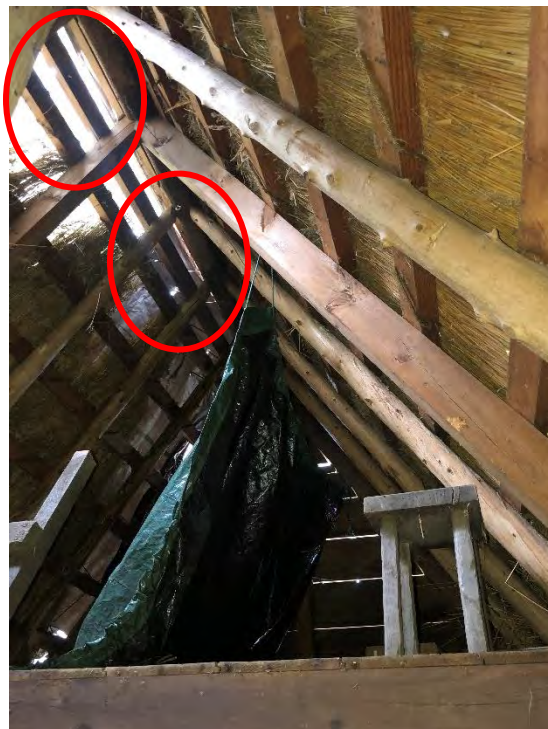
Photo 48: Structure (10), missing roof at north side of cottage with rotting rafters

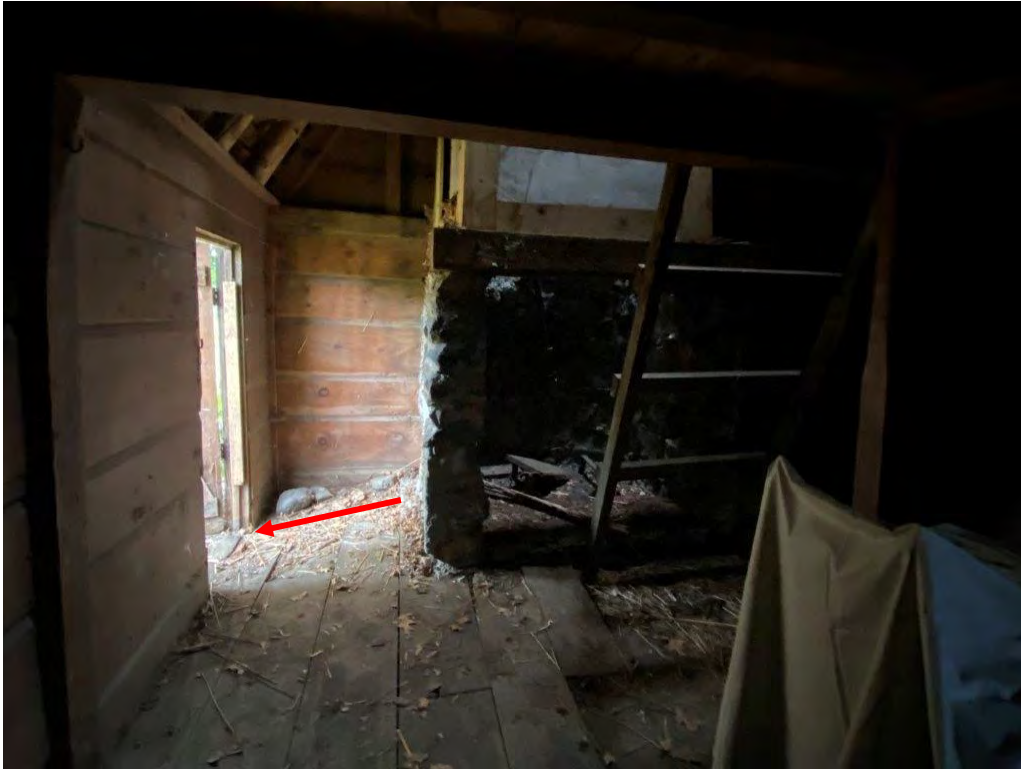
Photo 49: Structure (10), sloping floor at southwest corner
