Old Town Hall and Artists' Row Assessment Report

CITY OF SALEM

April 20, 2020

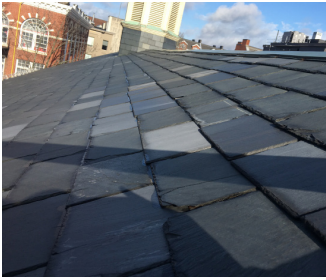
Figure 1 Slate roof North elevation

There is a slate gable roof system in fairly good condition at the Old Town Hall. With limited visual inspection, the team inspected the north side through the roof hatch. No leaks were observed from the roof membrane in the attic. However, a few items of note were observed:

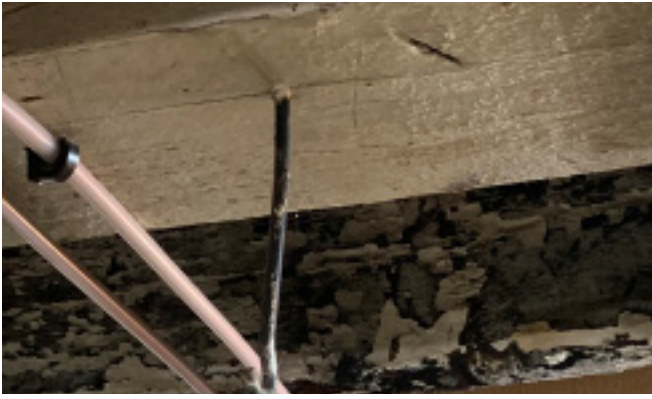
Figure 5

- Dark burning stain on floor joists
- Storage needs to be organized. Poor or no ventilation
- We found a puddle of water inside the electrical room
- There is no sump pump at the site south exit
- Crack on the foundation wall on the North elevation

Figure 5: Dark burning stain on floor joists (basement)

6. Repair the cracks on the CMU wall on the North Wall
7. Inspect burned wood floor joists to structural integrity is not compromised
8. No mold was found but ventilation is needed
9. Redo the bathrooms to accommodate more people, especially when there is activity in the building
10. Replace some of the granite pavers in the pedestrian walkway
11. Clean and organize the basement

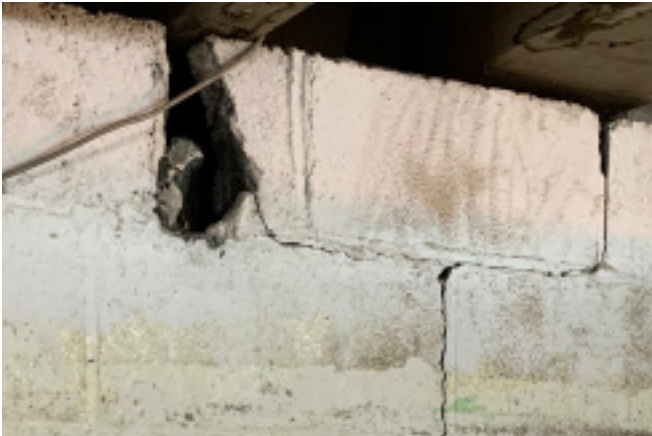
Figure 6

Figure 6: Crack in north foundation wall

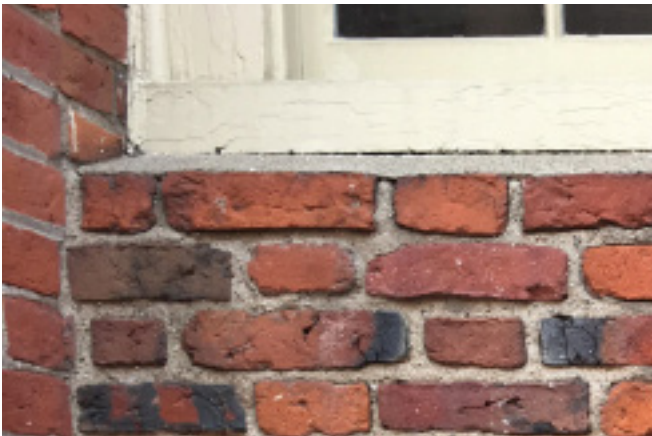
Figure 7

- Window frames are in distress despite restoration
- Red and mixed bricks need to be re-pointed in several sections on all elevations.
- Cracks were observed on the entry doors
- The decorative trims around the windows are in great shape

Figure 7: Wood Window frame in distress (N. Wall)

1. Repair and re-point red bricks on all elevations
2. Replace or restore main front and back wood doors
3. Repair window frames from the outside
4. Inspect roof and attic annually for leaks
5. Replace fascia board on the East and West elevations

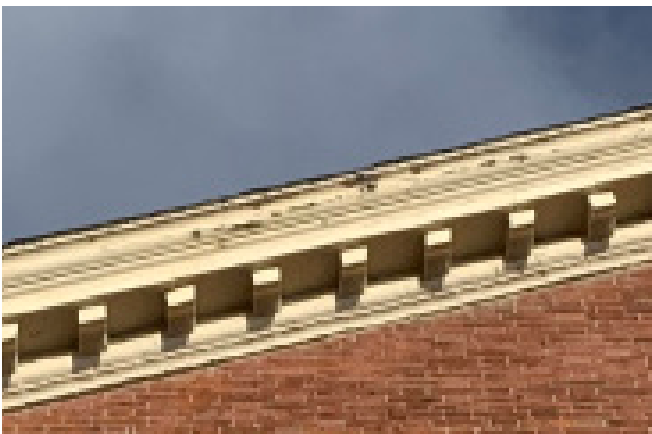
Figure 8

Figure 8: Barge board trim in distress (Needs to be restored)

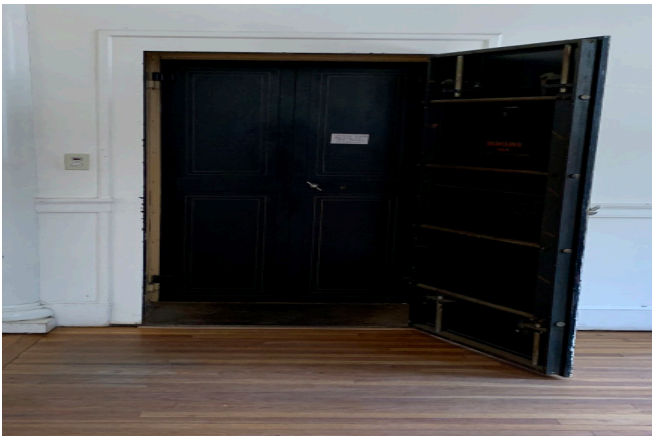
Figure 11 Vault / Storage for the City

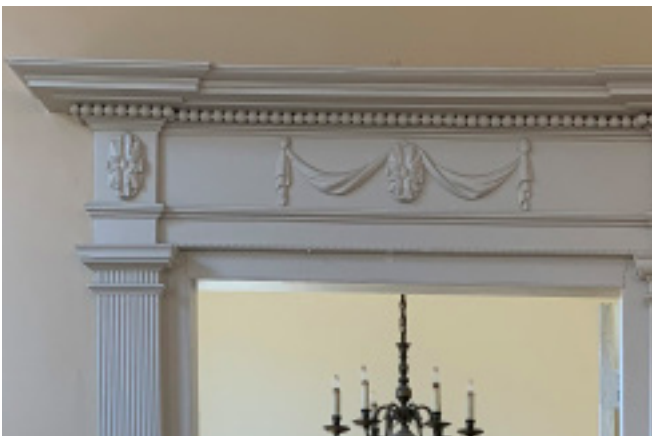
Figure 12

Figure 12: Decorative Trim Molding entering the Colonnade

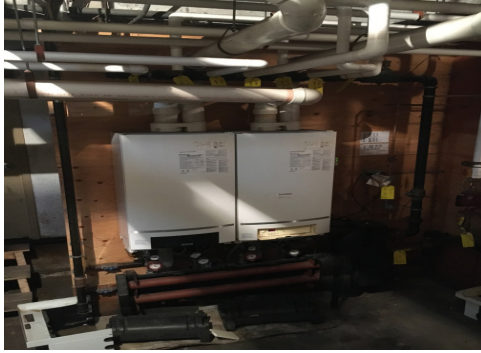
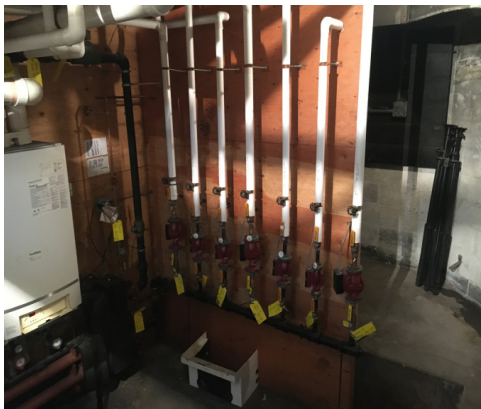
- The building heating system consists of condensing gas boilers, heating hot water pumps and piping serving radiators throughout the building. The heating system is approximately 10 years old and appears to be in good condition. (Figures 17, 18, 19)

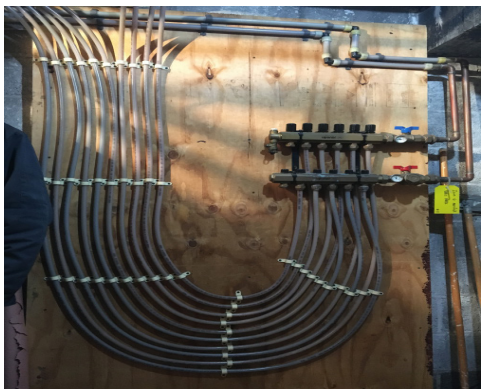
Figure 19 (Photo 6)

- A combination of copper and PEX piping was used for heating hot water piping. In general, pipe insulation was incomplete. Fiberglass pipe insulation was observed on portions of the copper piping, however, insulation was not continuous at pipe hangers, valves and some fittings. There was no insulation provided on PEX piping although it is required by energy code. Recommend providing insulation per IECC.

Figure 19: Radiators piping

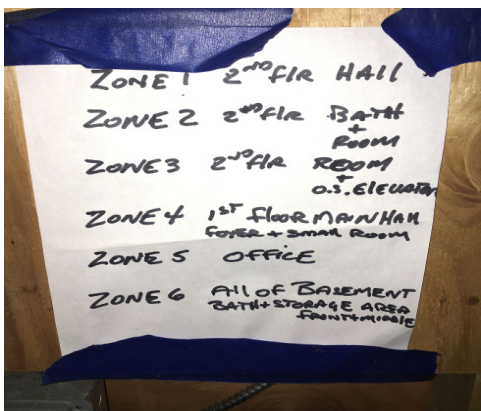
Figure 20 (Photo 8)

- Pipe and equipment labeling is very minimal. A handwritten note is provided to indicate hot water system zoning. (See Figure 20)
- Ducted toilet exhaust fans are provided for each bathroom on the lower level. The fans were functional but appear to be past their useful life. The fans were intended to be interlocked with the bathroom light switches, however, at least one fan was wired to the exterior lights, not the bathroom lights. Recommend to be fixed.

Figure 20: Hot water system zoning

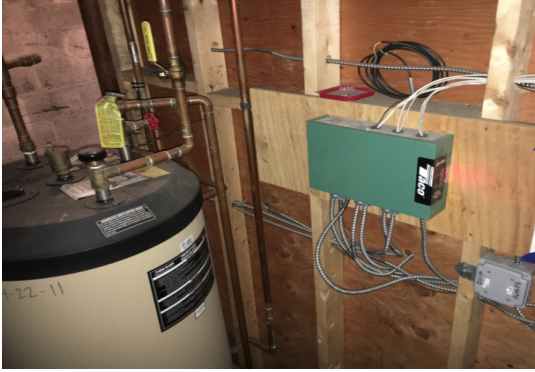
Figure 21

- An indirect domestic water heater (gas) is provided and was installed at the same time as the heating hot water system. A Taco controller is provided to control the boiler system. (Figure 21)
- Sanitary piping was observed in fair condition. The hub and spigot type cast iron piping suggests that the piping is at least 50 years old. (Figure 24)
- Water and gas meters appear to have been replaced recently. (Figures 22, 23)
- Plumbing fixtures appeared to be in good condition. Facilities staff indicated that most fixtures has been replaced approximately 10 years ago.

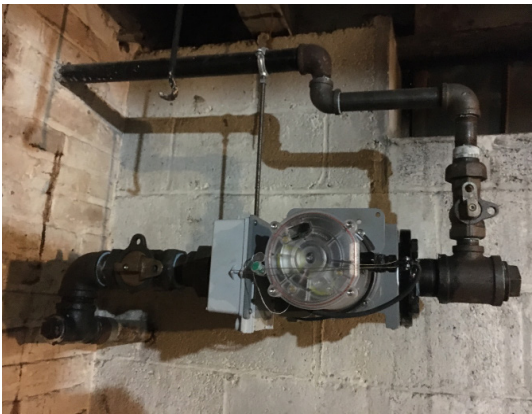
Figure 23

Figure 23: Gas meter

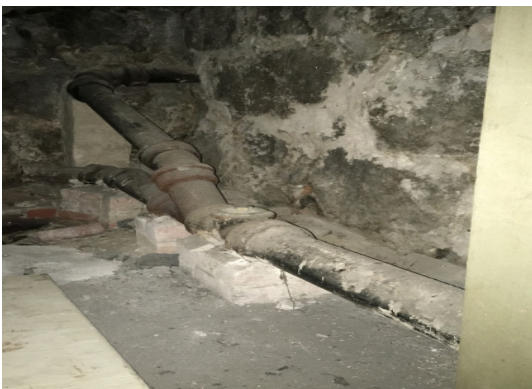
Figure 24

Figure 24: Cast Iron sewer pipe in the basement

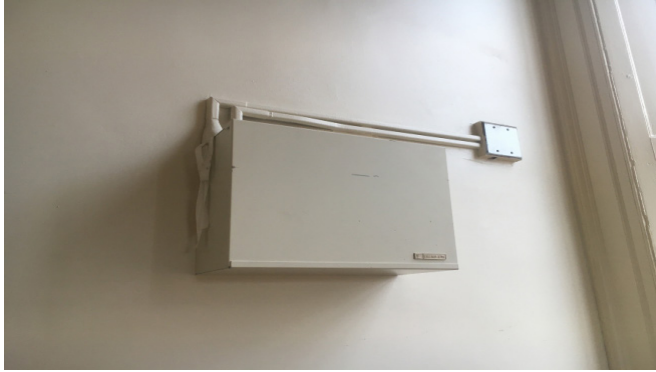
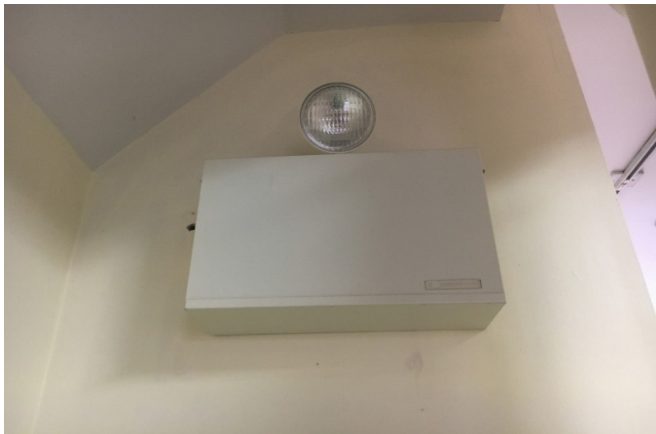
The fire alarm system appeared to be in functional condition and was installed in the 1990's. This system should be tested for verification. No sprinkler system was observed throughout the building (Figure 25)

Figures 25& 26: Battery Box for emergency lighting

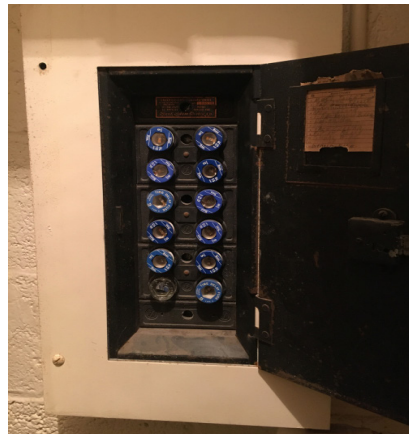
Figure 30

- The electrical infrastructure consists of a 600A main panel and numerous distribution panels of various ages. This building had an old electrical system setup with fuse breaker panel boards. The panel boards have been added onto over the years. Old panels should be considered to be replaced. (Figures 28, 29, 30, 31). In order to determine if the system is able to handle any future upgrades we recommend a load assessment is done.
- Battery boxes are provided for emergency lighting. Facilities staff indicated that the batteries require replacement. Recommend a battery maintenance routine. (Figures 25, 26)
- Lighting controls consist of basic switches and dimming dials that appear old and outdated.
- There is no backup generator at the facility

Figure 30: Fuse Breaker System

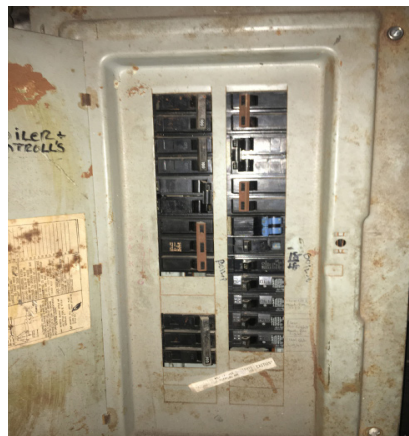
Figure 31

Figure 31: Main Circuit Breaker

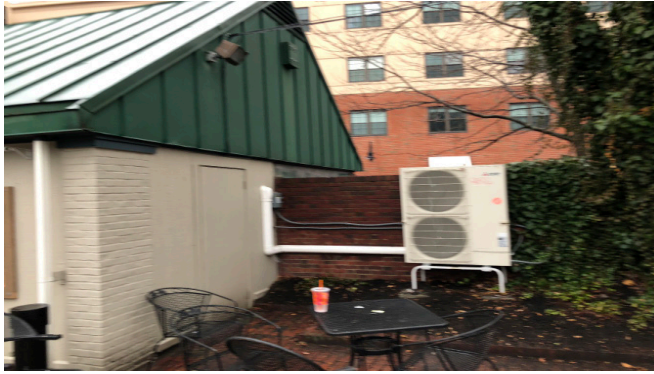
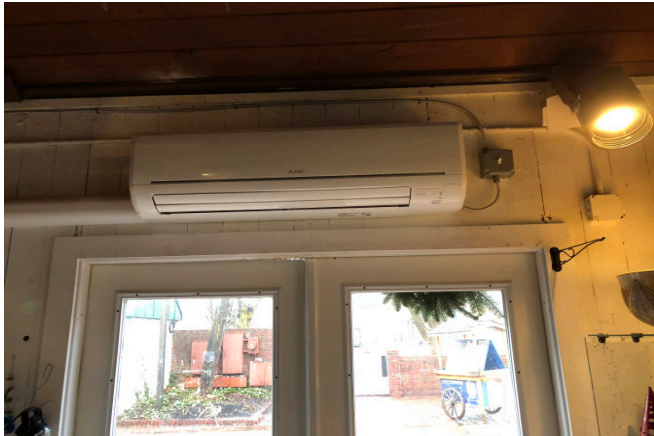
Figure 40/41: Mitsubishi Mini-split system

- This unit is served by a Mitsubishi mini-split system for heating and cooling/tempering. System is 2 years old and is in good condition. (Figure 40, 41 - example)
- The outside air-cooled condensing unit is a 4 ton unit with the ability to support up to 8 indoor fan coil units.
- The unit has 2 indoor, wall mounted, ductless fan coil units. Each fan coil is 2 tons. The fan coils are connected to a branch distribution box that connects to the outside condensing unit.
- Unit has an old obsolete furnace and duct system that should be removed.

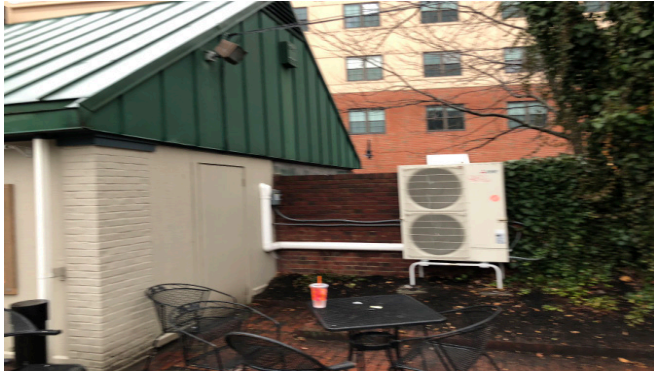
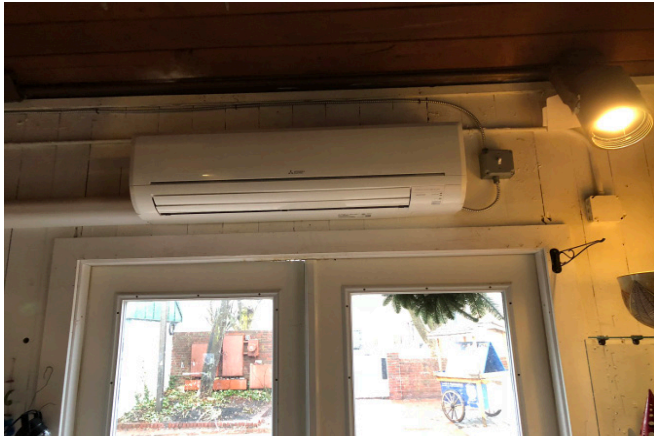
Figure 45/46: Mitsubishi Mini-split system

- This unit is served by a Mitsubishi mini-split system for heating and cooling/tempering. System is 2 years old and is in good condition. (Figure 45, 46 - example)
- The outside air-cooled condensing unit is a 4 ton unit with the ability to support up to 8 indoor fan coil units.
- The unit has 2 indoor, wall mounted, ductless fan coil units. Each fan coil is 2 tons. The fan coils are connected to a branch distribution box that connects to the outside condensing unit.
- This unit has an exhaust system for a kiln provided by the current tenant

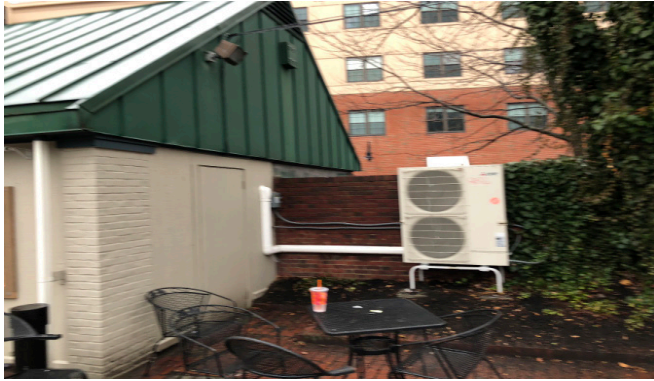
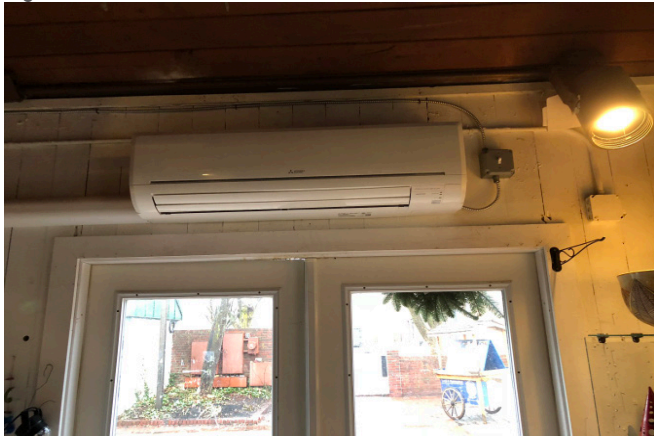
Figure 51/52: Mitsubishi Mini-split system

- This unit is served by a Mitsubishi mini-split system for heating and cooling/tempering. System is 2 years old and is in good condition. (photo 51, 52 - example)
- The outside air-cooled condensing unit is a 4 ton unit with the ability to support up to 8 indoor fan coil units.
- The unit has 2 indoor, wall mounted, ductless fan coil units. Each fan coil is 2 tons. The fan coils are connected to a branch distribution box that connects to the outside condensing unit.

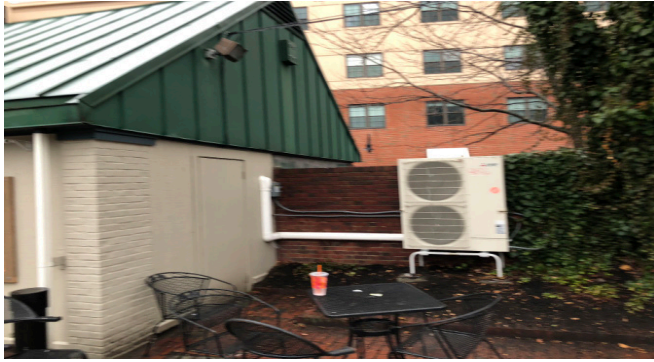
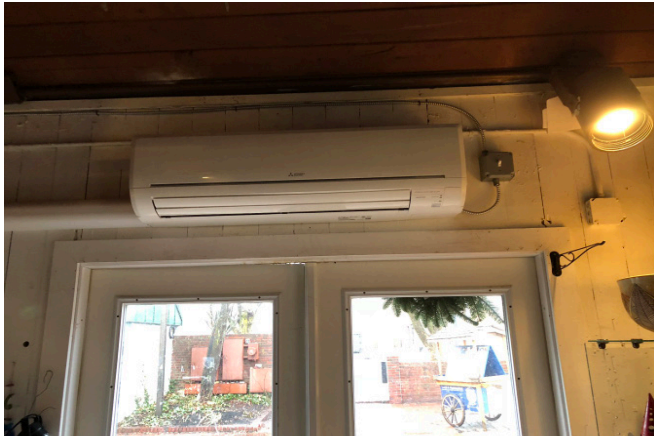
Figure 57/58: Mitsubishi Mini-split system

- This unit is served by a Mitsubishi mini-split system for heating and cooling/tempering. System is 2 years old and is in good condition. (photo 57, 58 - example)
- The outside air-cooled condensing unit is a 3 ton unit.
- The unit has 1 indoor, wall mounted, ductless fan coil units.
- Unit has an old Modine heater that should be removed

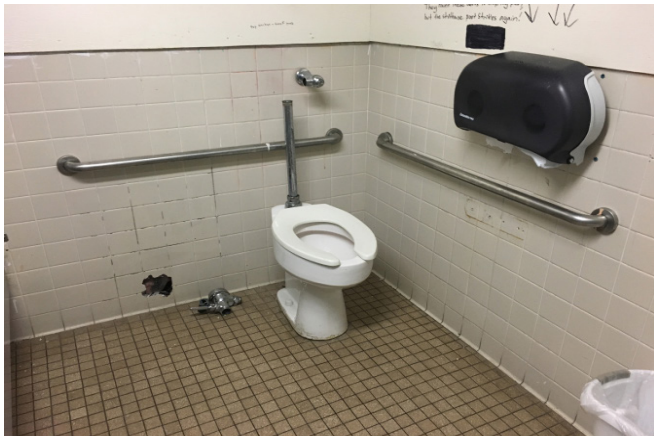
Figure 61

- The partitions and stalls are in bad shape.
- The bathroom Manual Flush Valve was damaged
- The floor had ceramic tiles and the wall had drywall.
- There is a Women's and Men's restrooms

Figure 61: Damaged Flushometer

- Repairs all the chipped coated metal in Stall #2, #1 and #5
- The south elevation of roof in Stall #1 needs to be painted
- Public bathrooms are in poor condition and need a complete make-over
