# ROAD SAFETY AUDIT

Boston Street at Proctor Street/Bridge Street and Essex  
Street at Boston Street to Jackson Street

City of Salem

April 2019

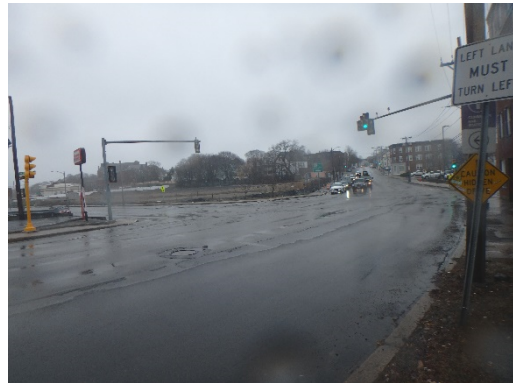
Observations during the field walk noted faded pavement markings throughout the whole intersection, particularly on the eastbound and westbound approaches. Approaches to the intersection lack lane use arrows, likely leading to an increased number of sideswipe crashes. In addition, crosswalk pavement markings are significantly faded.

**Image 1: Worn Pavement Markings on Boston Street Eastbound**

- Consider re-striping the existing pavement markings within the intersection and provide lane use arrows on all approaches to provide better lane definition and clarify which movements can be made from each lane.
- Consider restriping lane designations at Pope Street.
- Consider striping shoulders in locations where lane widths are wide enough to be misconstrued as multiple lane travel. Additionally, striped shoulders will help decrease travel speeds.
- Consider shifting the double yellow centerline on Boston Street westbound south to accommodate two right turn lanes (one to Goodhue Street and the other to Bridge Street) and one through-left turn lane.
- Consider adding pavement markings to enhance bus stop visibility.

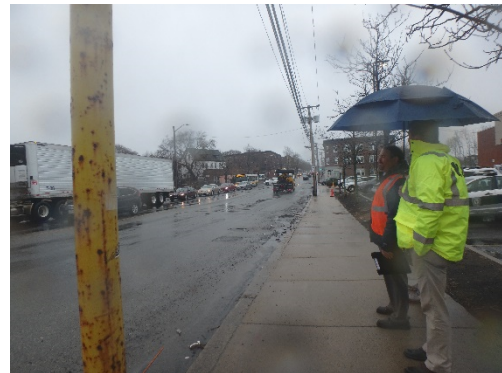
Also noted by audit participants was that the lane width on the east leg of Boston Street near the intersection is extremely wide for the one lane section of roadway and likely should be defined using shoulder pavement markings. Approaching each leg of the intersection the striping to delineate each lane is completely worn away. All approaches to the intersection consist of two lanes and without the striping it is difficult for motorists to determine which lane to be in. Furthermore, it was noted during the pre-audit meeting that there is a large number of vehicles turning right from Boston Street westbound to either Goodhue Street or to Bridge Street.

**Image 2: Wide Travel Lanes on Boston Street**

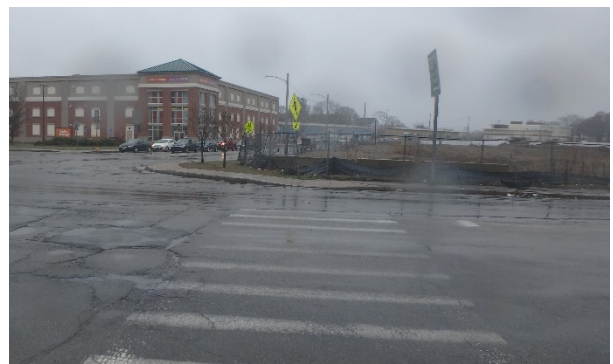
Pedestrian crossing pavement markings are extremely worn on all approaches. Additionally, a number of wheelchair ramps within the intersection are not ADA compliant. An additional pedestrian crossing has been installed north of the intersection of Bridge Street and Boston Street at Bridge Street and Goodhue Street. A pedestrian crossing exists across Goodhue Street however, there is no sidewalk on the south side of the street. It was noted by audit members that there is a residential development underway northeast of the intersection of Goodhue Street and Bridge Street. This gap in sidewalk on the south side of Goodhue Street between the residential development and Bridge Street may potentially pose a future risk as increased pedestrian traffic on Goodhue Street is anticipated.

**Image 3: Faded Crosswalk on Boston Street with Pedestrian Signing**

- Reconstruct wheelchair ramps throughout the intersection to meet ADA compliance.

- Consider consolidating the crosswalk across Bridge Street at the signal and the crosswalk just to the north at Goodhue Street into one crosswalk.
- Consider adding a crosswalk along the western approach to the intersection.
- Consider installing pedestrian signal equipment and incorporating a pedestrian phase to the signal.
- Consider repainting all crosswalks and providing proper maintenance to ensure crosswalks remain visible.
- Consider tightening up the intersection to shorten pedestrian crossings or consider adding pedestrian refuge areas in between long crossings.
- Consider reconstructing the curbing throughout the intersection.
- Consider removing the number of obstructions on the southwest corner of the intersection that narrow the pedestrian walkway.

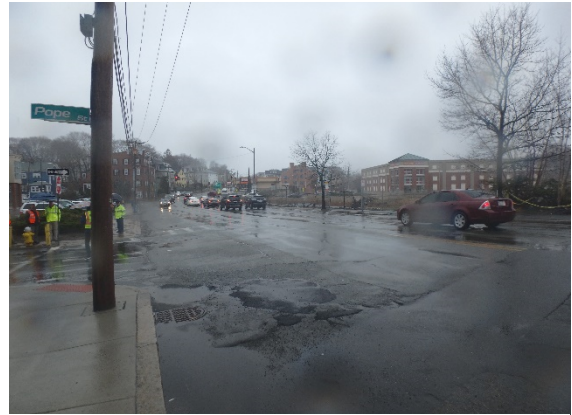
**Image 4: Missing Advance Lane Use Signage on Boston Street**

- Maintain existing signage and consider updating worn and faded signage to MUTCD standard signs.
- Consider installing advance lane use signage on all approaches to the intersection.

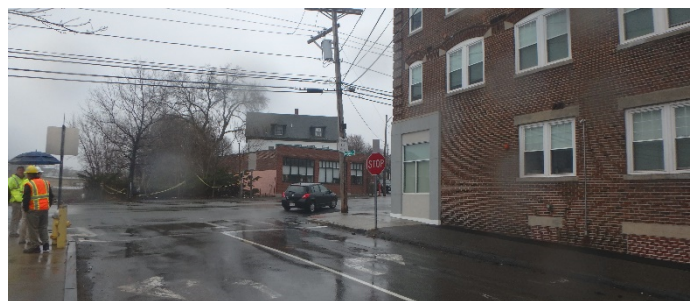
During the field walk audit members noted that there is no pedestrian signage at the intersection of Pope Street and Boston Street. During the pre-audit meeting it was noted that a bicyclist was hit in the crosswalk across Pope Street. Furthermore, there is only one STOP sign (R1-1) on the righthand side of the approach which may encourage motorists to turn left from Pope Street onto Boston Street from the righthand turn lane.

**Image 5: Missing STOP Sign on Pope Street**

<b>Signage</b>	Consider removing unnecessary signage throughout the intersection to reduce sign clutter.	Low	Short-Term	Low	City of Salem
	Consider adding a stop sign on the left-hand side of the Pope Street approach to Boston Street.	Medium	Short-Term	Low	City of Salem
	Maintain existing signage and consider updating worn and faded signage to MUTCD standard signs.	Low	Short-Term	Low	City of Salem

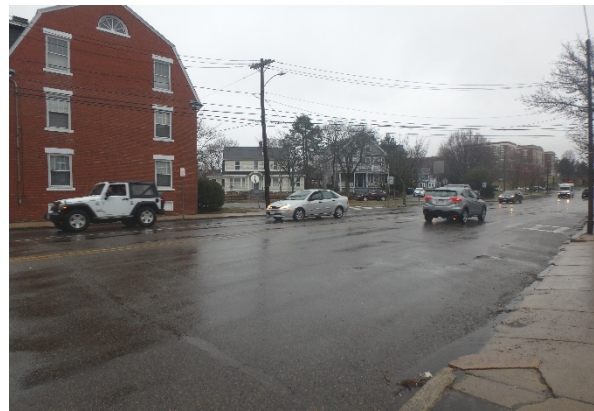
It was noted during the field walk that Essex Street is not striped as one or two lanes in both the northbound and southbound directions, particularly in the vicinity of the CVS. Currently there exists a small sign on Essex Street southbound telling motorists that it operates as single lane, however the lane is particularly wide without striped shoulders, leading motorists to believe it may operate as two lanes. Traveling northbound Essex Street is meant to be two lanes, however lane lines and shoulders are not striped to delineate each lane.

**Image 6: Wide Travel Lane on Essex Street Southbound**

- Consider striping the shoulders to define and narrow travel lanes, particularly on Essex Street southbound.
- Consider re-striping all existing pavement markings throughout the corridor and implement lane use arrows to define lane usage on intersecting side streets.
- Repaint the “do not block the box” pavement marking in front of the firehouse to prevent vehicles from stopping in front of the firehouse exit.
- Consider striping Essex Street to formalize the two travel lanes northbound and reduce the frequency of sideswipe and angle collisions.

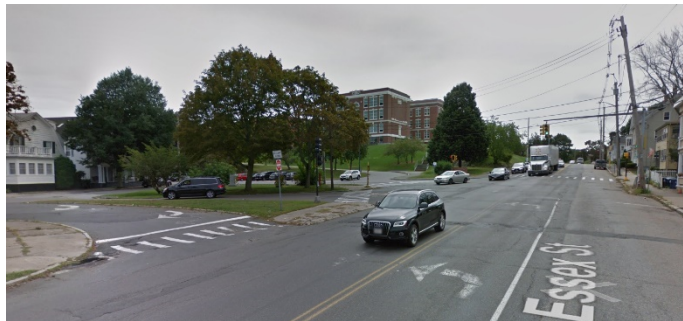
Further down Essex Street at the intersection with Jackson Street, the audit team noted that Dalton Parkway was not included in the signal. Considering the proximity of Jackson Street to Dalton Parkway it seemed this traffic control may be confusing to motorists entering or exiting Dalton Parkway.

**Image 7: Proximity of Dalton Parkway to Jackson Street Traffic Signal**

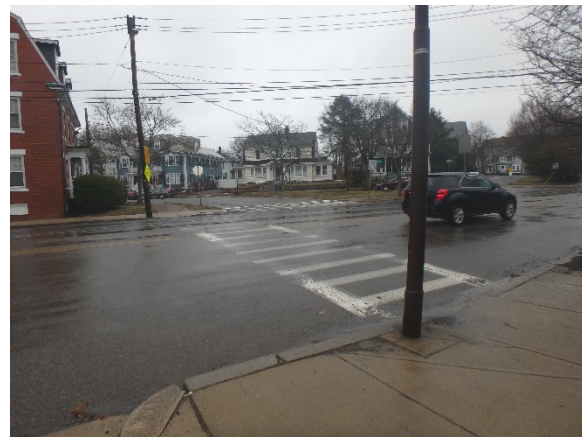
There is a lack of pedestrian accommodations along the Essex Street corridor which creates a safety concern for pedestrians wishing to traverse the corridor. Sidewalks are provided along both sides of Essex Street. A crosswalk is provided across Essex Street in the vicinity of Warren Street to the CVS parking lot. Non MUTCD signage is provided on the east side of the crosswalk and no signage is provided on the western side making the crosswalk less noticeable to motorists.

**Image 8: Pedestrian Crossing from Warren Street to CVS Parking Lot**

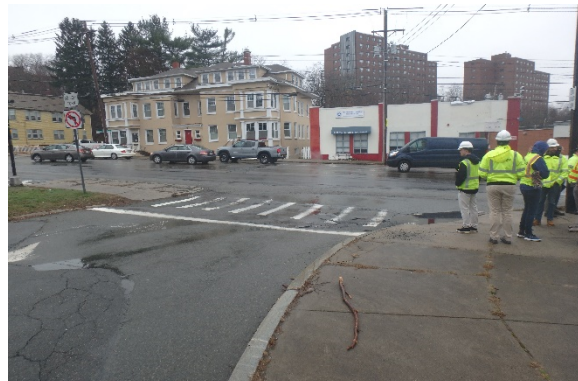
During the field walk audit members noted that similar to the intersection of Boston Street at Proctor Street/Bridge Street the Essex Street corridor had a large amount of sign clutter. Most signs were not MUTCD standard signs and several were faded and missing words. A majority of crosswalks were missing pedestrian signage and the right turn from Dalton Parkway to Essex Street was missing a STOP sign. Sections of Dalton Parkway and Warren Street operate as one-way however there was no signage to notify drivers.

**Image 9: Missing STOP Sign Dalton Parkway**
