SALEM'S PIONEER VILLAGE AND CAMP NAUMKEAG

Background Information for a Consultation with the Salem Historic Commission

June 2, 2021

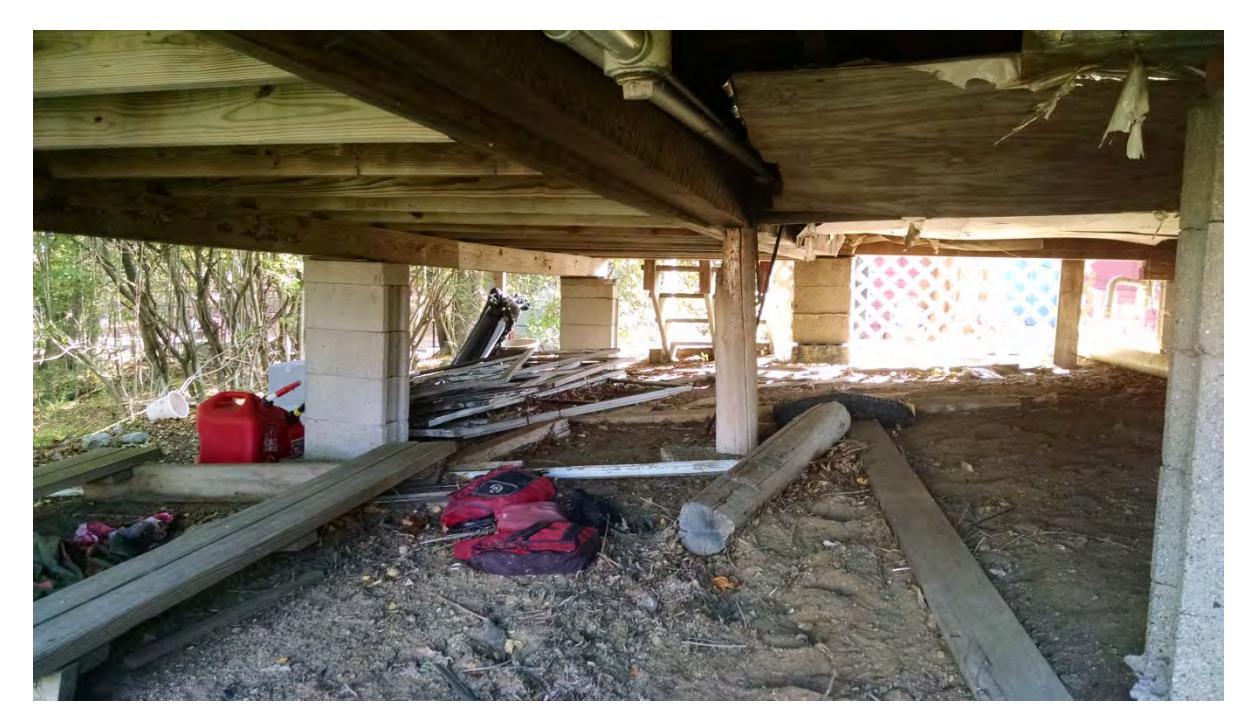
With limited or no physical connections tying the structure to the piers these buildings lack the basic hold down anchoring requirements of a common residence. As they are elevated on piers and adjacent to the coast these buildings are subject to a higher probability of damage in a severe wind event.

Typical pier construction

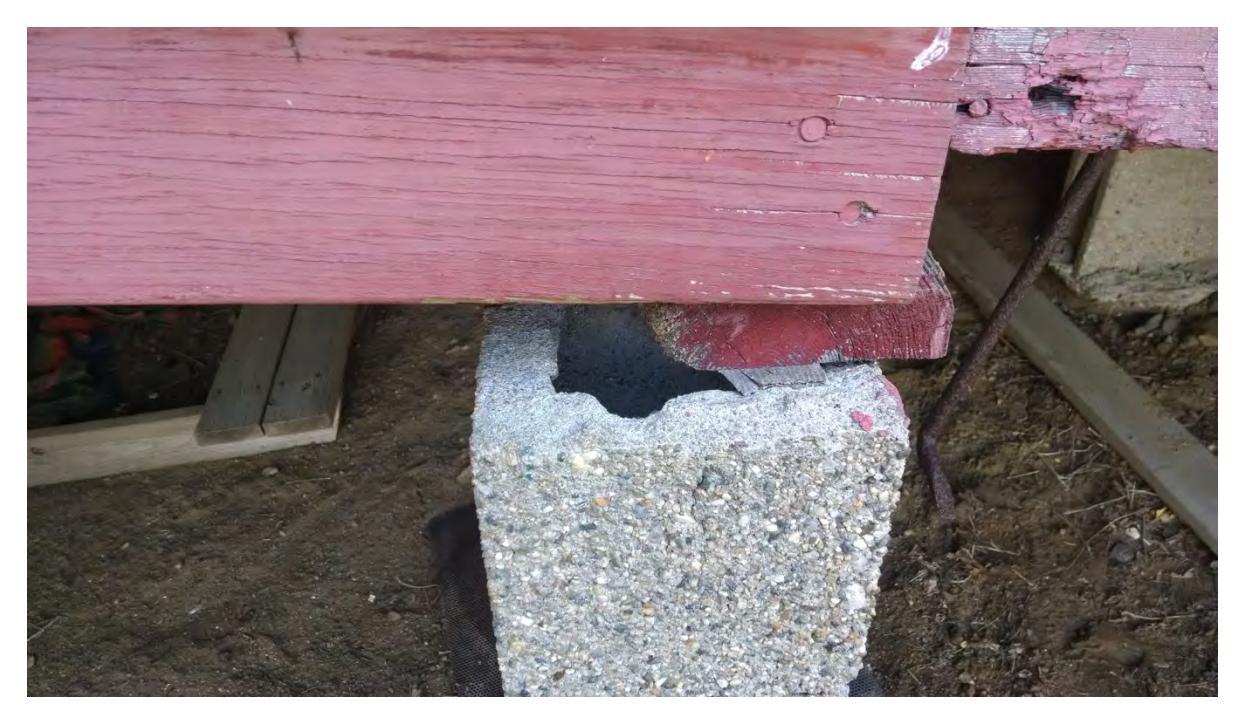
Typical unrestrained pier to beam connections

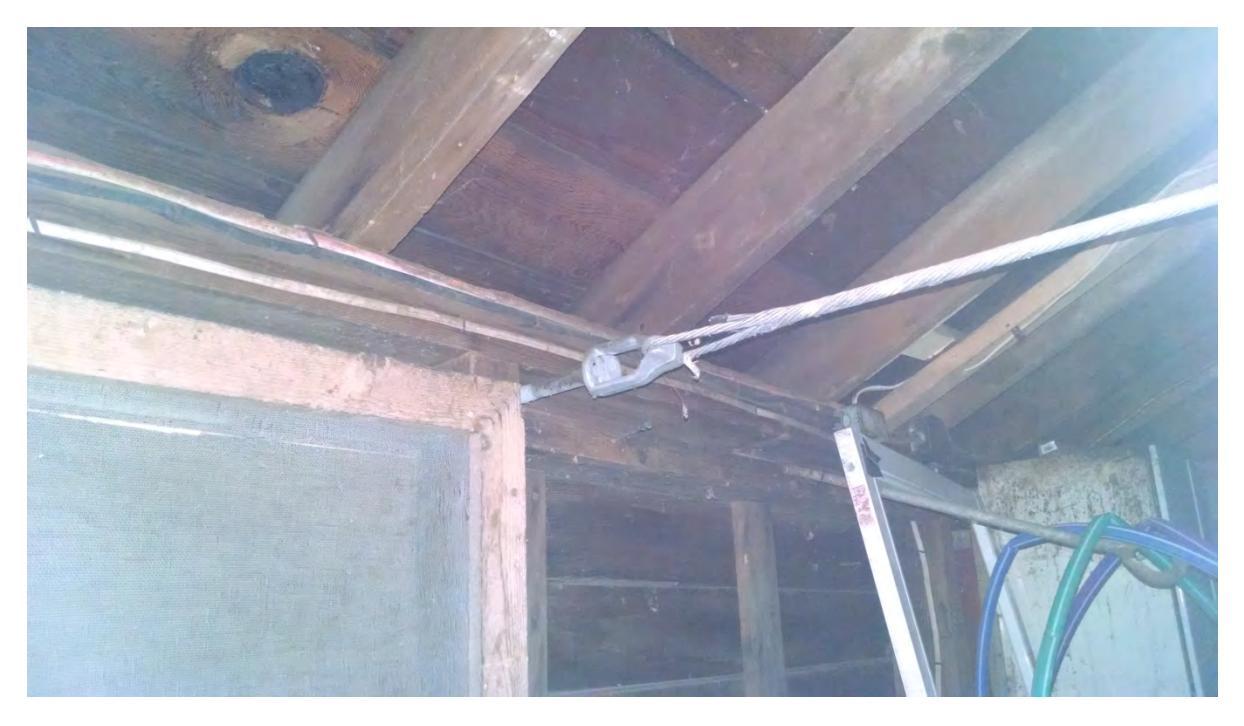
Steel cables added to prevent outward roof thrust.

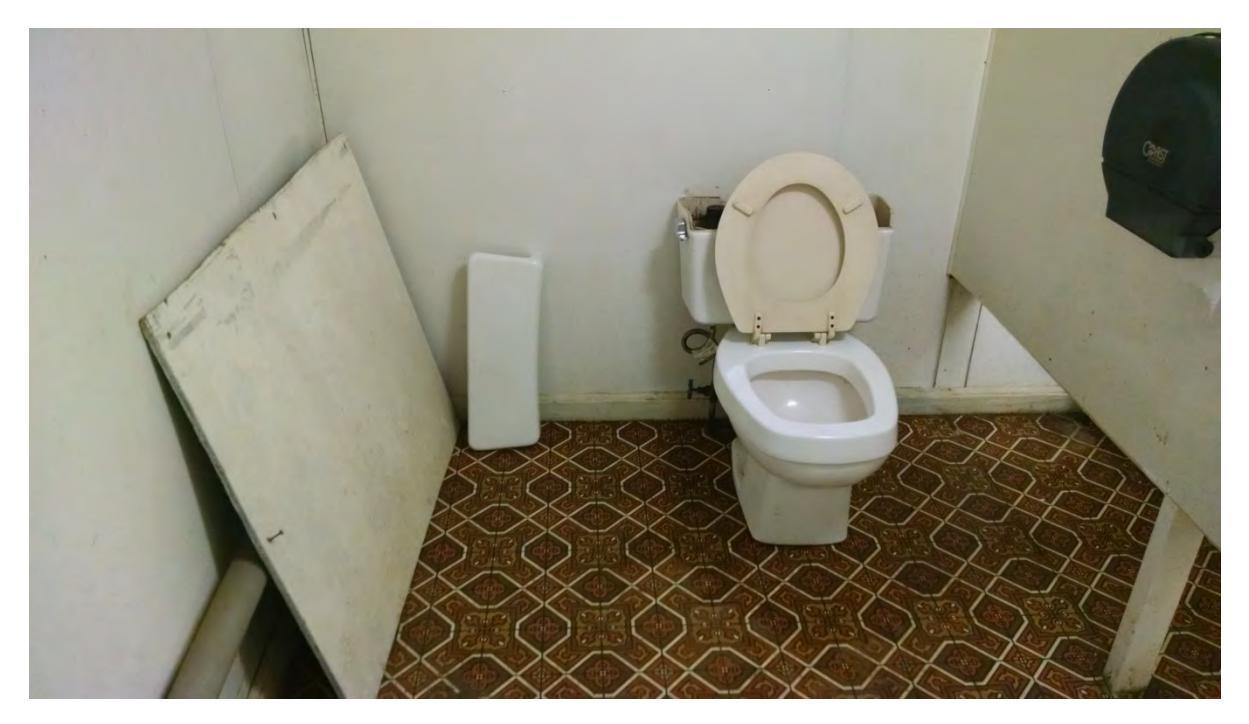
Non-compliant accessible stall. Note Caretakers building electrical conduit feed to the left.

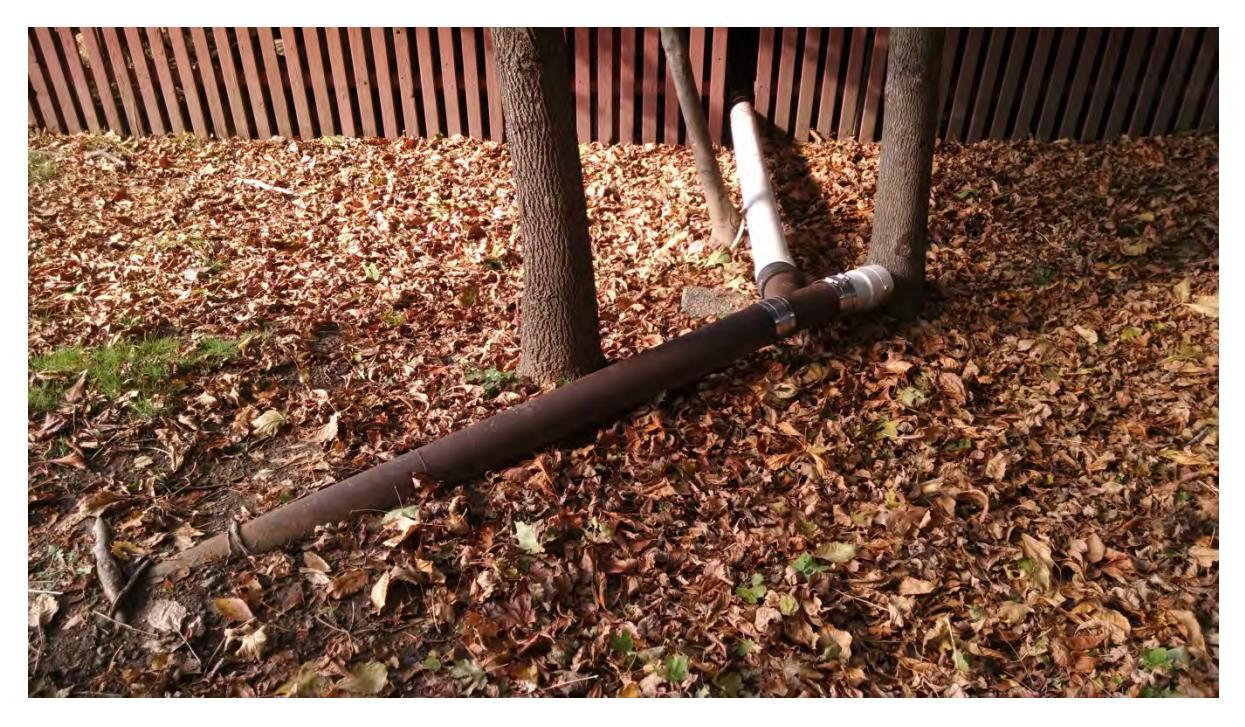
Sanitary service runs above grade in several areas and is subject to frost heaving. Potable water and toilets must be drained seasonally as the nature of a raised structure offers no protection from pipe freezing. The two wooden framed structures that have public restrooms do not have a means to provide hot water.

Exposed sanitary line.

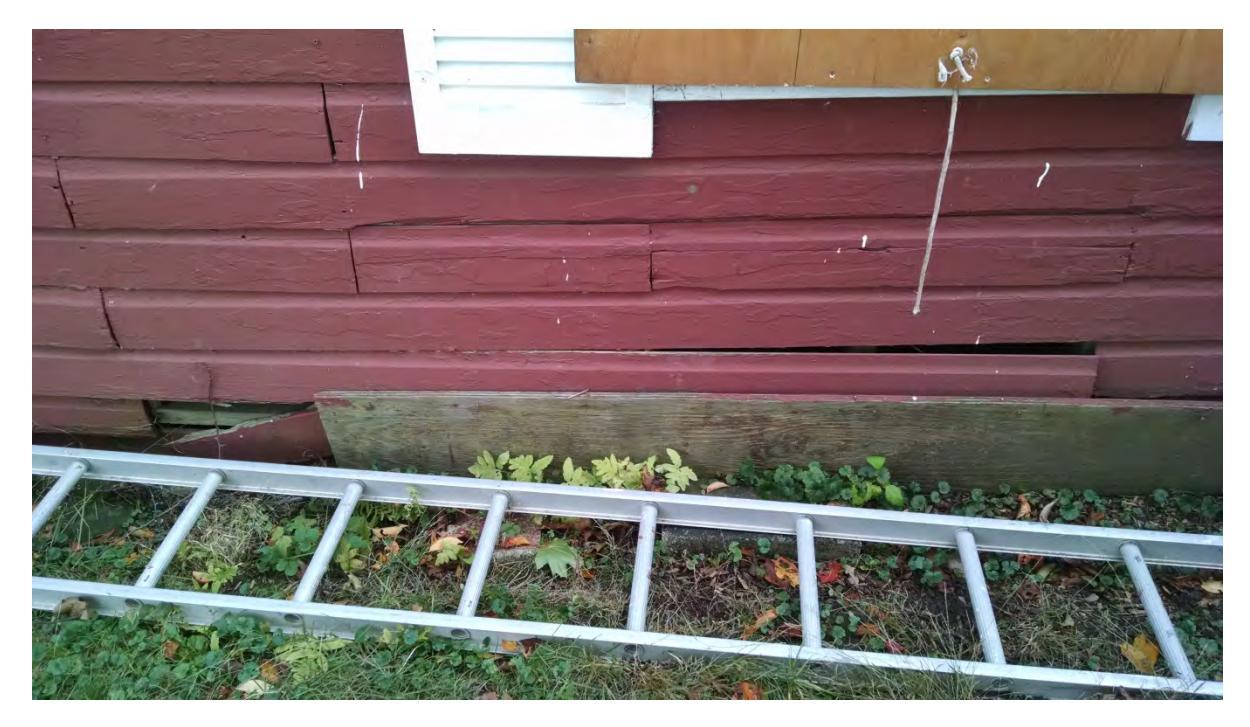
Siding deficiencies

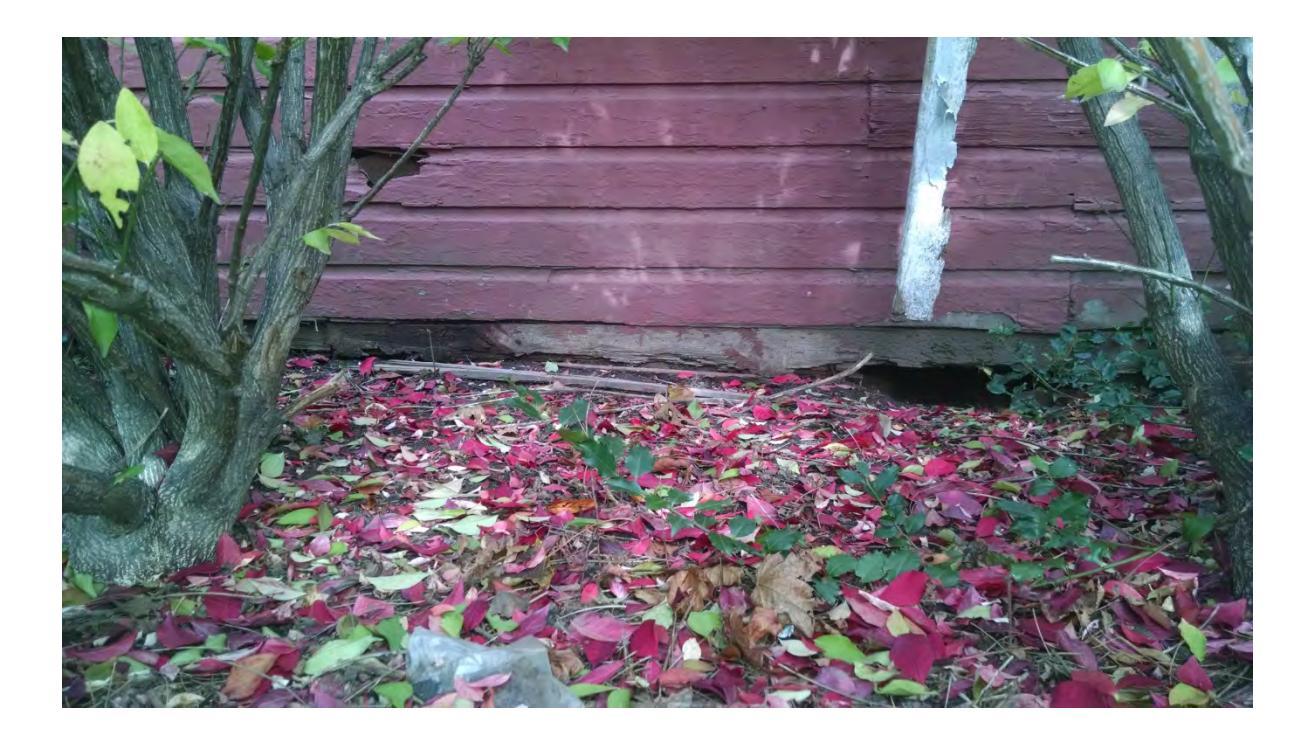
Siding in contact with ground

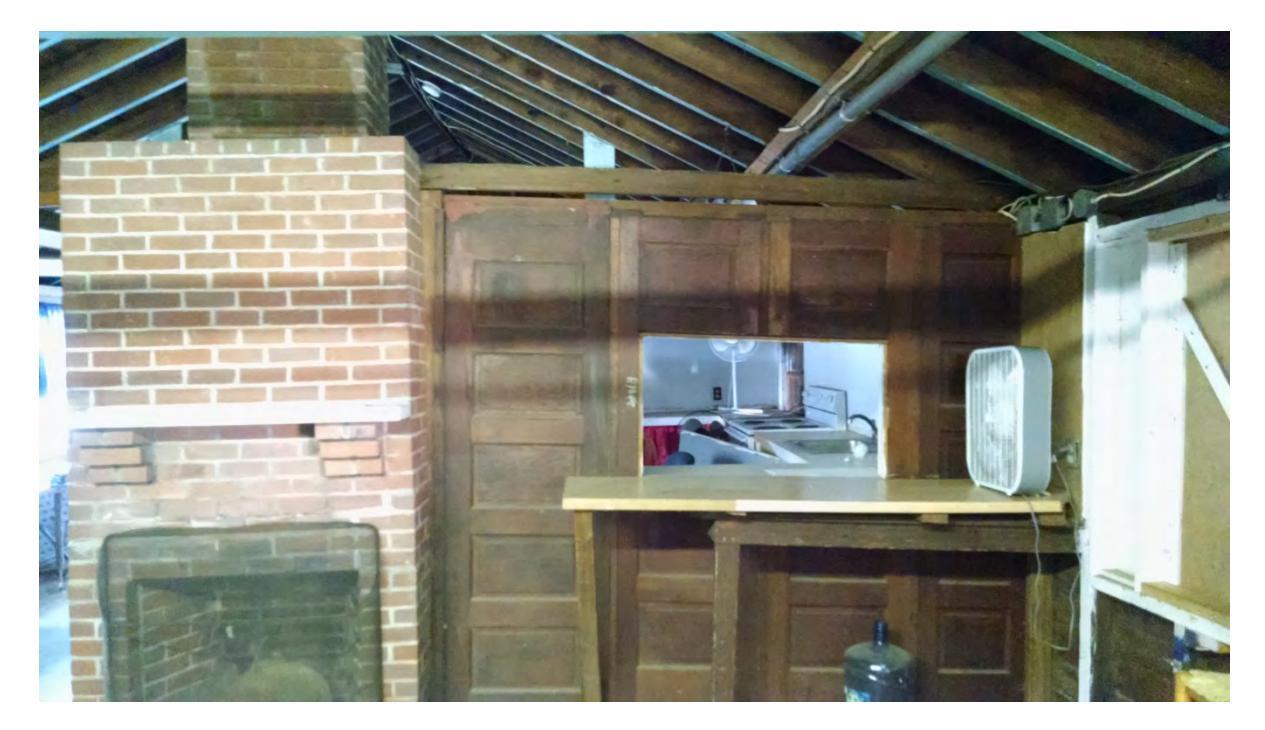
Settlement of the east side of building (3.2 degree floor slope)
