DRAFT 22 February 2022

Reference: Camp Naumkeag Conditions Assessment

Camp Naumkeag Building Evaluation Salem, MA

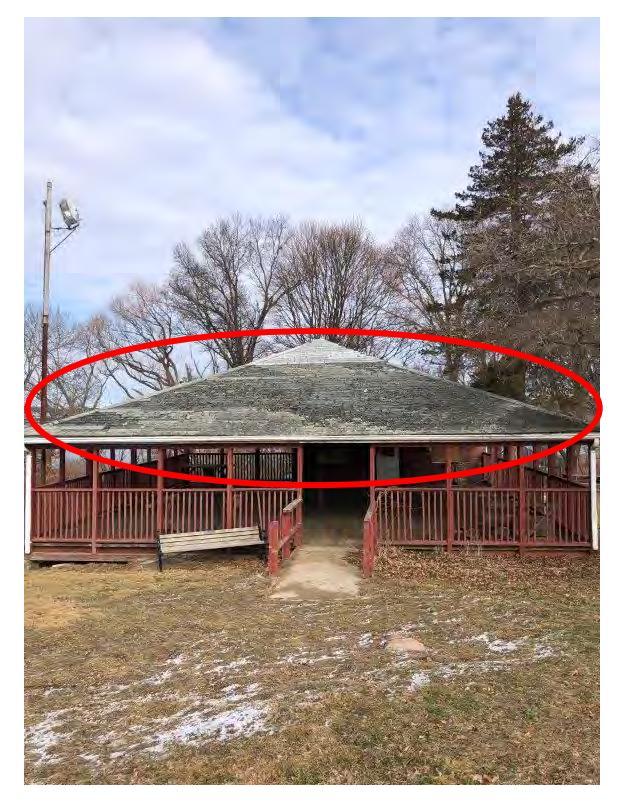
The bottom two-thirds of the pavilion roof is heavily worn and covered in biological growth (please see Photo 1 of the Appendix). The decking beneath the asphalt shingles is water damaged, as seen from the pavilion's exposed underside. Due to the likelihood of water entering into the roofing system and remaining, the sheathing and roof rafters in this area are experiencing deterioration. Photo 2 shows several sheathing boards failing while the surrounding ones are either water damaged or stained with biological growth.

• Part of the deck's sill is built into the grade (near the entry way seen in Photo 1) which will encourage unwanted damage as water from the soil seeps into the exposed wood grain.

Photo 1: Pavilion roof suffering from heavy biological growth

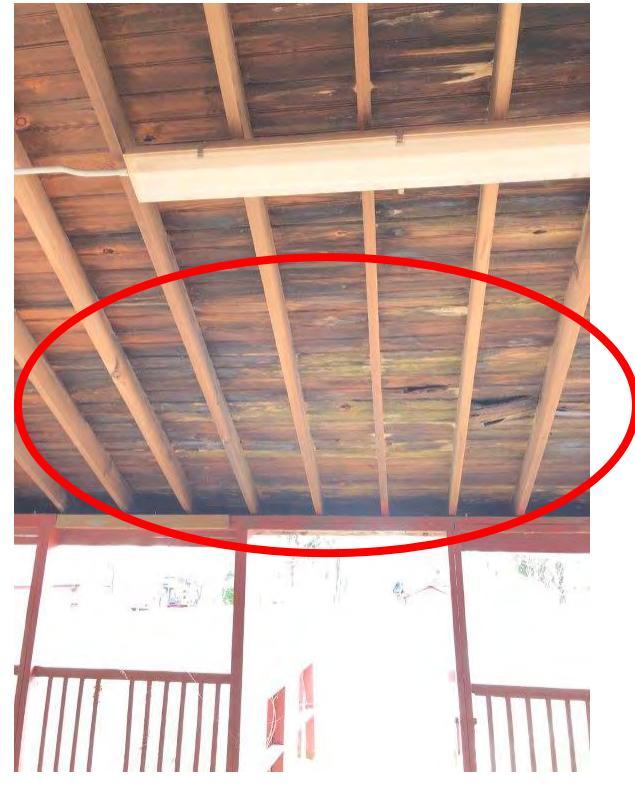
Photo 2: Rot-damaged pavilion roof (facing south)

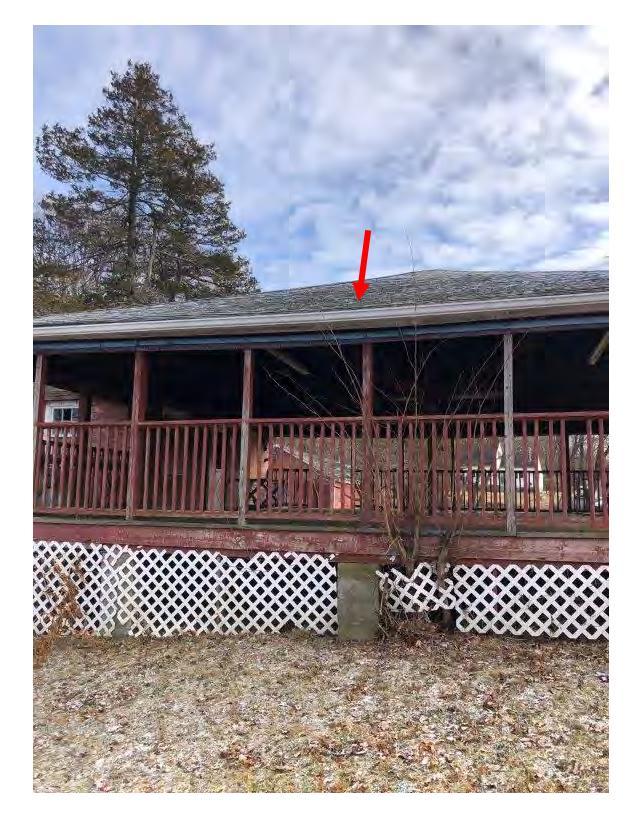
- The pavilion roof on the west side is also experiencing heavy amounts of biological growth, as well as some sagging in the center (Photo 3). Just like at the south side, the rafters and decking are damaged from the water entry and are now rot-deteriorated enough where it is not sufficiently carrying the load.
- At the north end of the west façade, there are wood siding boards missing, exposing the interior wall sheathing and framing. Beneath the opening, the boards that are still intact are bulging out consequently from constant water entry and plant growth along its surface. The facia along the roof eave is also sagging, suggesting that the roofing issues continue at this end. The southernmost window at this elevation also has several broken glass panes, permitting rain and wildlife to penetrate through (Photo 4).

Photo 3: Sagging and damaged pavilion roof (west elev.)

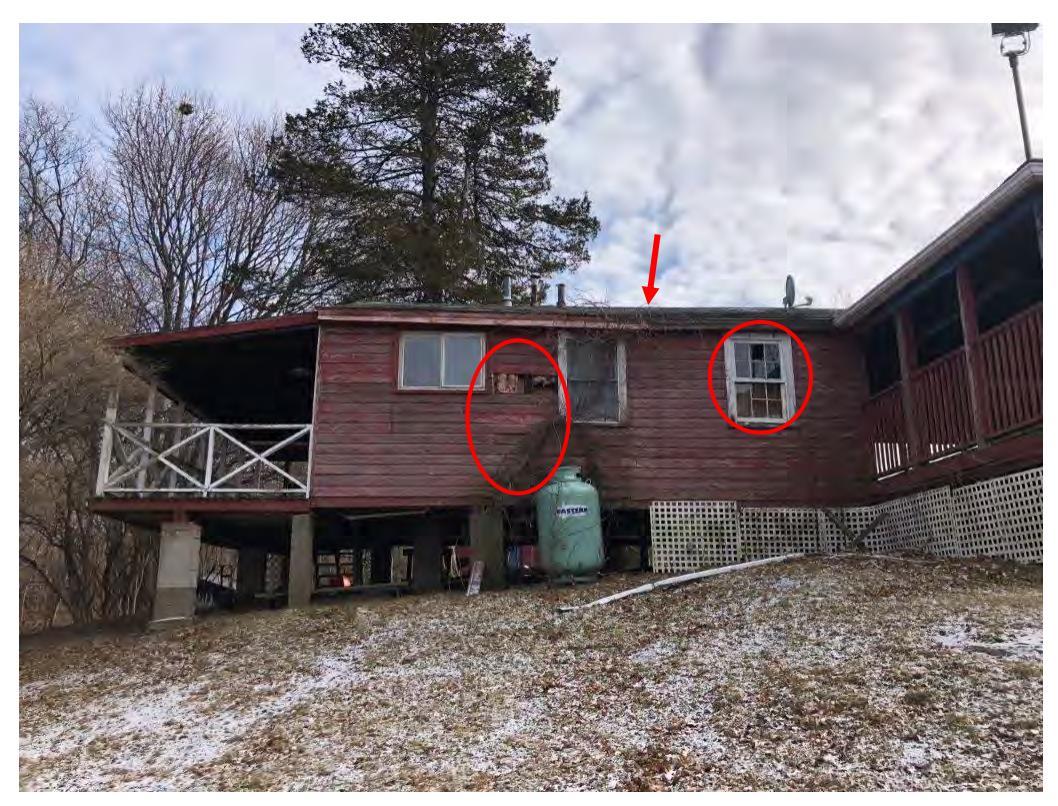
Photo 4: Missing siding, sagging roof, and broken window (west elev.)

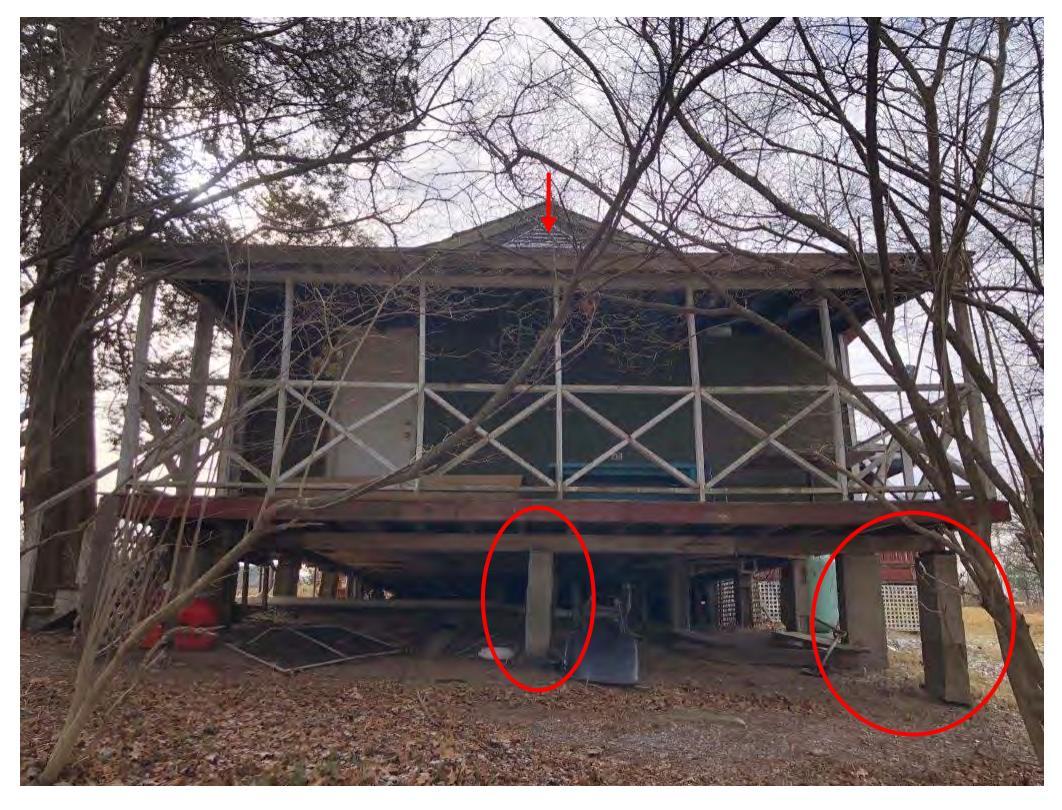
- The north side of Building A has a porch wood deck that overhangs a beam running over the northernmost line of CMU piers and picks up the porch's roof along the outer edge. The cantilevered joists are small for the overhanging span and there appears to be insufficient counterbalance on the interior span to keep the cantilever from tilting outward were the roof to be full of snow and the outer edge of the porch full of people. The beam that runs across the piers below sags, causing the wood deck and roof edge to sag.

- As will be discussed in the "Foundation" portion of Building A, many of these piers are slanted and/or not embedded in grade, meaning they are relying solely on the weight of the structure to keep them from shifting. Additionally, the beams that are supporting the joists of the deck visibly sag, implying the member is overloaded. The dips in the framing members are felt on the deck itself as the decking shifts up and down along the joists. Photo 5 shows an overall view of the deck, its shifted piers, and bending framing members.

Photo 5: Insufficient foundation and sagging floor framing (north elev.)

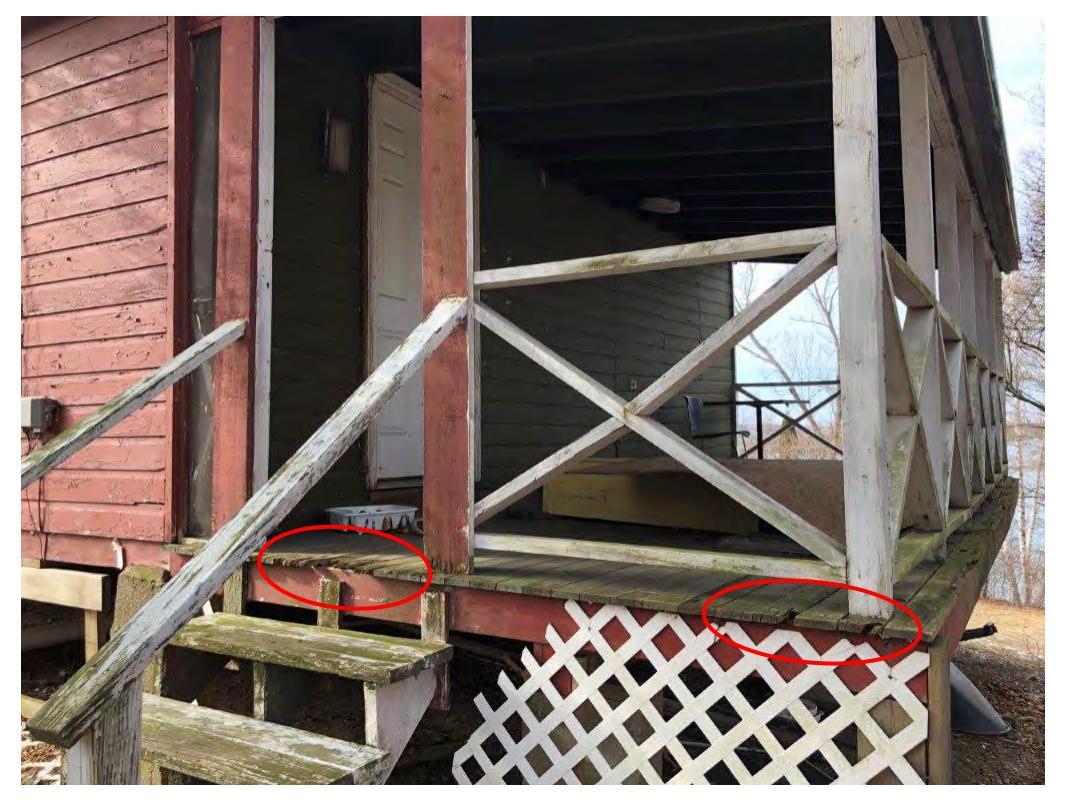
- The wood siding slopes down towards the center of the north wall, following the dip in the floor beams. The decking on the balcony are also suffering end grain damage and biological growth. Photo 6 shows the sloping siding and worn state of the deck.

Photo 6: Sagging clapboard and deteriorated deck ends (northeast elev.)

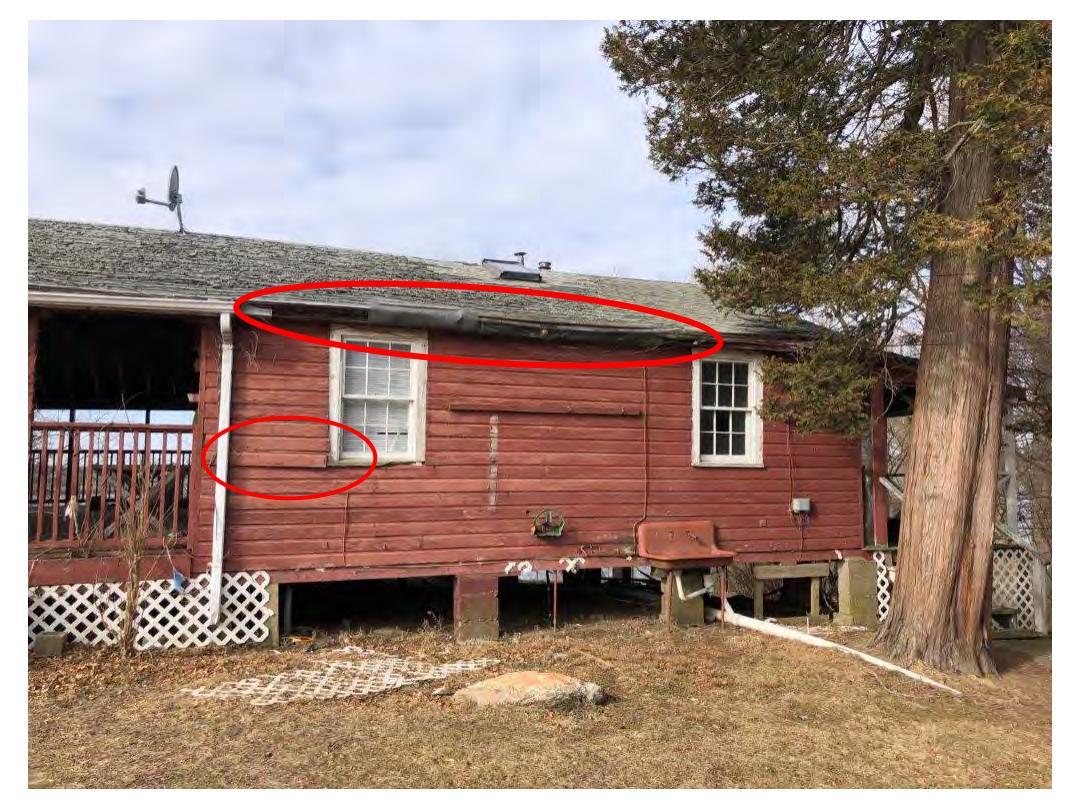
At the north end of the east elevation, the fascia and soffit are missing (Photo 7). As discussed with the previous conditions, this situation will lead to further water damage within the wall and ceiling.

• There is a pronounced sag in the easternmost part of the ceiling. The sag location corresponds to where the fascia and soffit are missing from the exterior and is probably related to water intrusion.

Photo 7: Missing fascia and soffit & shifted siding (east elev.)

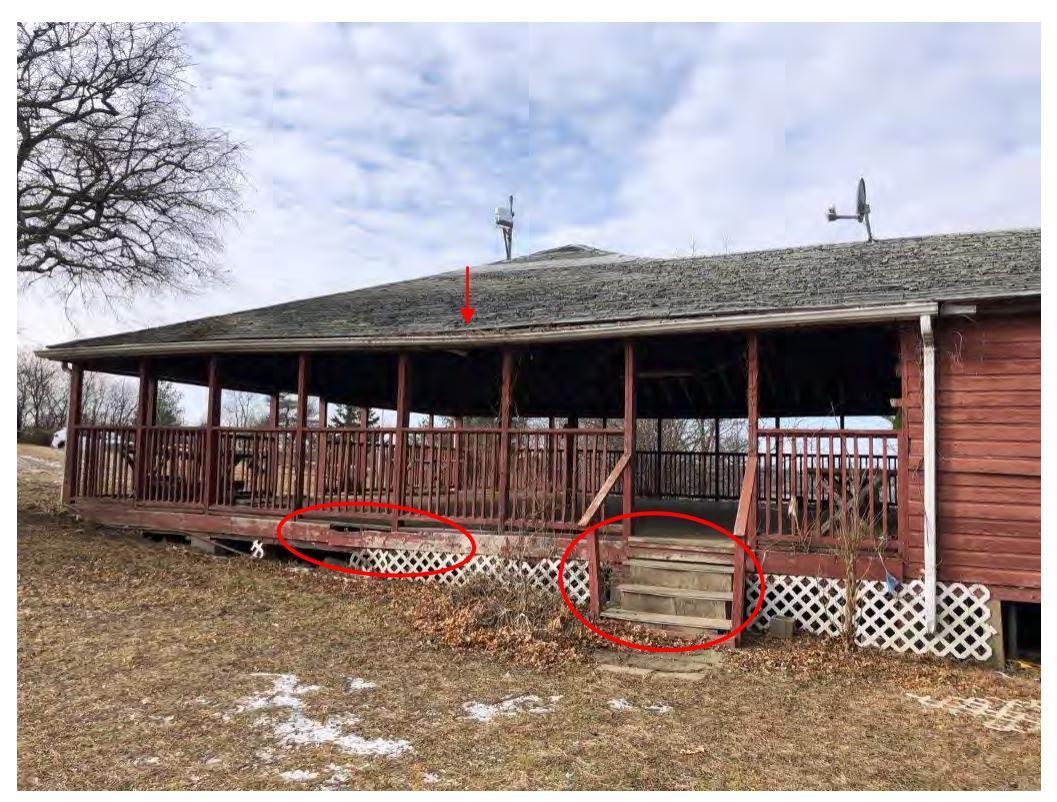
- Beneath the southernmost window, a few of the wood siding boards have become dislodged (Photo 7).
- Both the stairway to the pavilion and north end deck are extremely worn and suffering decay (Photo 8).
- At the pavilion's east elevation, the roof is heavily deteriorated, leaking and contributing to the rotting of the roof structure and floor structure below (Photos 8 & 9).
- The east roof eave sags due to the rotting and compression of the supporting structure below, where a gap in the skirt board is letting water seep into the framing (Photo 8).

Photo 8: Deteriorated roof, sill and stairs (east elev.)

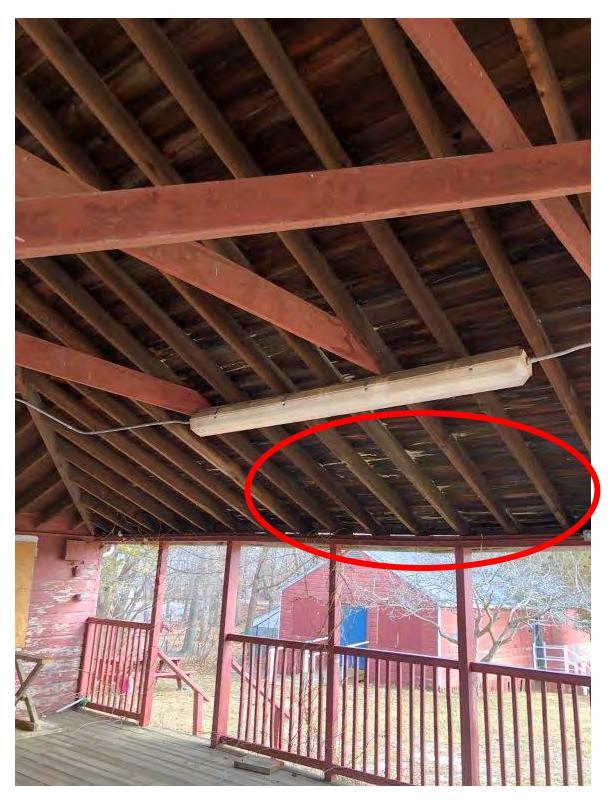
Photo 9: Warped and damaged roofing members (facing east)

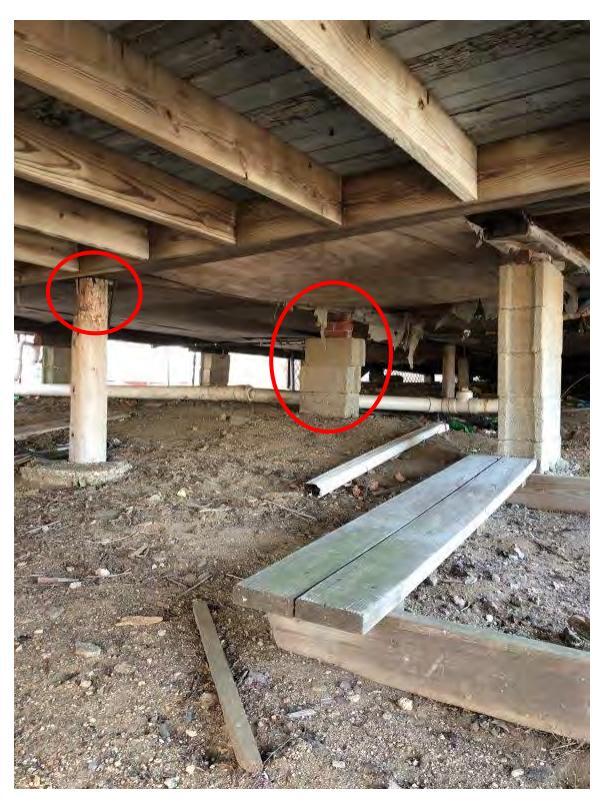
Several of the wood foundation posts are deteriorated at the top where they
make contact with floor framing. Additionally, a large majority of the CMU piers
are out of plumb and are topped with brick masonry to reach the underside of the
beams (Photo 10). As mentioned previously, several of the beams are sagging,
indicating that there are not enough posts to carry the load.

Photo 10: Rotted wood posts and shifted CMU piers

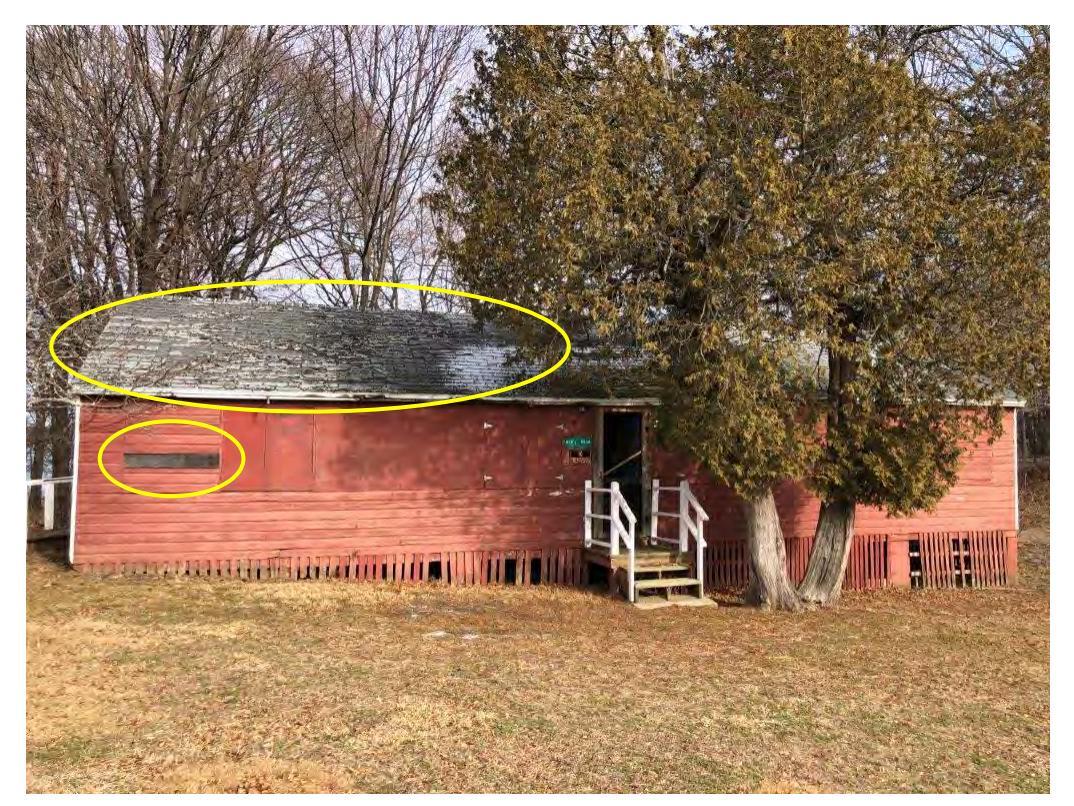
- The roof shingles are extremely deteriorated and have begun to lift up and away from the membrane. The roof structure itself sags heavily in the center above the doorway, where the fascia is also missing (Photo 11).
- Several siding boards are misaligned or deteriorated enough that small gaps and holes are forming in the elevation (Photo 11). Water that enters within can promote wood rot and damage to the interior structure of the wall.
- Large portions of the elevation display extremely worn and alligatored paint over the exterior wood siding.
- Several of the CMU foundation piers that run along the east end of the south elevation were found to be shifted and out of plumb.

Photo 11: Damaged roof and siding (south elev.)

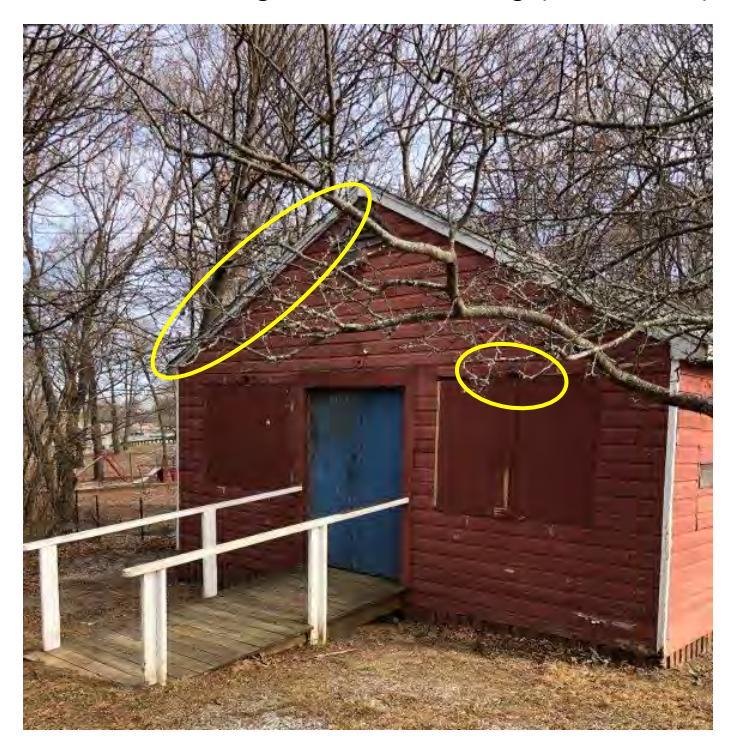
• As seen on the south side, the paint is in poor condition and there are several holes in the siding boards, specifically above both windows. The rake boards at the gable ends are also in a state of deterioration (Photo 12).

Photo 12: Decaying rake boards and siding (west elev.)

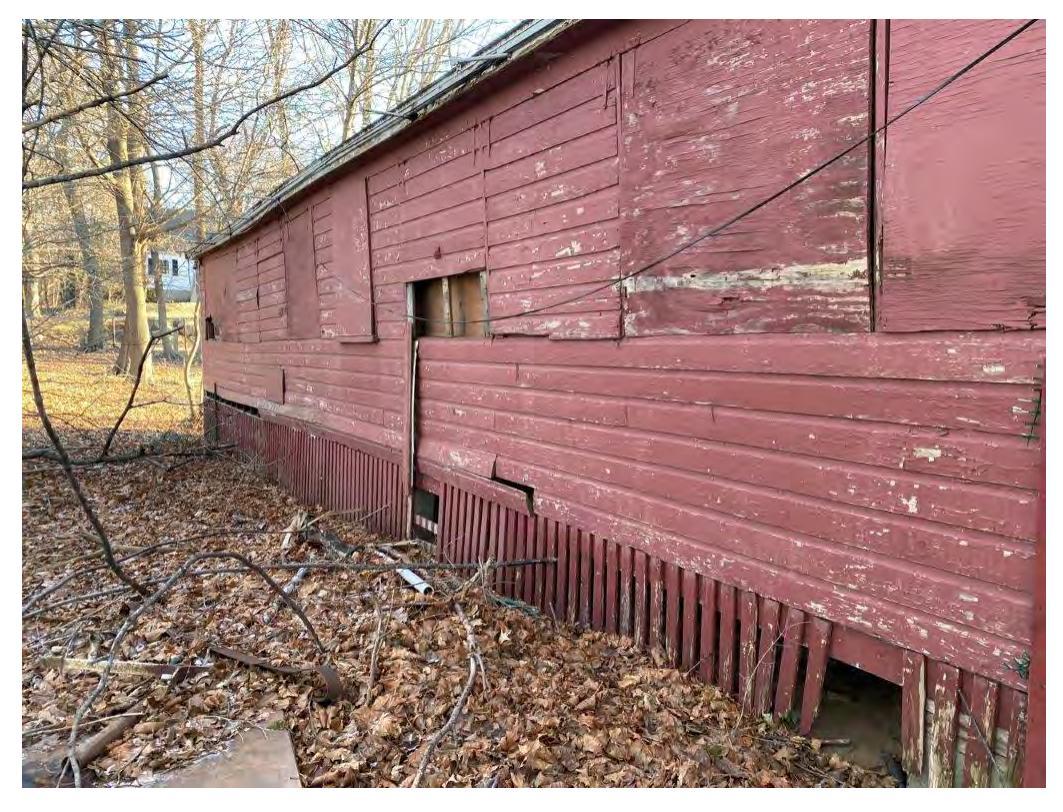
- The fascia member along the entire span of this elevation is rotted and covered in biological growth.
- Several areas are missing siding boards or in some cases, where the clapboards are still present, they have begun to bulge out. The bulging could be from detachment of the boards from the sheathing, or, more critically, buckling of the sheathing due to rotting and compression of the wall framing behind it. There is also a noticeable sag in the roof eave that is impacting the siding below; the boards warp up and down following the deformation of the roof (Photo 13).

Photo 13: Missing siding, sagging roof, and wall structure (north elev.)

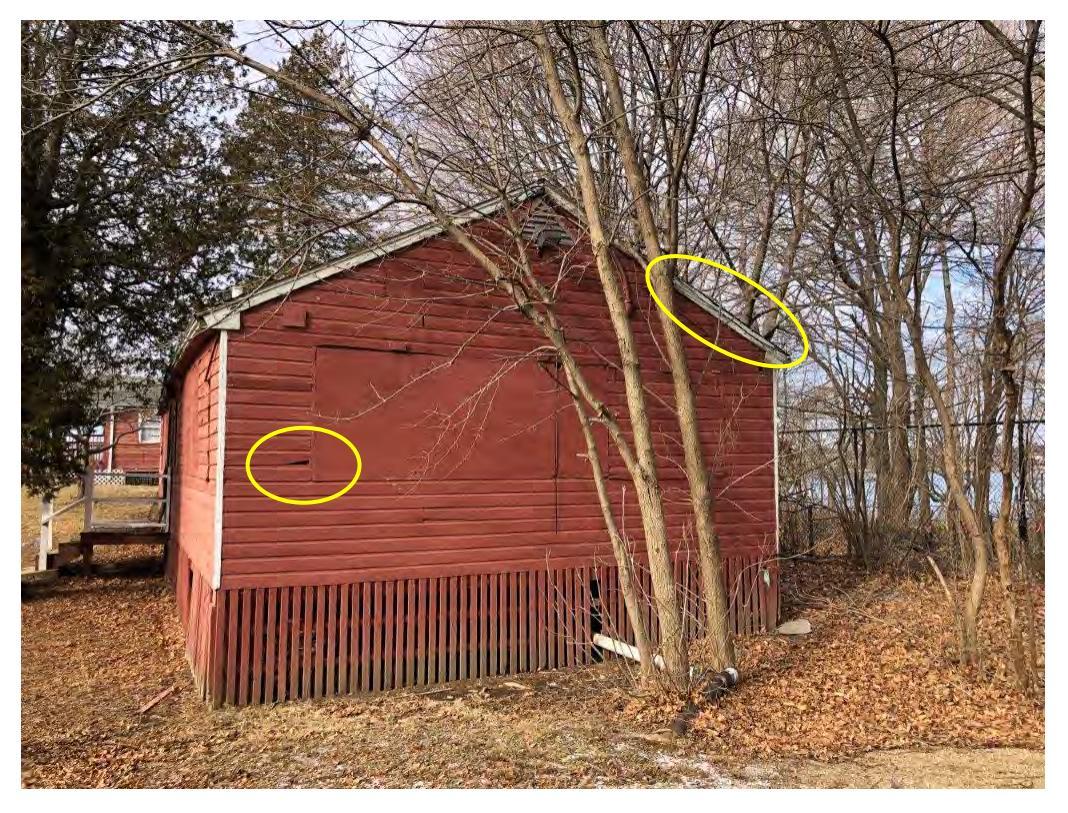
• The damage at this elevation is very similar to what was seen at the west end. The gable ends have rotted rake boards, the paint is weathered, and there are holes between the clapboards which have begun to detach from the wall (Photo 14).

Photo 14: Small siding gaps and eroding rake boards (east elev.)

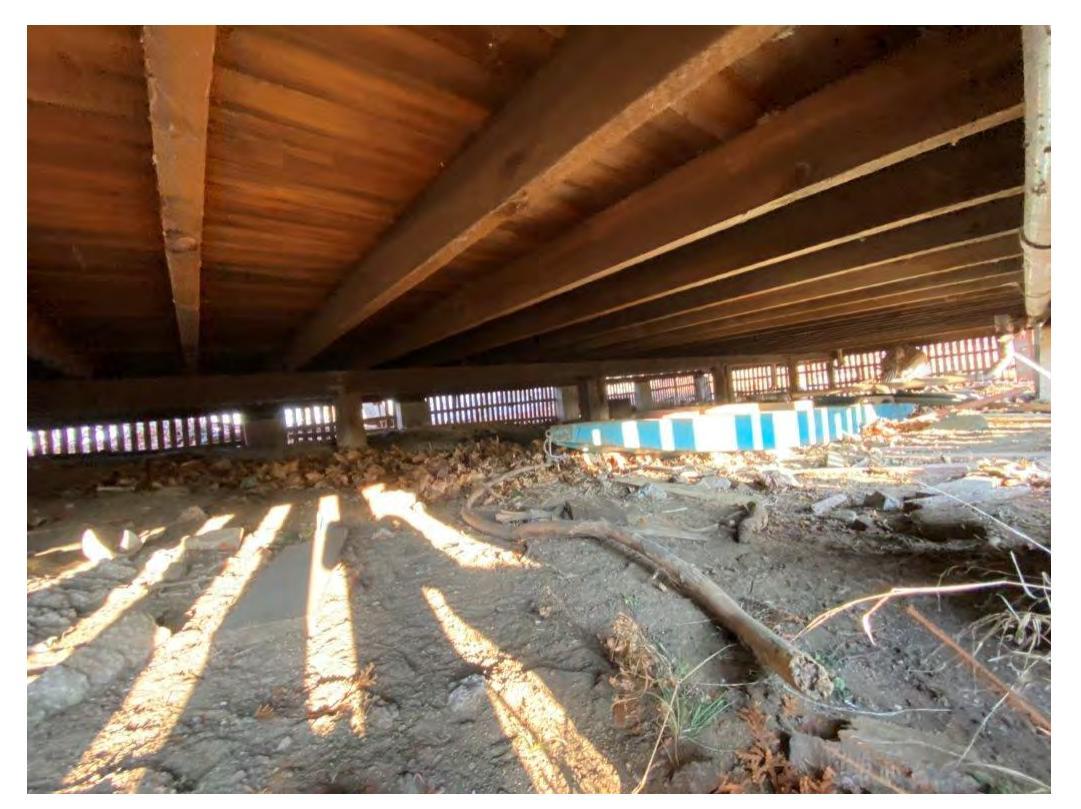
• Though the access was limited, we were able to view the foundation under Building B from the outside. The perimeter of the building is supported by CMU piers, while the center beam rests on square timber posts (Photo 15).

Photo 15: Overall view of Building B's foundation system

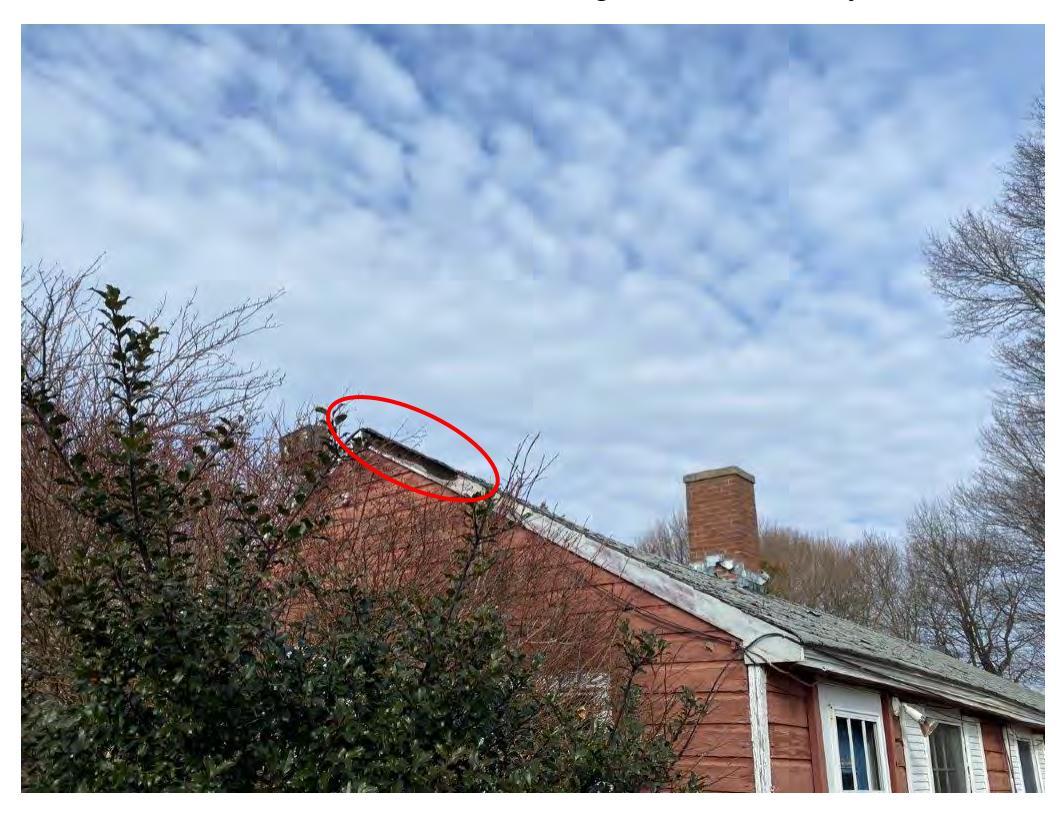
- The top third of the east end rake board is completely rotted away (Photo 16), exposing the internal wall system to the weathering elements.
- The siding at the gable has several gaps, contributing to the internal decay. Holes in the boards progress with each freeze thaw cycle as rot consumes the member, as can be seen in many areas of these buildings.

Photo 16: Deteriorated rake board at Building C (south elev.)

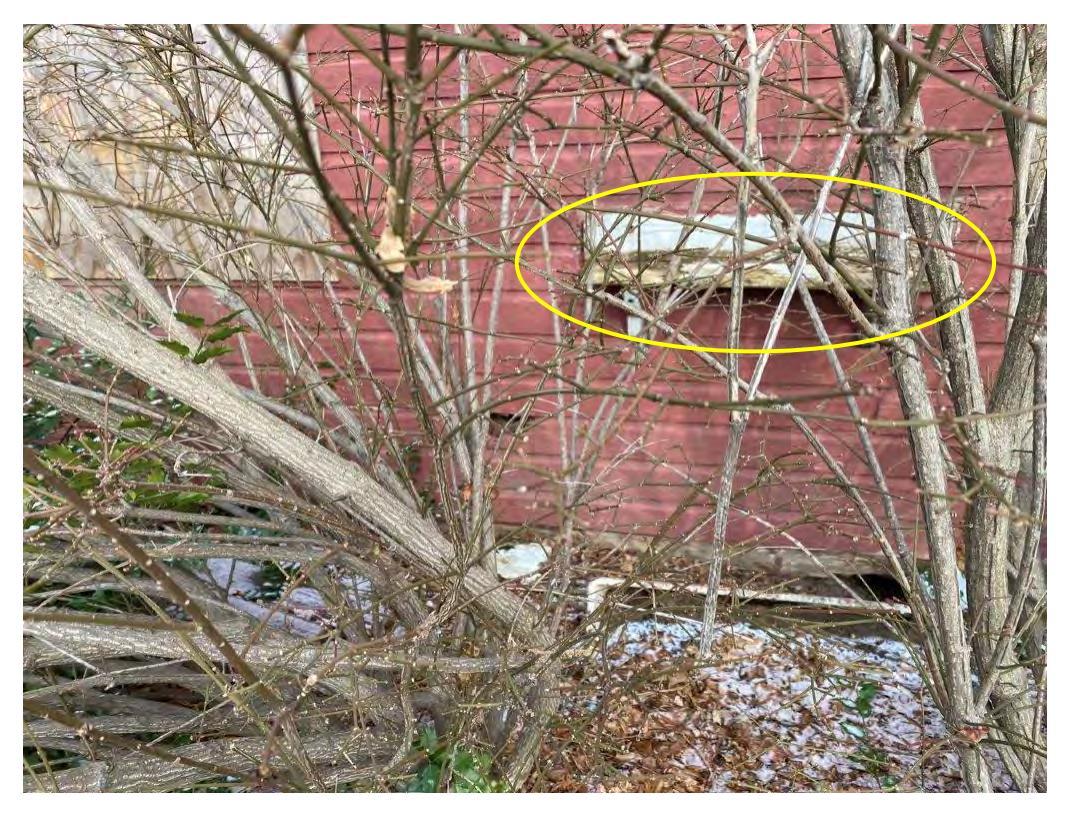
• Between the two windows, there is a wood shelf that is also deteriorating (Photo 17). Its connection to the siding will encourage more rotting as water becomes trapped between the two elements.

Photo 17: Rotted wood shelf attached to façade (south elev.)

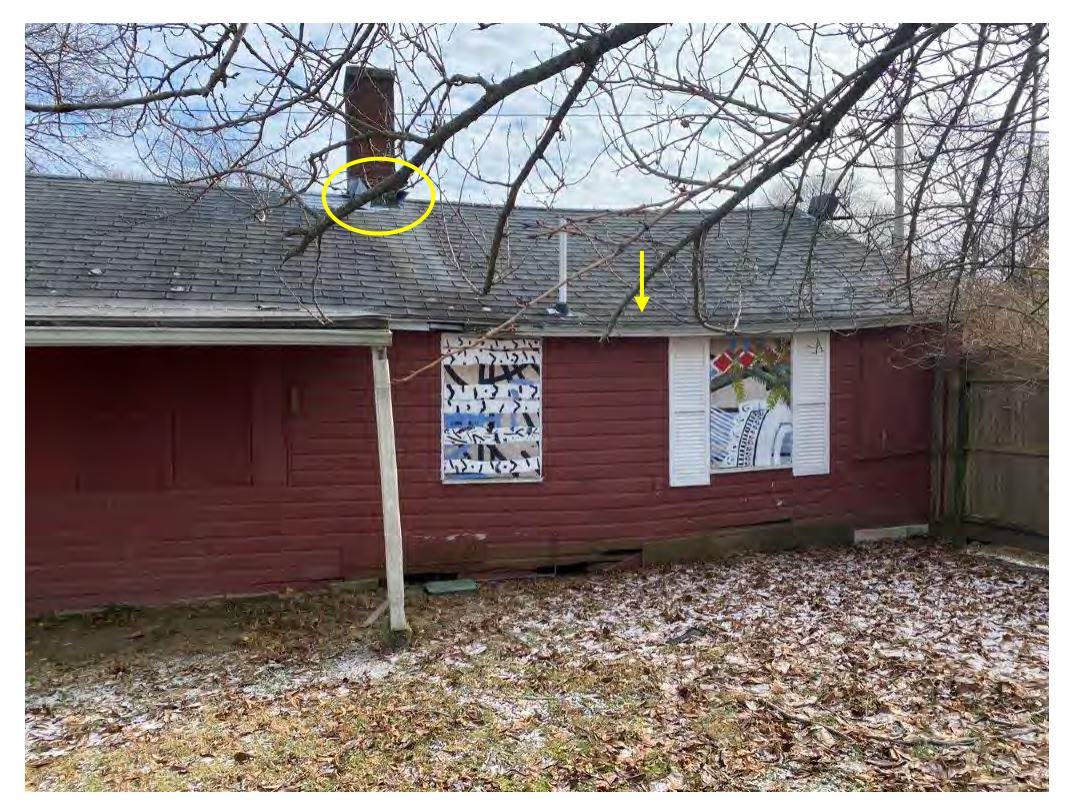
- The roofing is very weathered and the fascia is rotting away.
- At the south end of the west elevation, there is a significant sag in the roof, which is following a corresponding sag in the west wall, which can be seen in Photo 18. At the base of this sagging façade, the lower siding is rotting away, leaving a gap that is covered by a makeshift plywood panel (Photo 19).
- The sill and shutters of the southernmost window is rotted; the end grain is rotting most likely from exposure to water that pools at the ledge (Photo 20).
- The flashing surrounding the base chimney has failed (Photo 18), letting water seep into the interior.
- The north end of the west elevation is in better condition than at the south end, however, at the base of the elevation, the clapboard siding runs right down and into the grade (Photo 21), causing the base of the wall to rot.

Photo 18: Sagging roof and eroded flashing around chimney (west elev.)

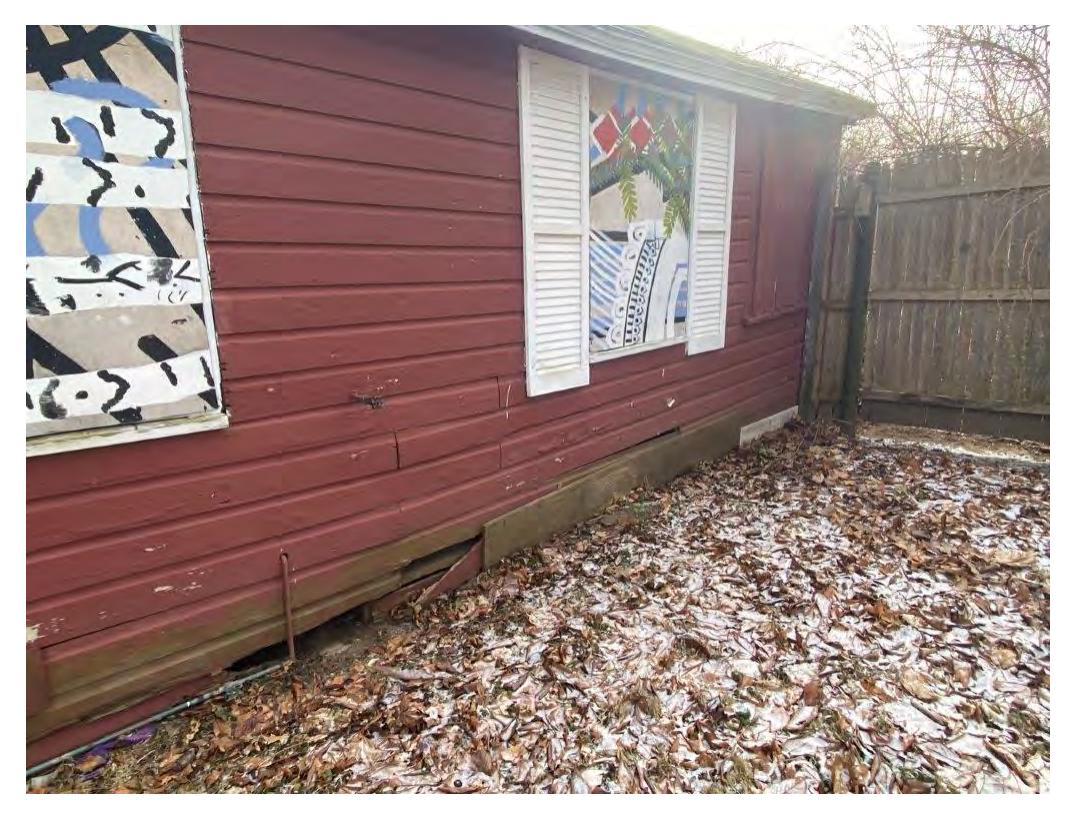
Photo 19: Missing siding boards at base of west elevation

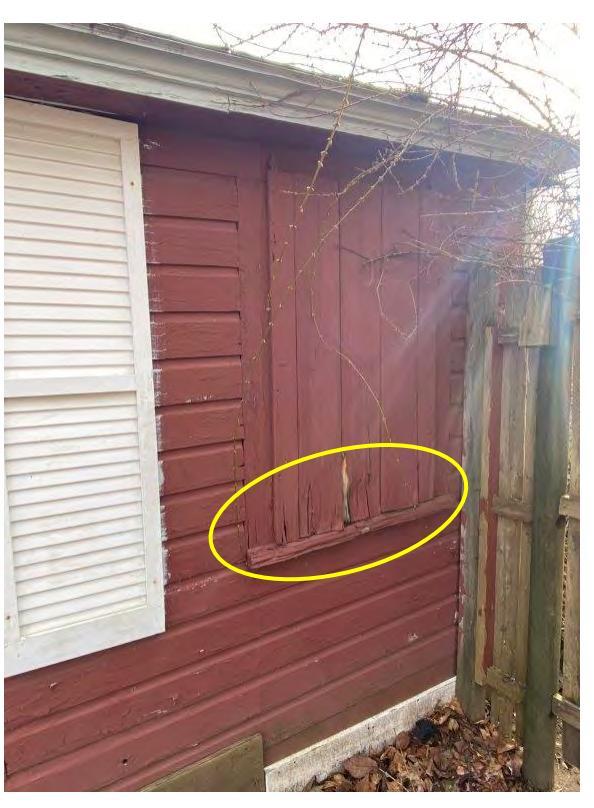
Photo 20: Southernmost window with rotted sill and shutters (west elev.)

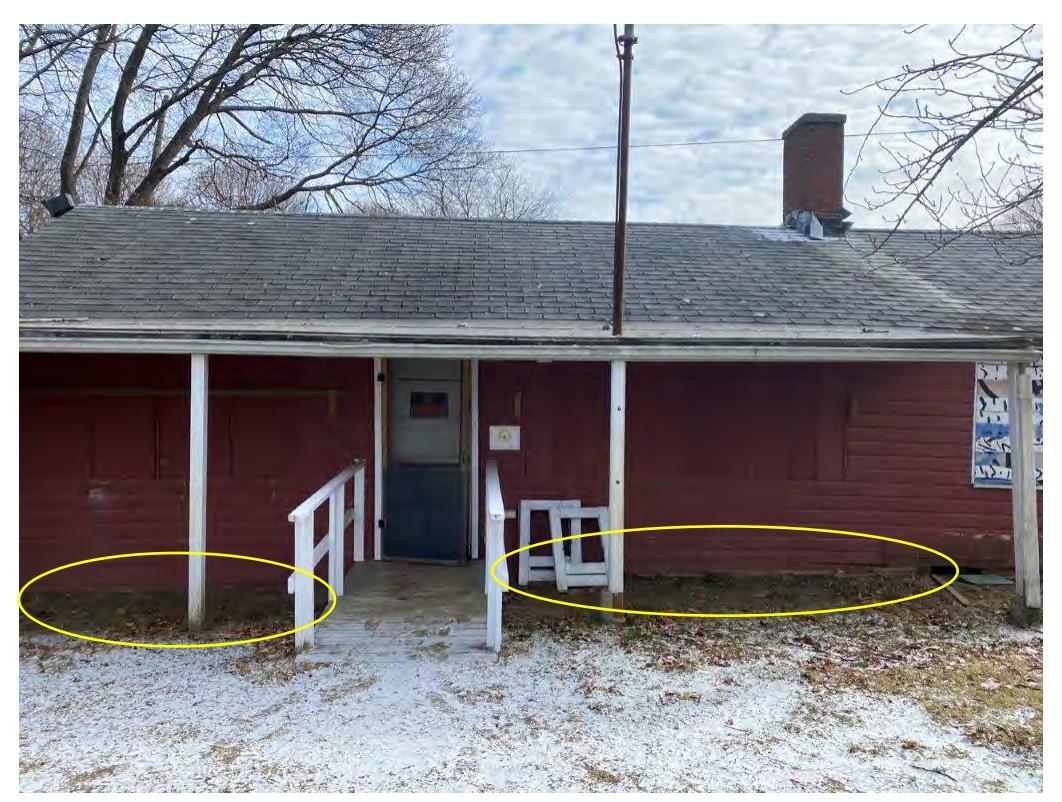
Photo 21: Siding boards covered by soil (west elev.)

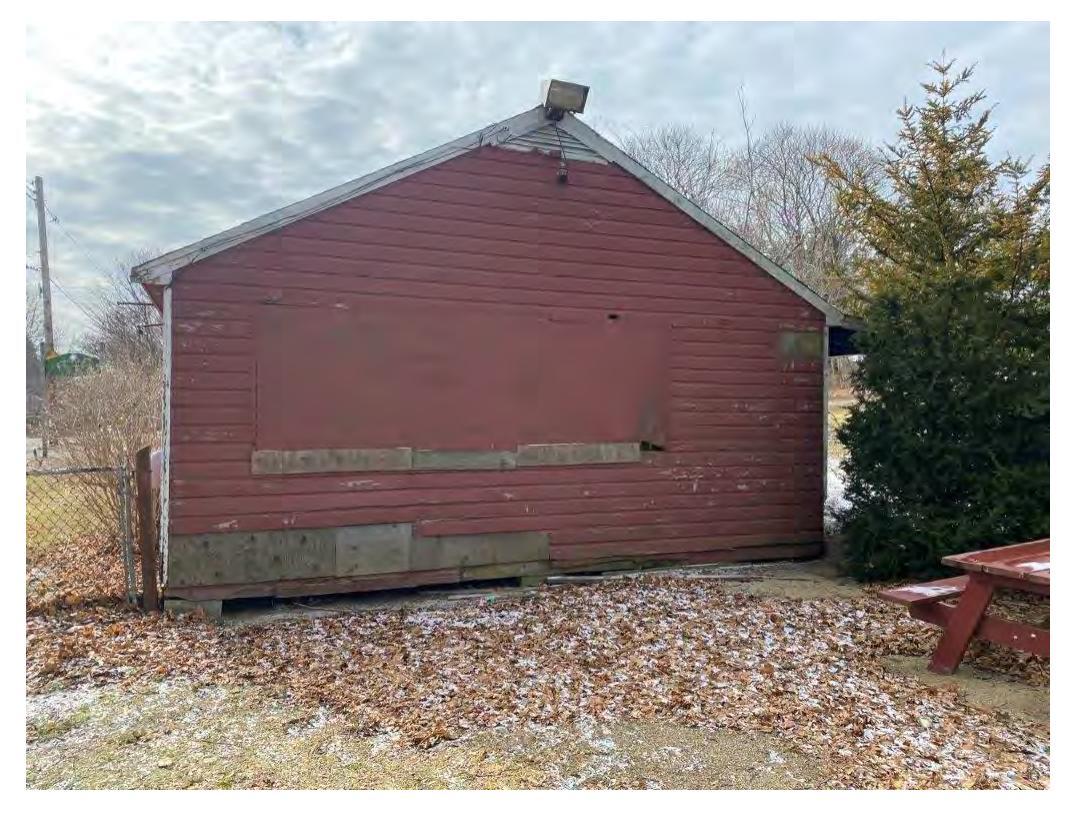
• The north elevation has several areas where siding is no longer present or rotted gaps are forming and strips of plywood have been used to cover the damage (Photo 22).

Photo 22: Covered up rotting and missing clapboards boards (north elev.)

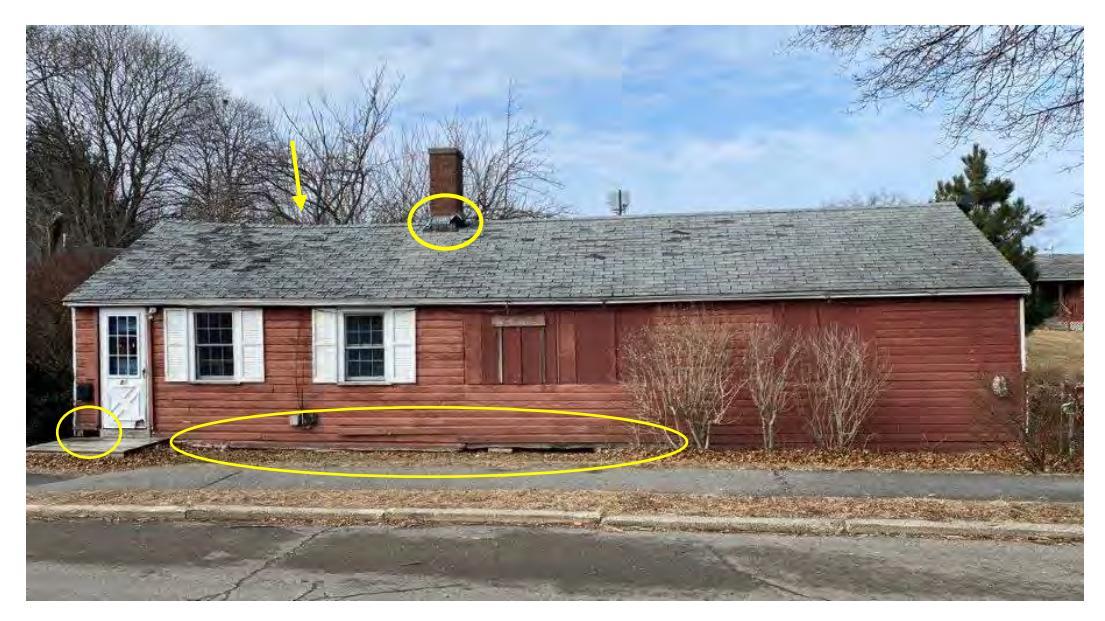
• The failed flashing, worn roof, and south end sag of the west façade continues over to the east elevation. In addition to this damage, the base of the building is suffering from rotted and detached siding. There is a large hole next to the sill of the doorway, inviting water and rodents to enter the building structure (Photo 23).

Photo 23: Overall view of east façade damage

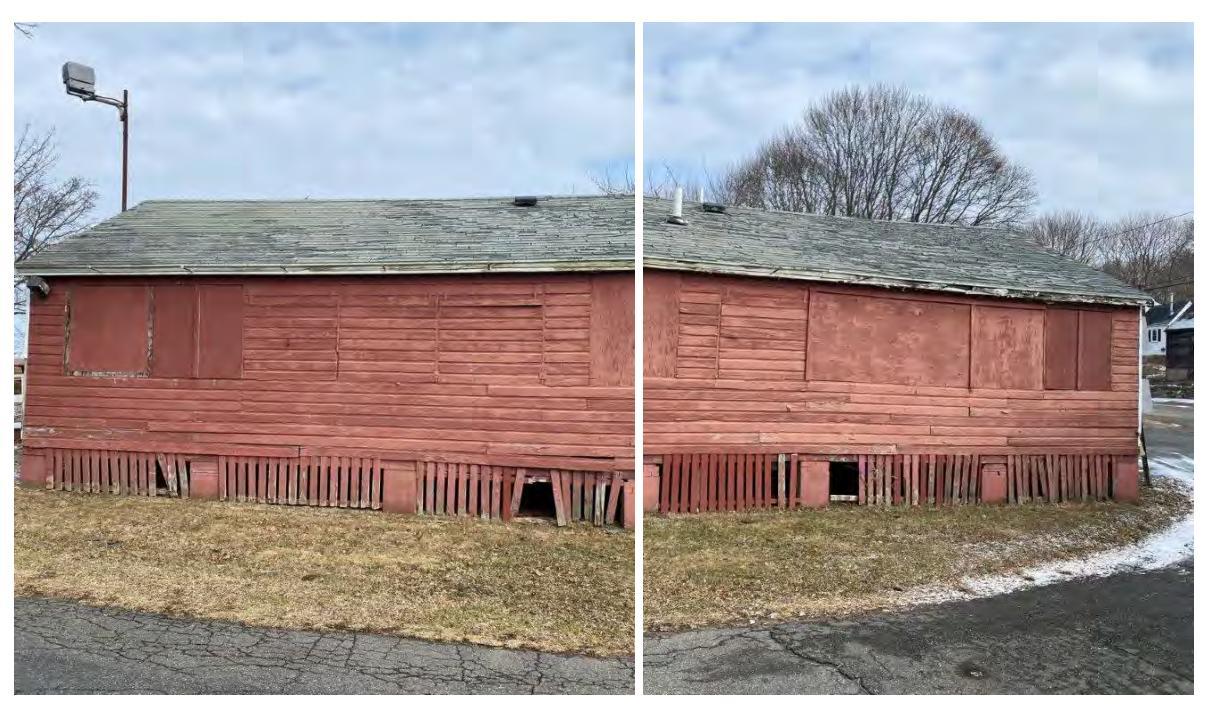
- The roofing shingles are heavily weathered and there is a dip in the ridge and eaves at the center of their span. The east end fascia is completely eroded, and remnants of a gutter system remain in its place.
- The siding is starting to detach and fall off, mainly at the westernmost end of the south elevation, which at the east end there are large gaps forming between the panel connections.
- The CMU piers of the foundation are exposed at this side and are sinking into the grade, which is contributing to the sag of the façade and roof (Photo 24).

Photo 24: Overall view of south façade damage

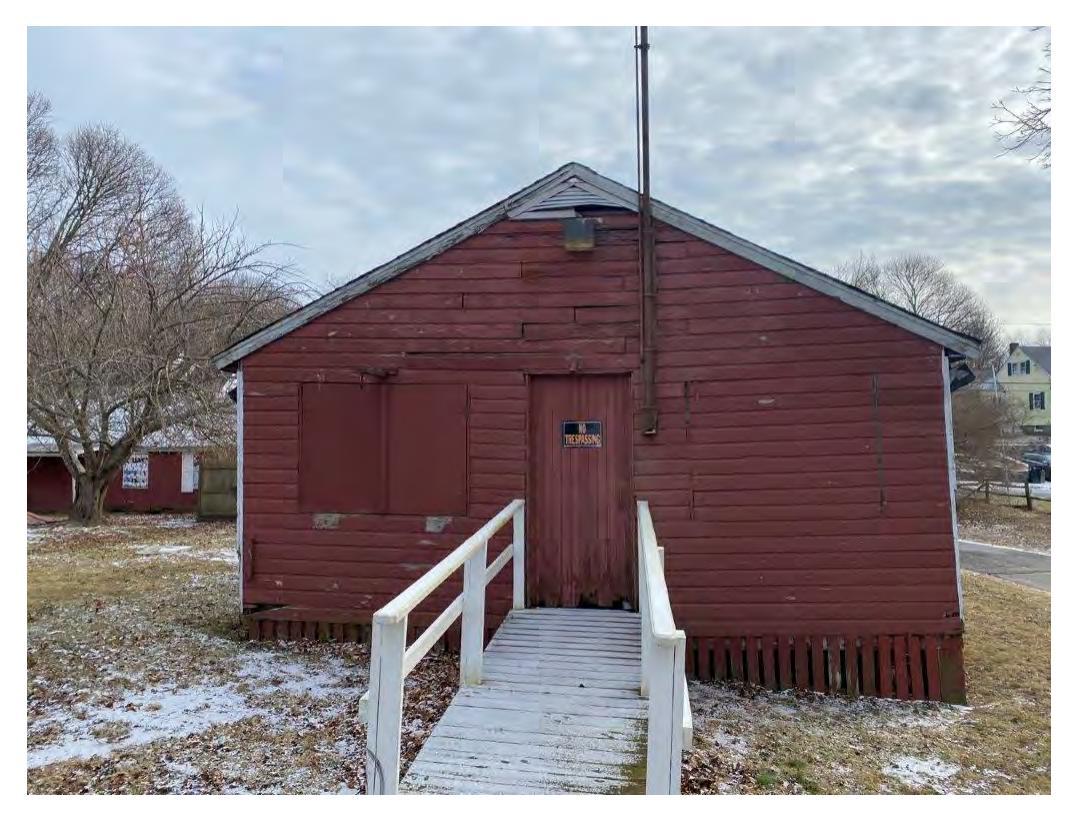
- At the gable, the boards are pulling away from one another, allowing for gaps and rot damage at the panel ends. The damage continues to the peak of the elevation, where the vent is distorted and falling apart.
- The base of the door is riddled with rot damage, leaving behind gaping holes at the bottom. See Photo 25 for an overall view of the west elevation.

Photo 25: Overall view of damage at west elevation

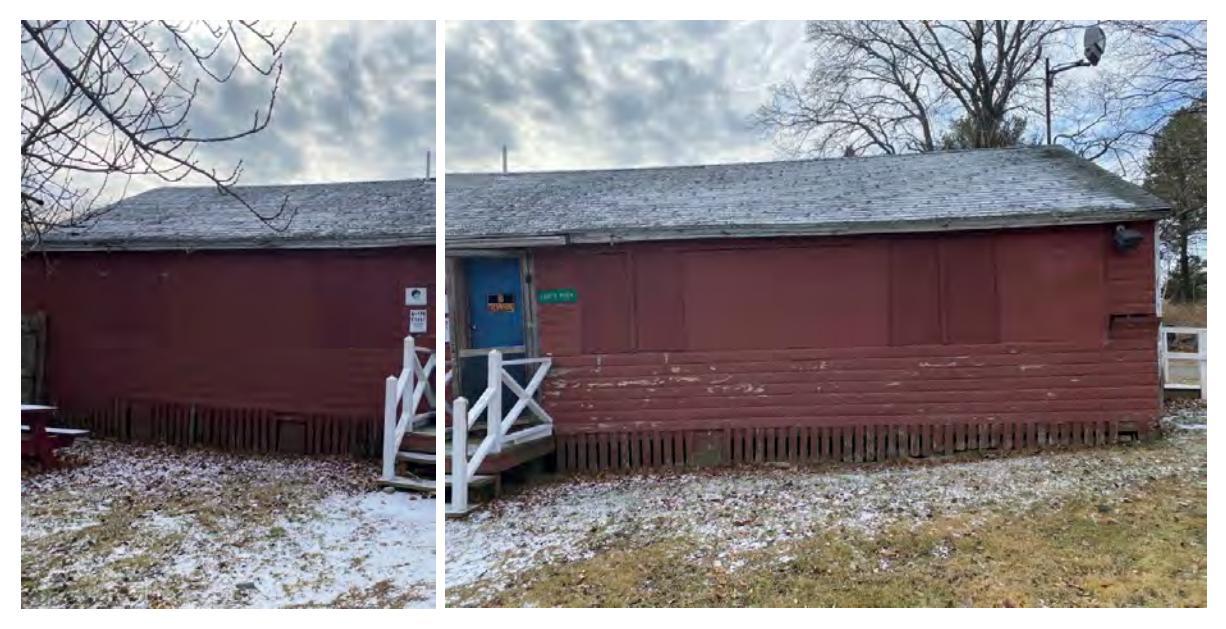
• The north elevation shares the same damage as what was observed on Building D's south side. This includes roof damage and movement, dislocated boards and holes, and sinking foundational CMU piers (Photo 26).

Photo 26: Overall view of damage at north elevation
