DRAFT 22 February 2022

Reference: Camp Naumkeag Conditions Assessment

Camp Naumkeag Building Evaluation Salem, MA

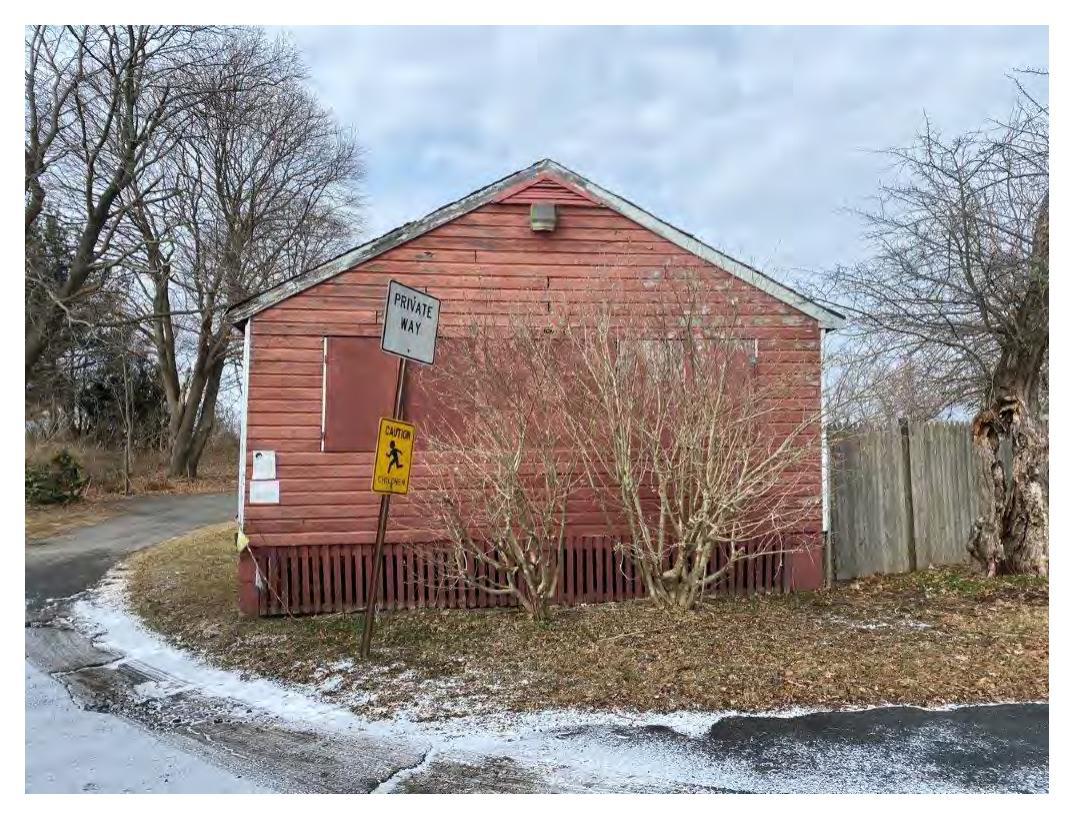
• The east elevation displays similar damage in the siding, just like at the west elevation, however, there is also a noticeable lean in the CMU piers at its foundation level. The façade damage can be seen on Photo 27.

Photo 27: Facade damage at east elevation

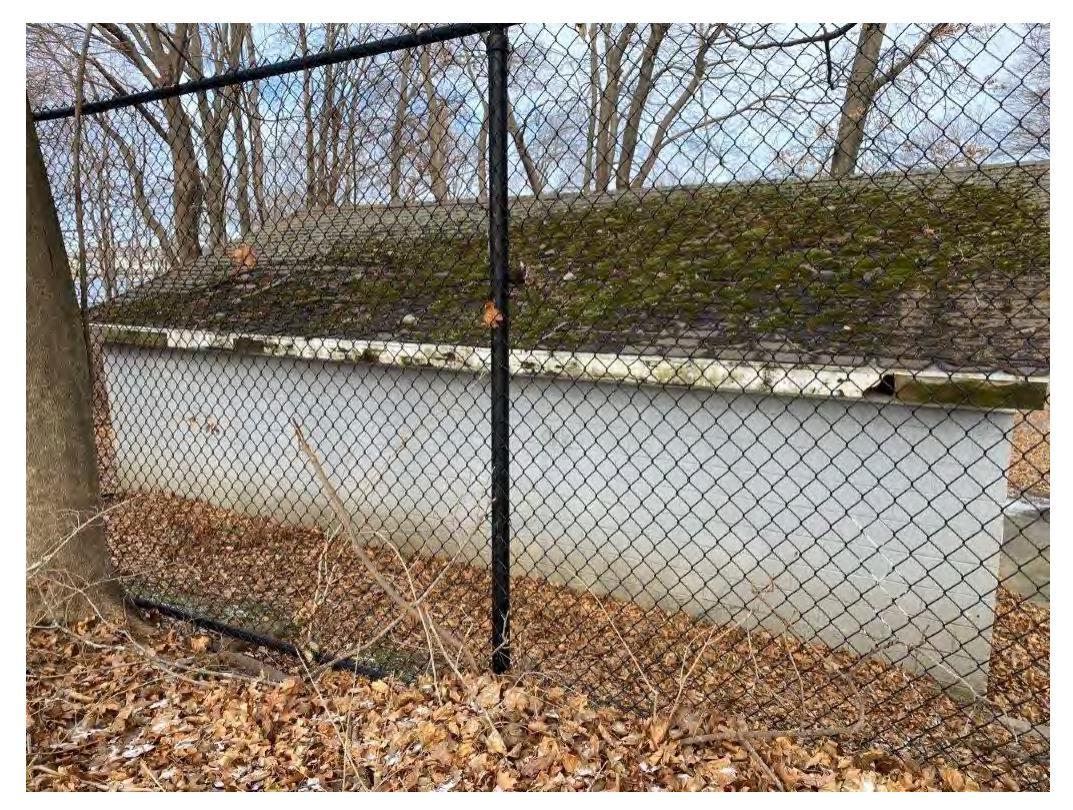
- The roofing shingles are deteriorating and collecting biological growth.
- The fascia on the north and south elevations are rotting and even missing in some areas (Photos 28 & 29).
- There is a missing windowpane at the west elevation.

Photo 28: Roof and fascia damage at south elevation

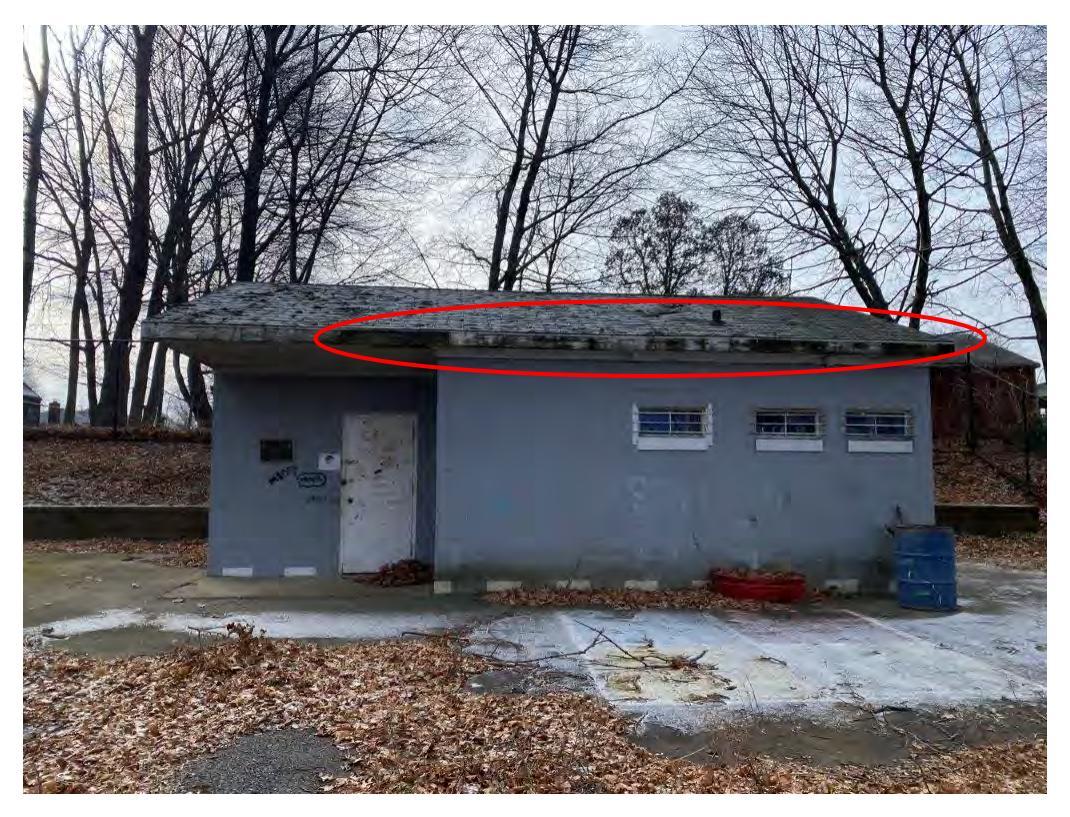
Photo 29: Rotting fascia at north elevation

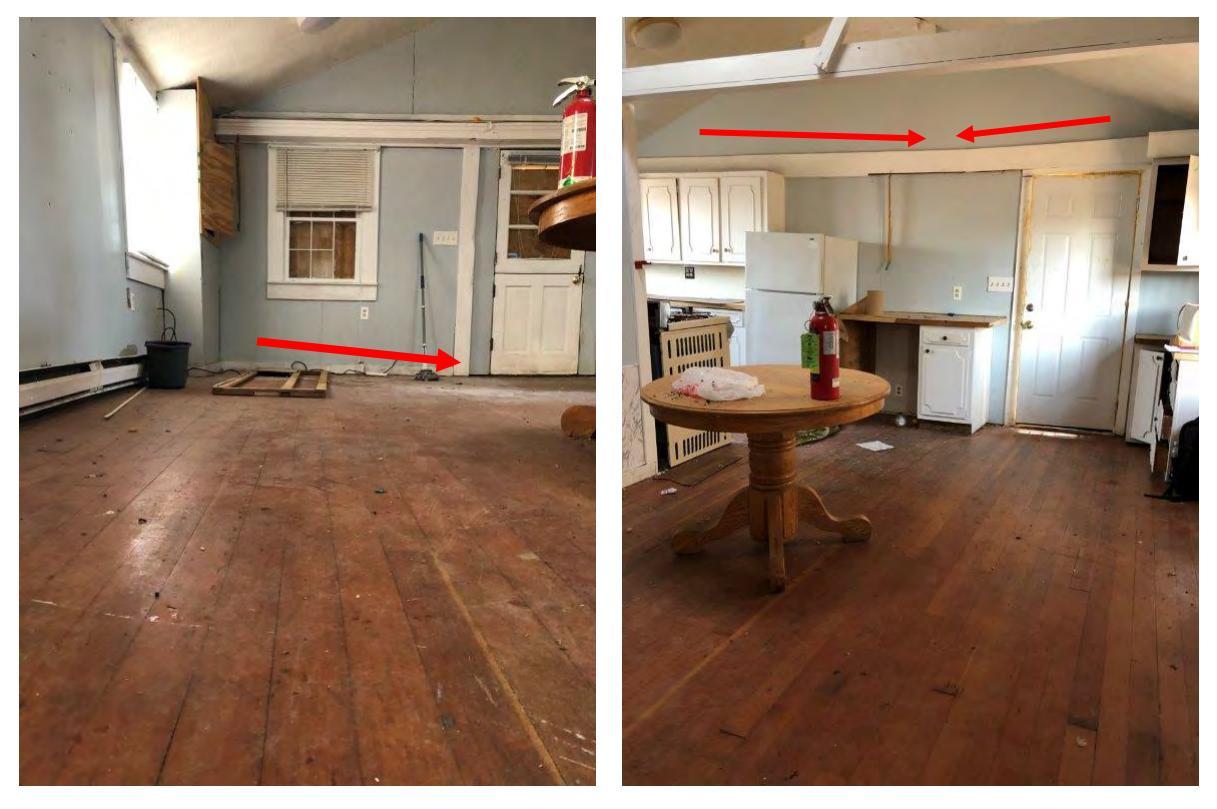
Photo 30: Visual of floor framing deformations at north and south elevations

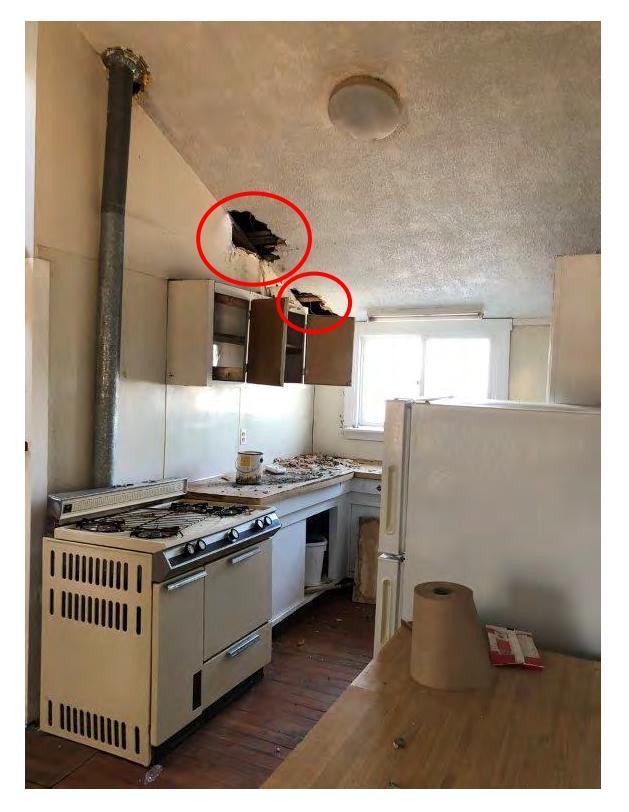
- At the north end of the building, about five feet south of the wall, there is a rise in the floor where the beam below spans east to west. However, at the north and south end walls, the floor dips down towards the middle span where the floor beams sag below. The floor movement has influenced the wall paneling within, causing it to sag with it (Photo 30).
- Within the building's northwest corner, where the kitchen is located, there are large holes in the ceiling, exposing the lath and strapping system (Photo 31). These holes were probably initiated by roof leakage and then worsened by rodents.

Photo 31: Holes in ceiling at northwest corner of kitchen

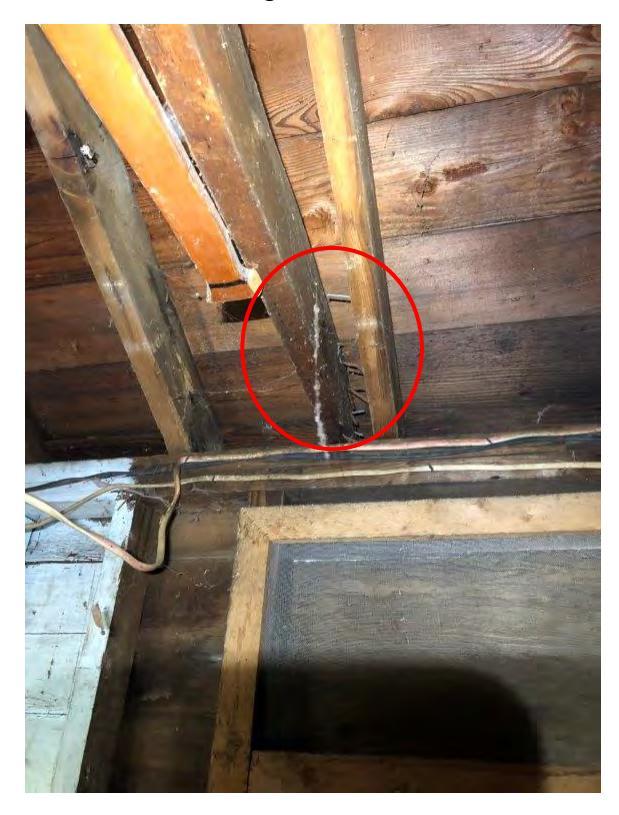
- There are six trusses in total, one of which that has failed after the collar tie separated from the rafter (Photo 32), and two that are on the verge of experiencing the same failure. These two that have almost reached failure are undergoing rafter separation at one end and wood rot at the other.
- The westernmost truss has a large notch cut in its collar tie, which reduces its capacity to carry load (Photo 33).
- At the easternmost end of the structure, the roof is not supported by any trusses but rather two vertical wood members, which is most likely one of the factors contributing to the sagging in the roof line (Photo 34).
- The floor of the building slopes down towards the center, which is associated with foundation movement, discussed in the "*Exterior*" conditions section.

Photo 32: Failed rafter and collar tie connection (facing north)

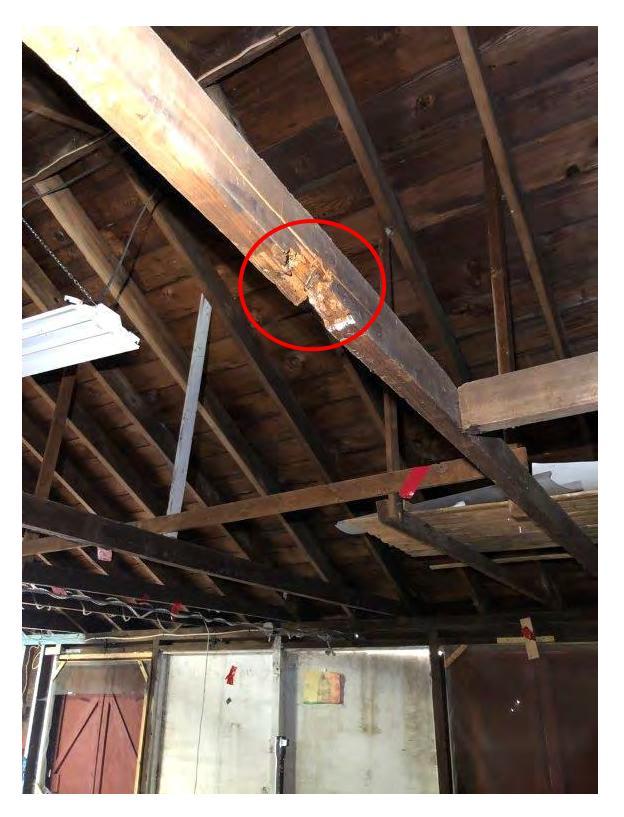
Photo 33: Notch cut in collar tie at west end truss

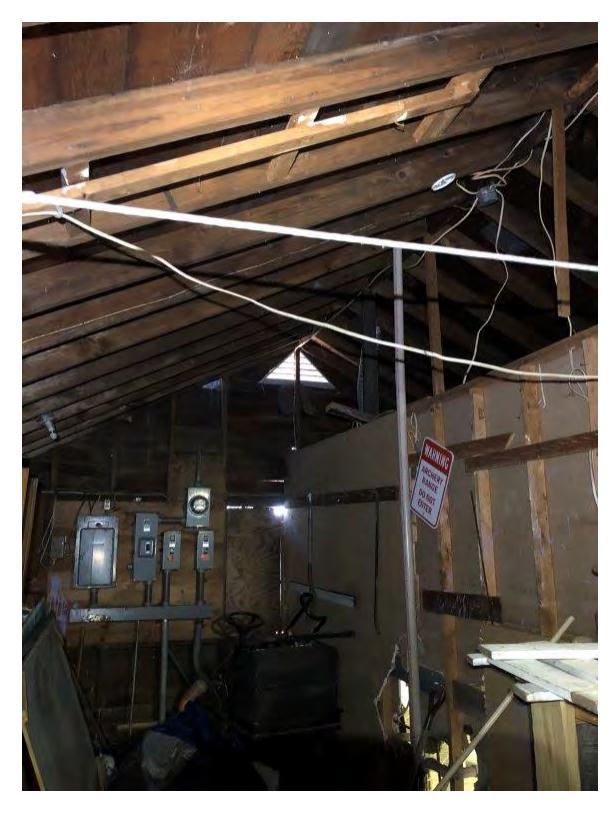
Photo 34: Lack of truss system at east end of Building B

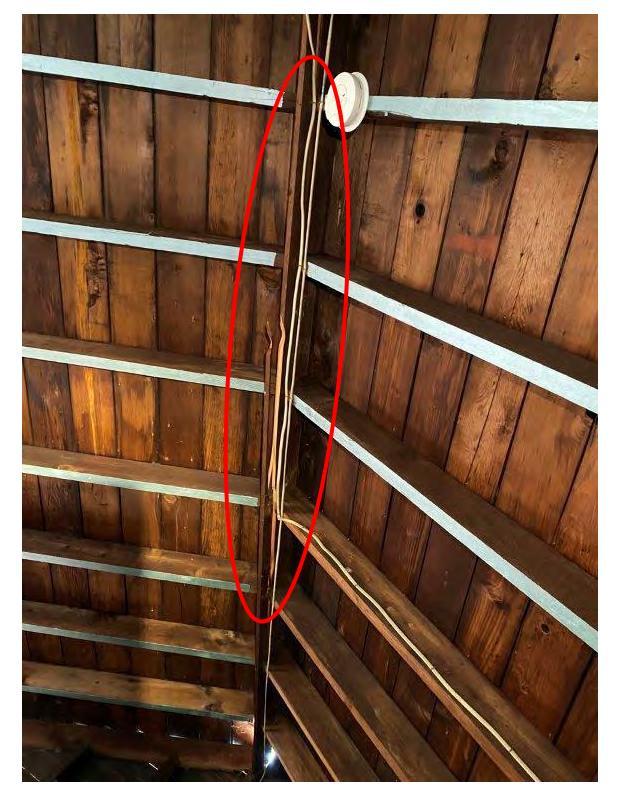
- At the south end, where the roof was observed to be sagging the most, is where interior truss damage is located. Because of the truss failure and associated deflection, the roof ridge board has failed in bending (Photo 35). Associated with that is the connection failure of the collar tie and west end rafter of the fifth truss from the north (Photo 36). This is where the lowest point of the roof sag is located.
- At the floor framing level, the decking is noticeably higher at the center of the building and then slopes down towards the perimeter (Photo 37). The low points are found to be near the corners of the building. The total drop in the floor is estimated to be about 8" of deformation.

Photo 35: Failed rafter at south end of Building C

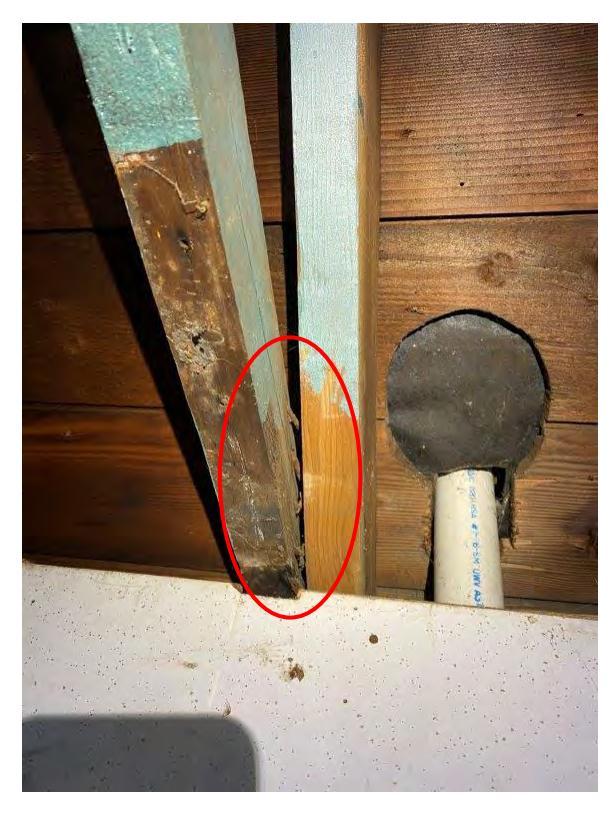
Photo 36: Collar tie and rafter connection failure in Building C

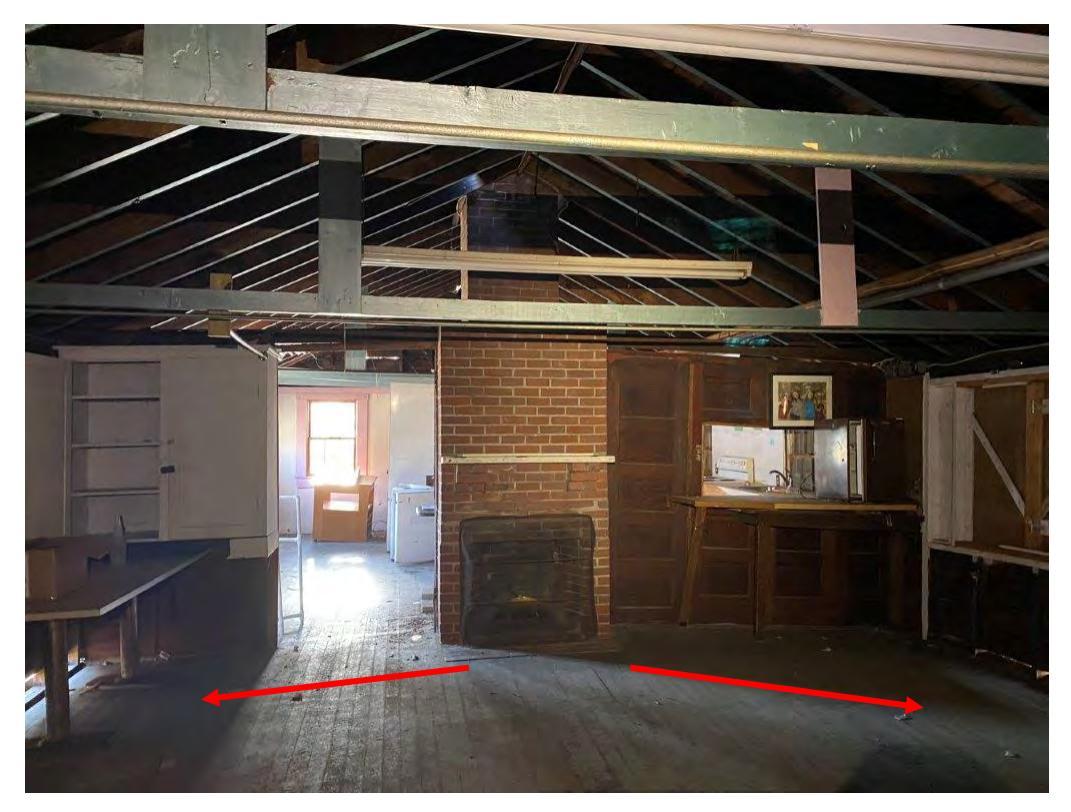
Photo 37: Slope away from high point at center of floor framing system (Building C)

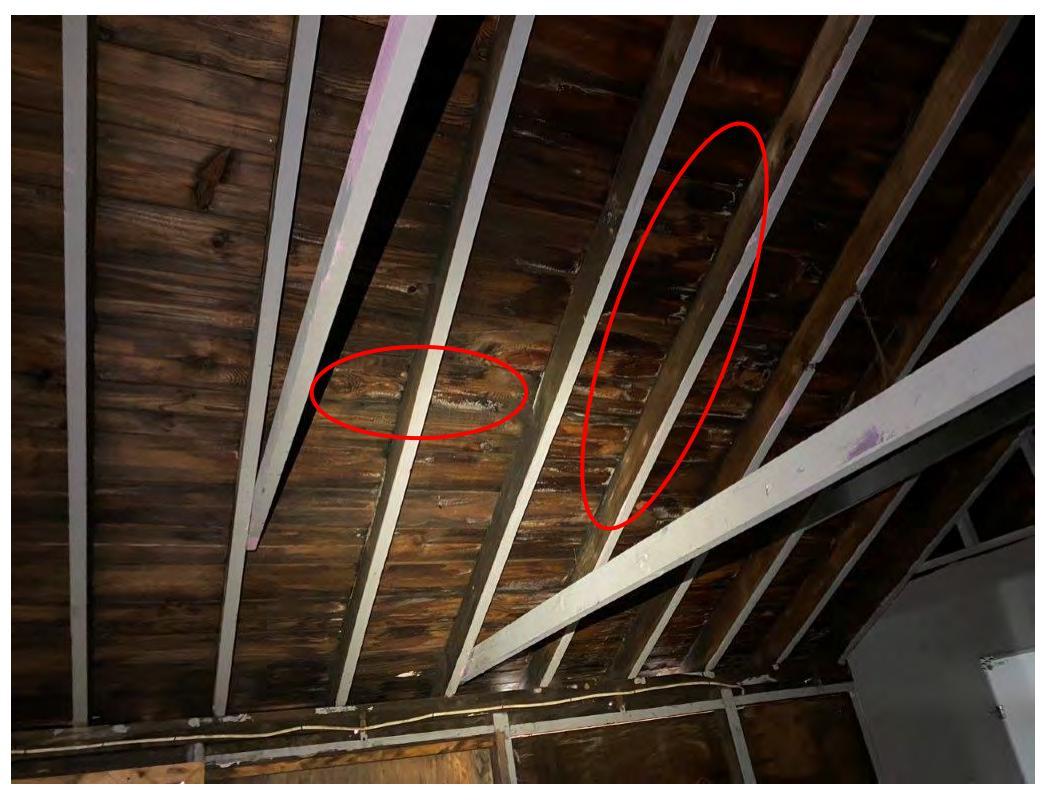
- Along the north elevation, there is detectable eave spread along the entire span.
- At the southeast corner of the building, there is a form of white mold or rot developing on the sheathing, indicating consistent water presence (Photo 38). This lines up with the missing fascia on the exterior of the south façade.

Photo 38: White mold growth/rot on roof sheathing of Building D

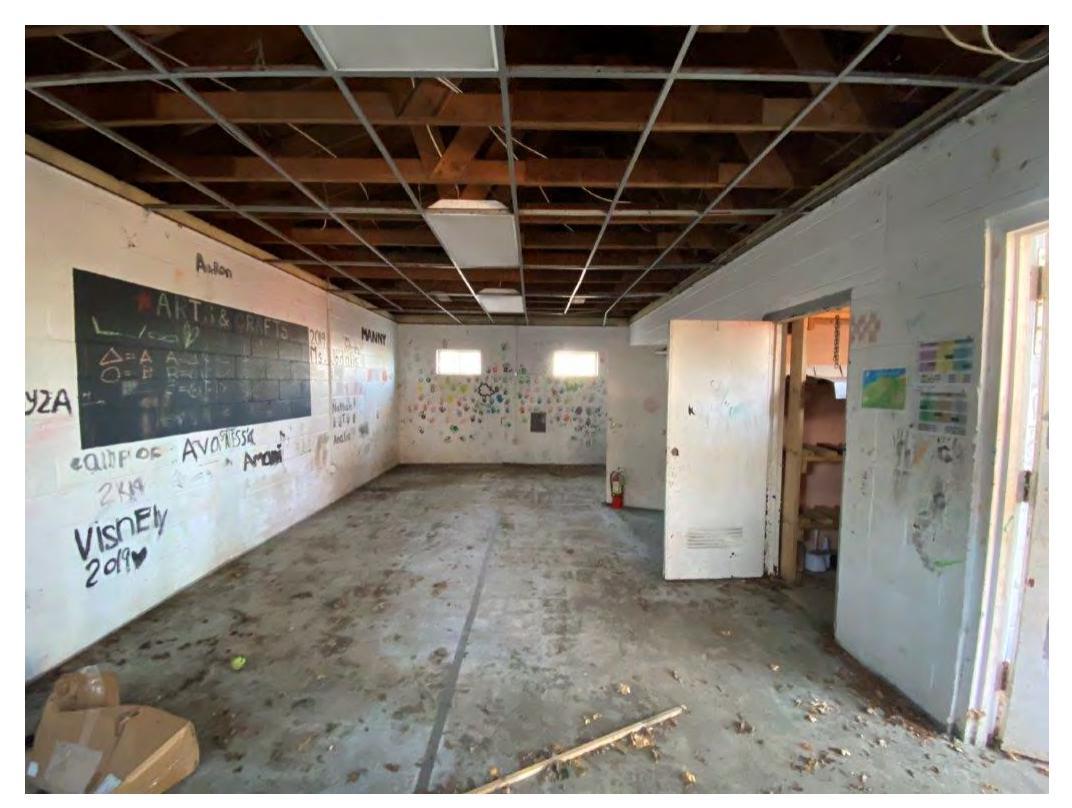
The interior conditions of the building are safe. See Photo 39 for overall view of the building.

Photo 39: Safe interior conditions of Building E
