EXECUTIVE SUMMARY

OLD TOWN HALL RENOVATIONS

32 Derby Square / Salem MA

PHOTOGRAPHS OF EXISTING CONDITIONS

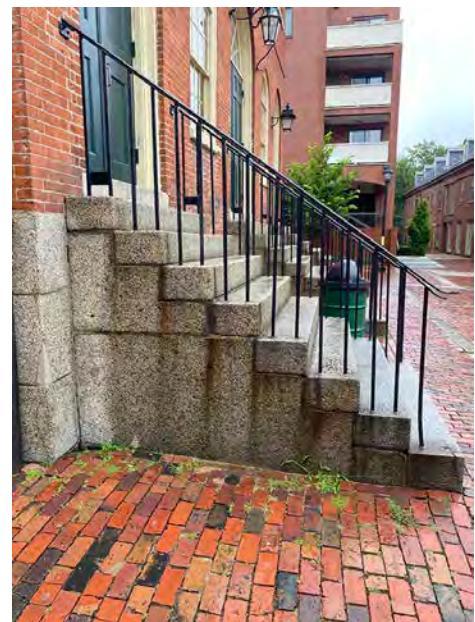
Side View of Granite Stairs and Iron Railings; Missing + Bent Baluster Posts at First Tread, Railing Delaminated from Subrail at Low End

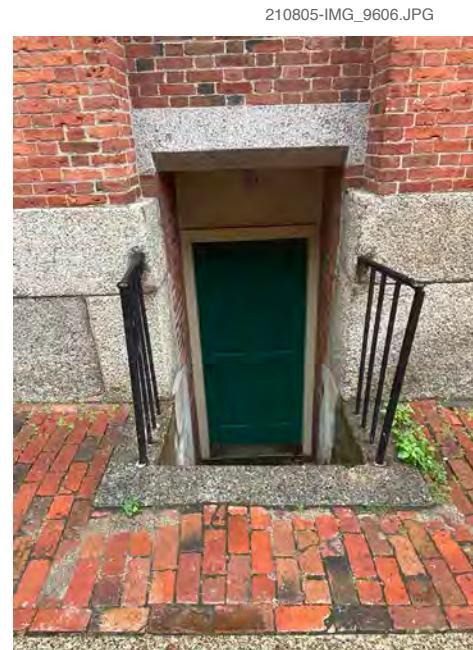
Basement Exit Door Well at West Facade; Missing Handrail on Hinge Side of Door

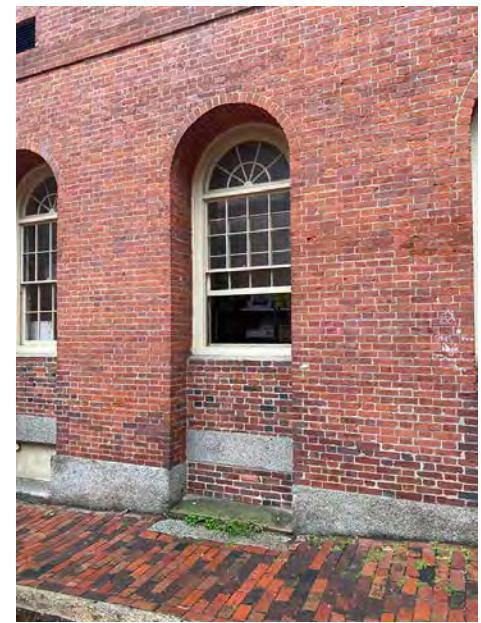
210805-IMG_9573.JPG

Typical First Floor Window in Arched Brick Opening with Visual Evidence of Brick Repairs

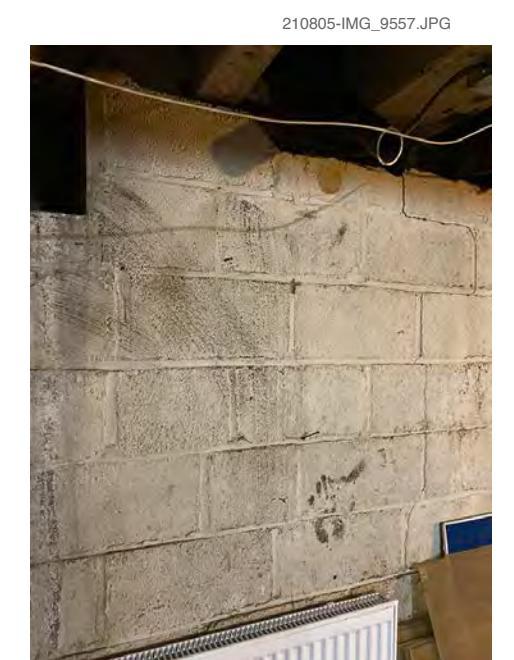
Contemporary Concrete Block Masonry Added to Interior Surface of Stone Foundation Walls Circa 1933

- Remove the low headroom central beam and flush frame replacement beams above columns. Lower basement slab by 7" where structural changes are made.
- Remove the perimeter circa 1933 concrete block interior finish that conceals the original rubble stone foundation. Repoint stonework and insulate the exterior walls.

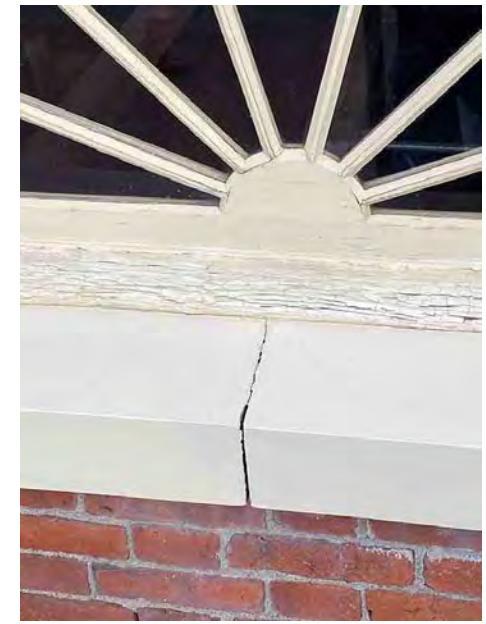
220119-IMG_0615.JPG

Cast Stone Replacement Sill at South Attic Window; Open Butt Joint in Painted Sill Allows Water Infiltration; Painted Wood Sill and Window in Good Condition

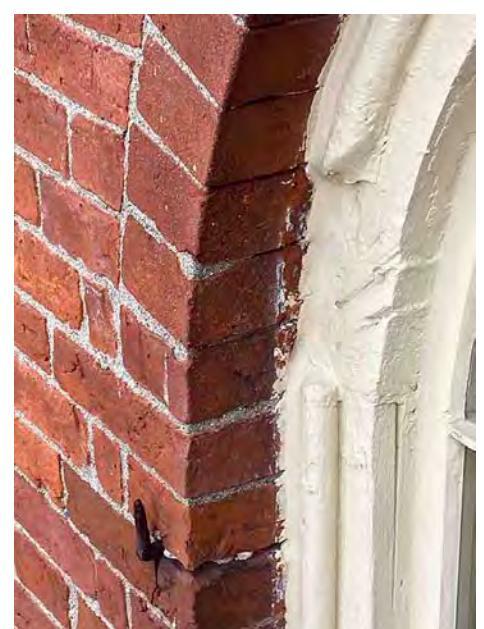
Remnant Iron Pintel Hinge at Jamb of South Facade Second Floor Window Evidence of Former Shutter; Portion of Missing Brick Mould Suggests Former Awning

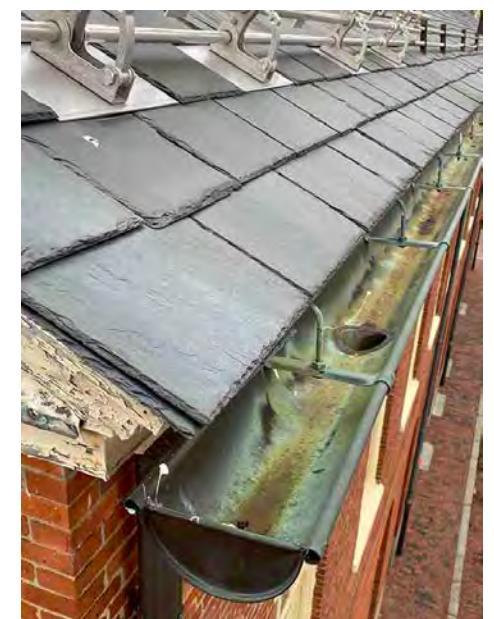
Detail of Suspended Half Round Copper Gutter at East Eave; Replacement Snow Guard at Left

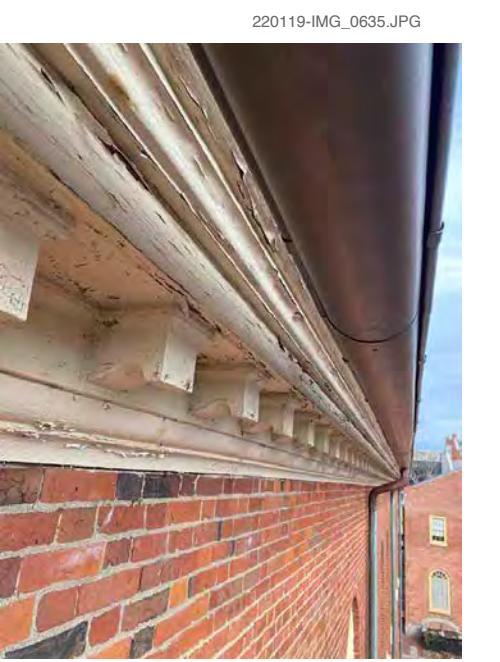
Detail of Eastern Eave Below Gutter; Bed Moulding, Modillions, Fascia & Crown are Painted Wood at Eaves vs. Painted Masonry at Gable Ends

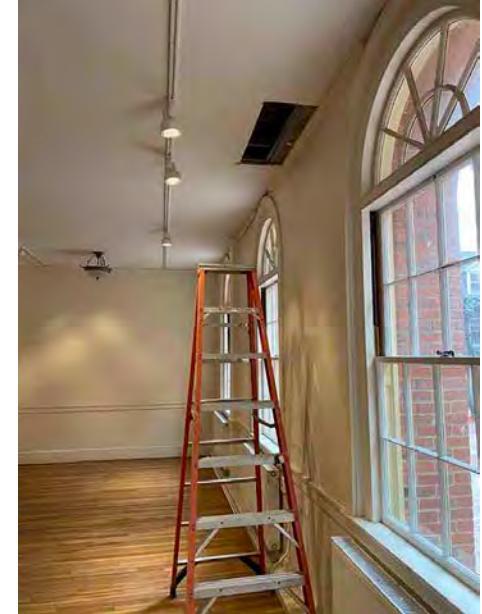
220128-IMG_0756.JPG

Portion of Ceiling Removed Adjacent to West Wall at First Floor Colonnade to Review Framing Conditions at Masonry

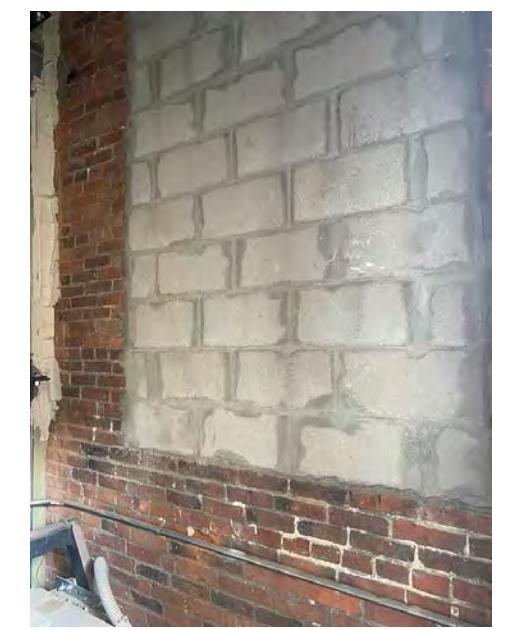
220714-IMG_1704.JPG

Concrete Block Hoistway Infill of South Facade Window

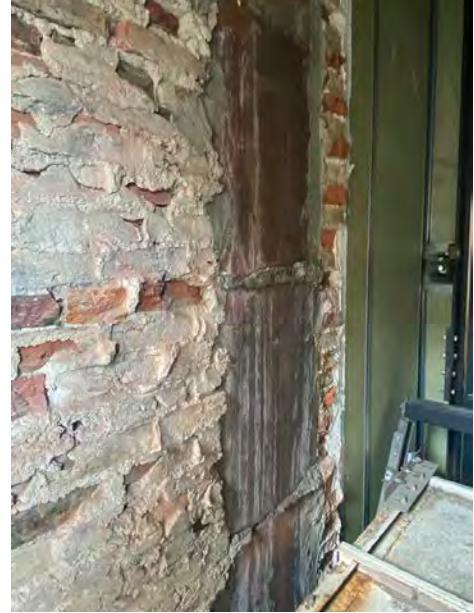
220714-IMG_1706.JPG

Chimney at Left Side of Hoistway Showing Terracotta Flue Liner Exposed

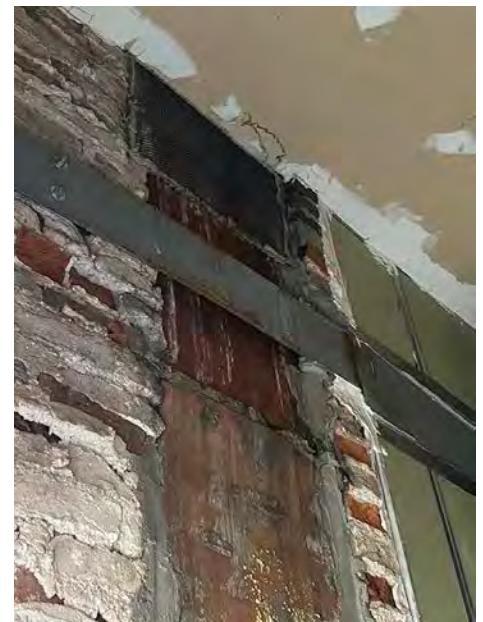
220714-IMG_1705.JPG

Upper Portion of Exposed Chimney and Flue Liner; Ceiling of Hoistway Projects Into Attic Space; Steel Strap Reinforces Masonry for Flue Vent

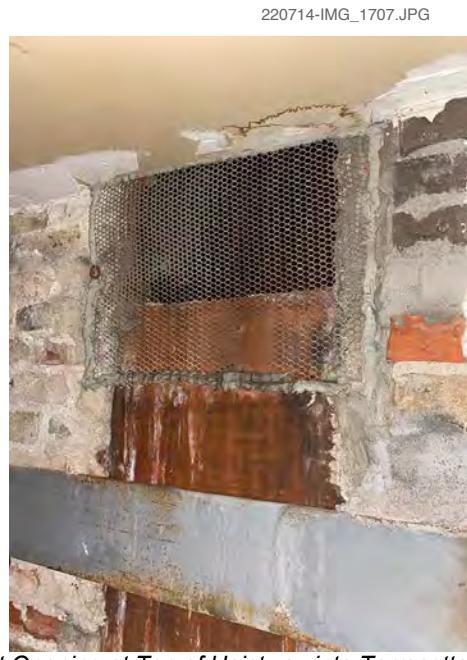
Vent Opening at Top of Hoistway into Terracotta Flue Liner; Chimney Opening Reinforced with Steel Strap

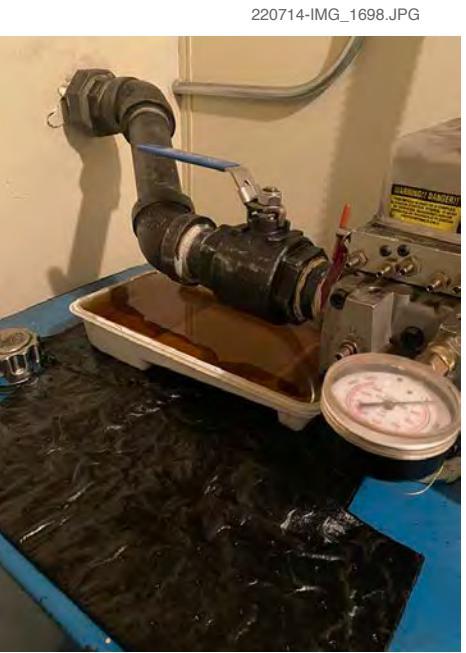
Hydraulic Fluid Leaking from Valve at Elevator Machine

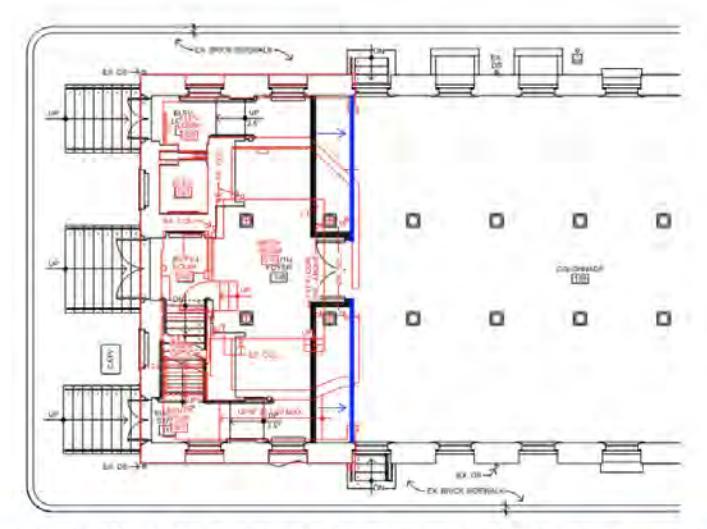
Figure 1: Recommended Modification of Wall Position, to avoid a direct vertical adjacency between the mechanical room and the Colonnade space

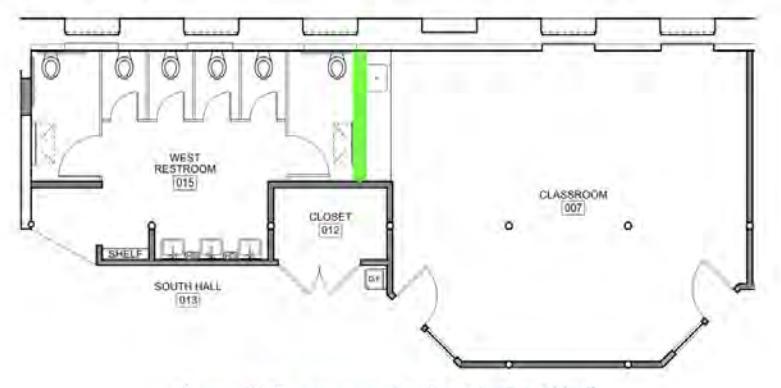
Figure 2. Recommended Double-Stud Wall

We recommend that the demising wall between Classroom 007 and West Restroom 015 be a double-stud construction. Include a 1" airspace between the stud rows and batt insulation in the cavities.

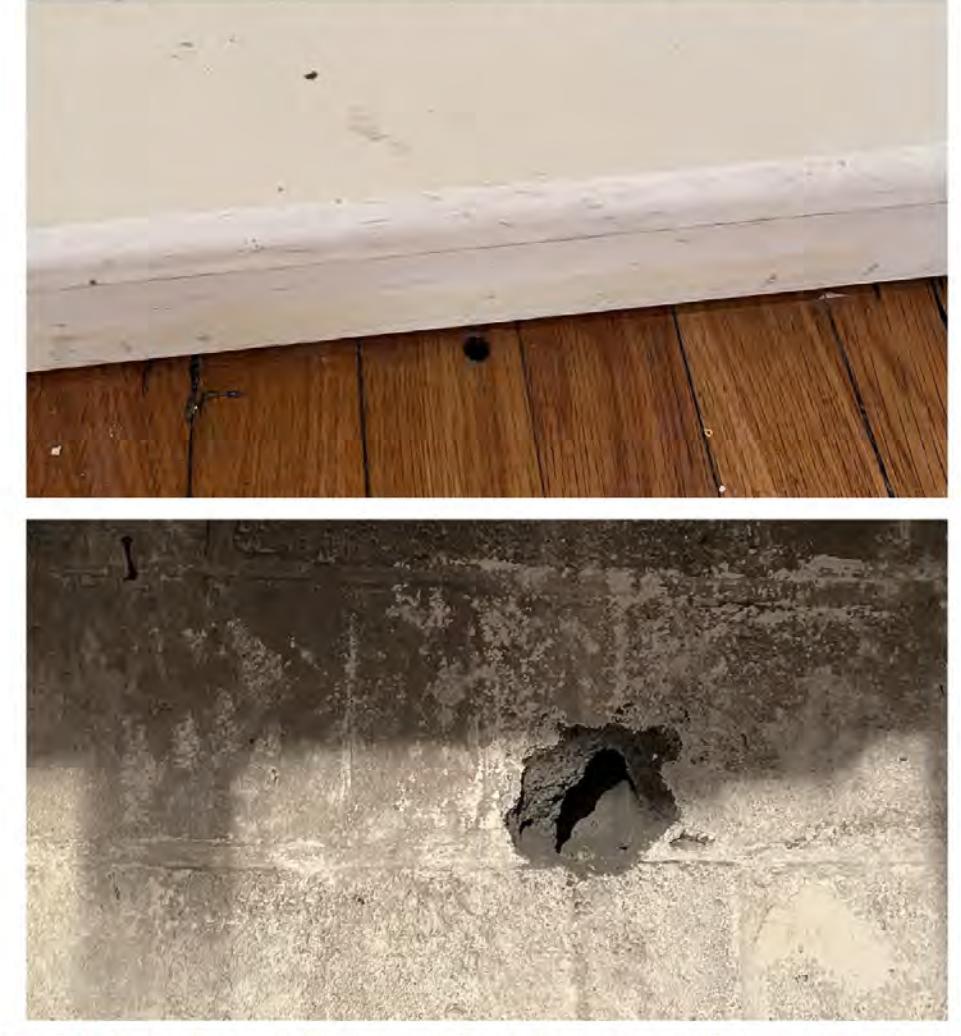
We noted a number of holes and penetrations in the Colonnade wood flooring and basement mechanical room walls (see Figures 4 & 5). All holes and penetrations will need to be sealed to prevent them from serving as sound leaks. Larger penetrations should be filled with backer rod and/or mineral wool, closed off as tightly as possible, and covered with firestop spray. Smaller holes in walls, floors, or ceilings should be plugged.

Figures 4 & 5: Hole in Colonnade Floor (above) & Penetration in Basement Mechanical Room Wall (below)

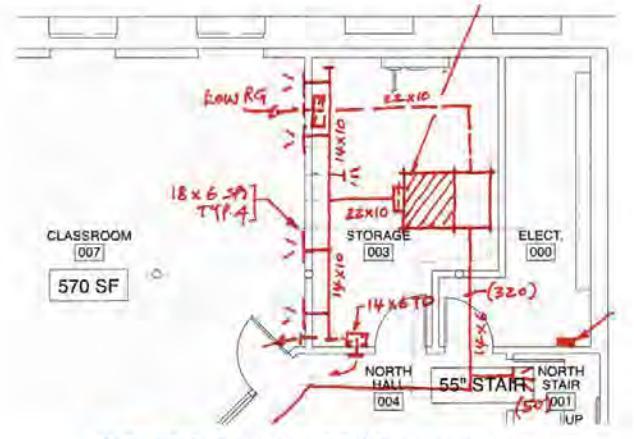
The current configuration of the FCU serving the Classroom (model HDY-12) is shown in FIGURE 2 below. There is not currently enough duct length for the fiberglass lining alone to provide enough attenuation. For both the supply and return paths, we recommend including attenuators that achieve at least 5 dB DIL at the 125 Hz octave band. Note that this is *in addition to* the fiberglass lining.

FIGURE 2: Classroom FCU Ductwork Layout
