# Pioneer Village Living History Museum and Visitor's Center

Salem Historic Commission  
February 22, 2023

## Camp Naumkeag Structures

## Pioneer Village

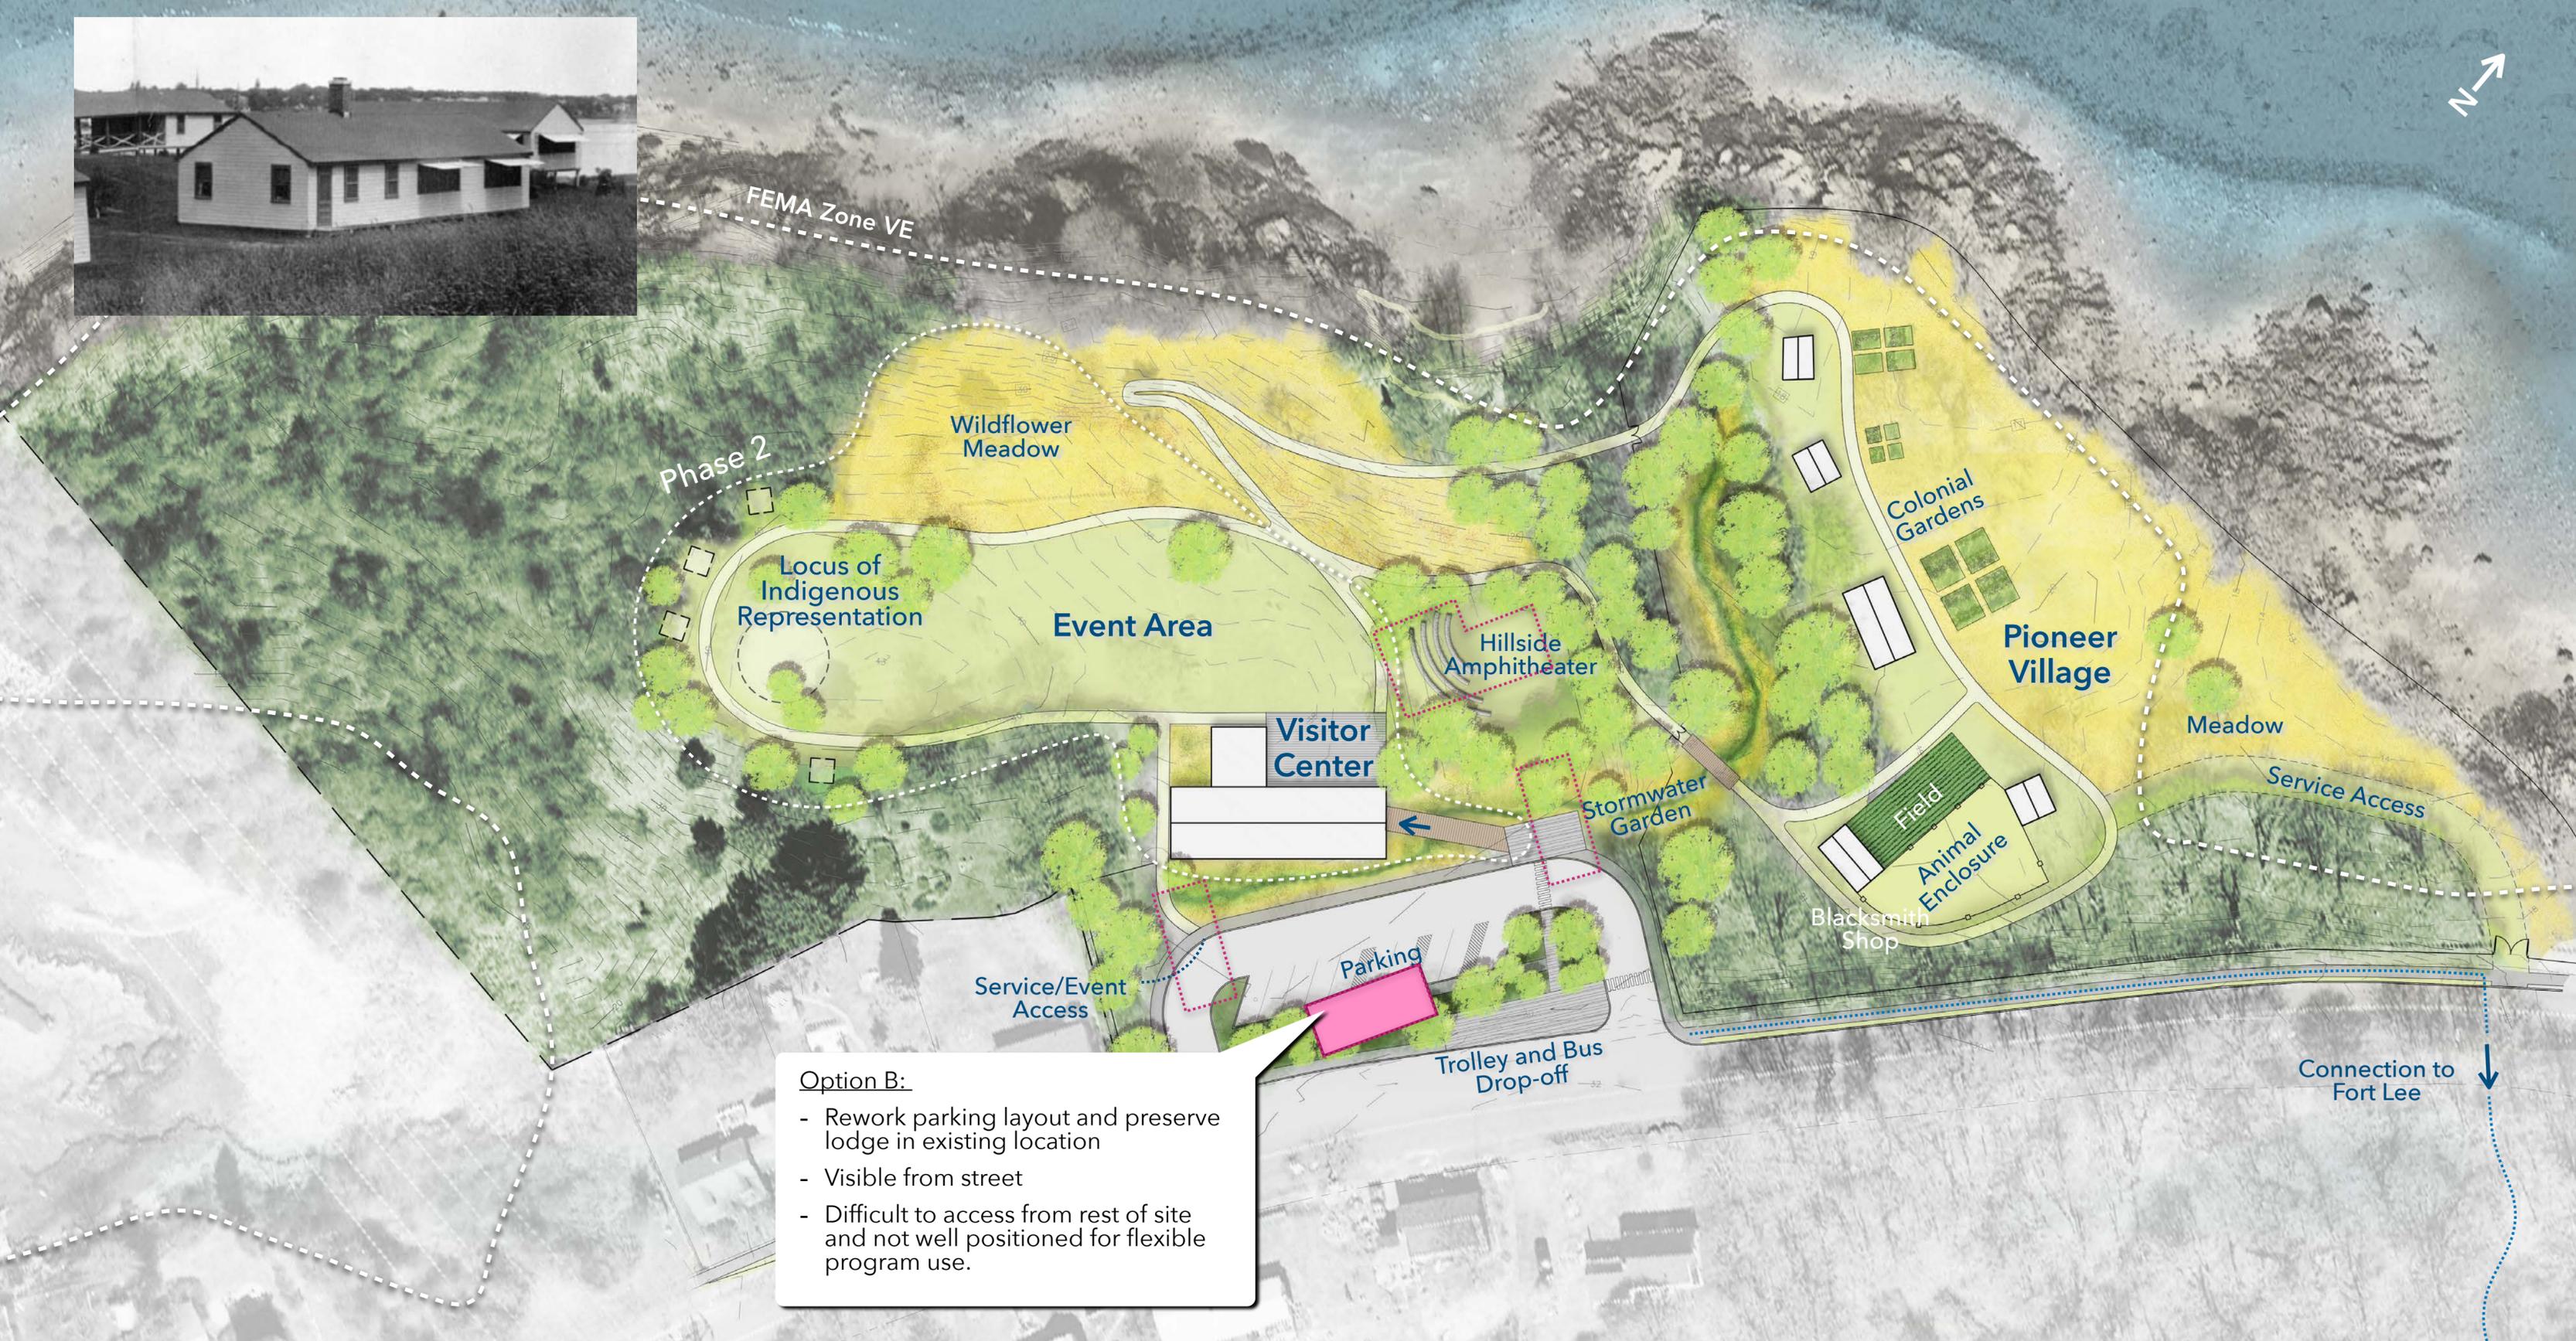
**Option B:**

- Rework parking layout and preserve lodge in existing location
- Visible from street
- Difficult to access from rest of site and not well positioned for flexible program use.

- Rework parking layout and preserve lodge in existing location
- Visible from street
- Difficult to access from rest of site and not well positioned for flexible program use.

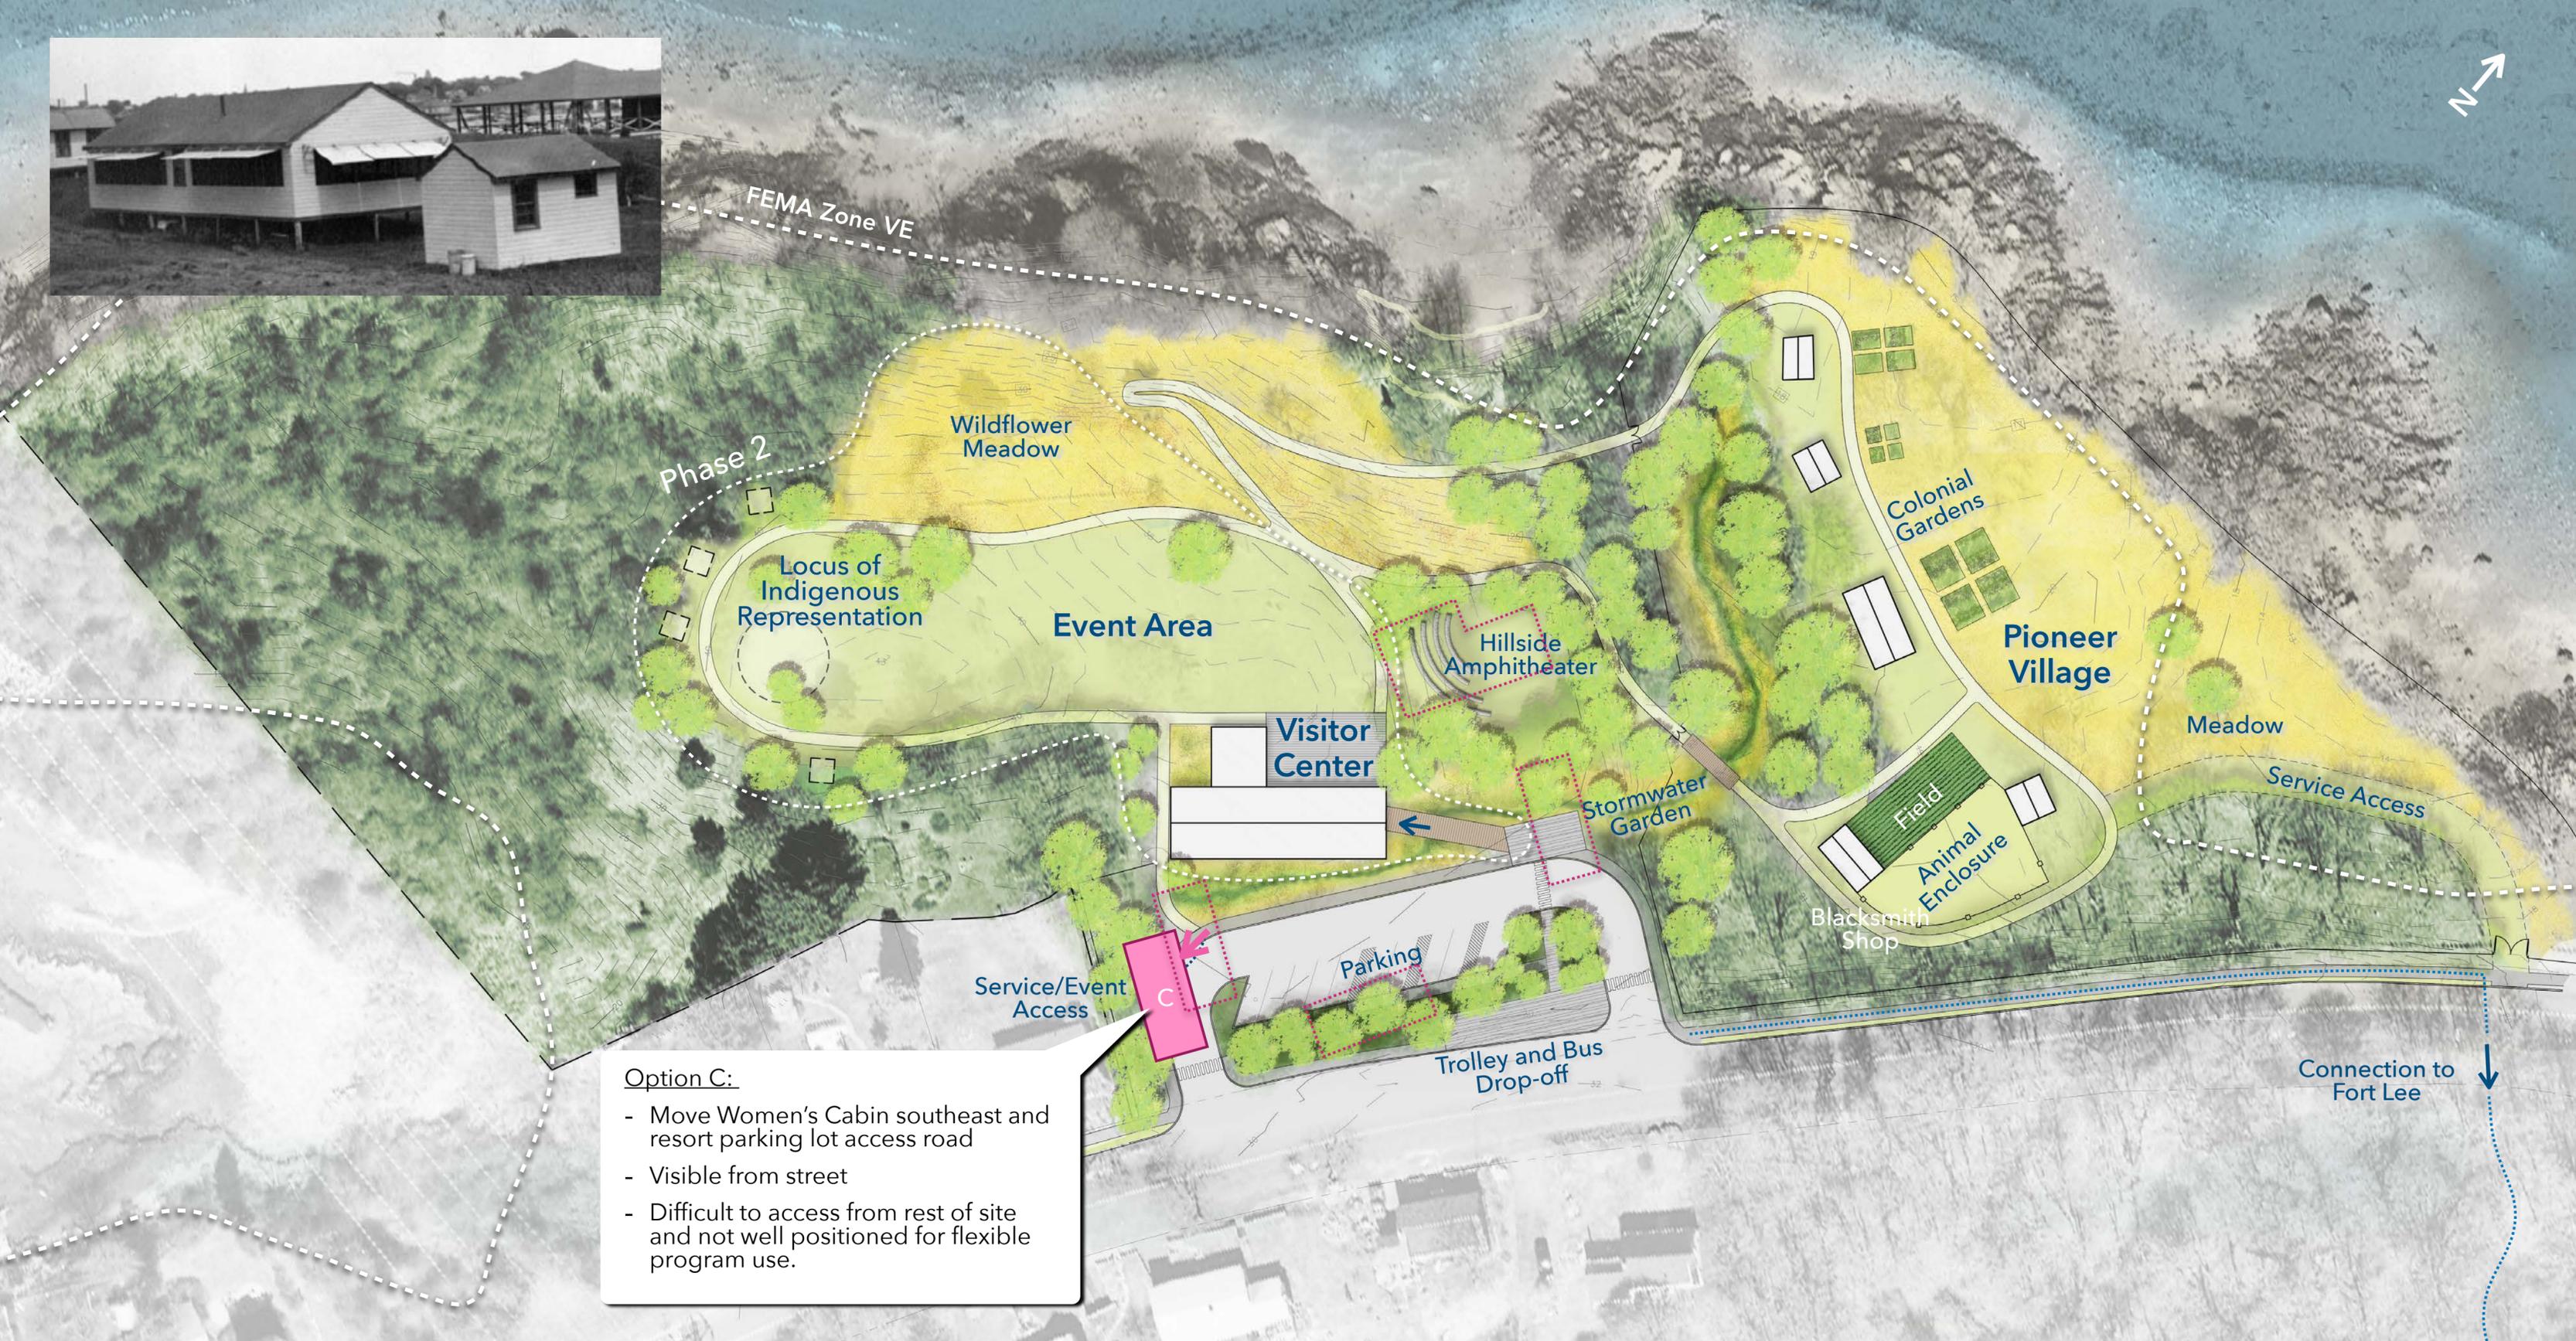
**Option C:**

- Move Women's Cabin southeast and resort parking lot access road
- Visible from street
- Difficult to access from rest of site and not well positioned for flexible program use.

- Move Women's Cabin southeast and resort parking lot access road
- Visible from street
- Difficult to access from rest of site and not well positioned for flexible program use.

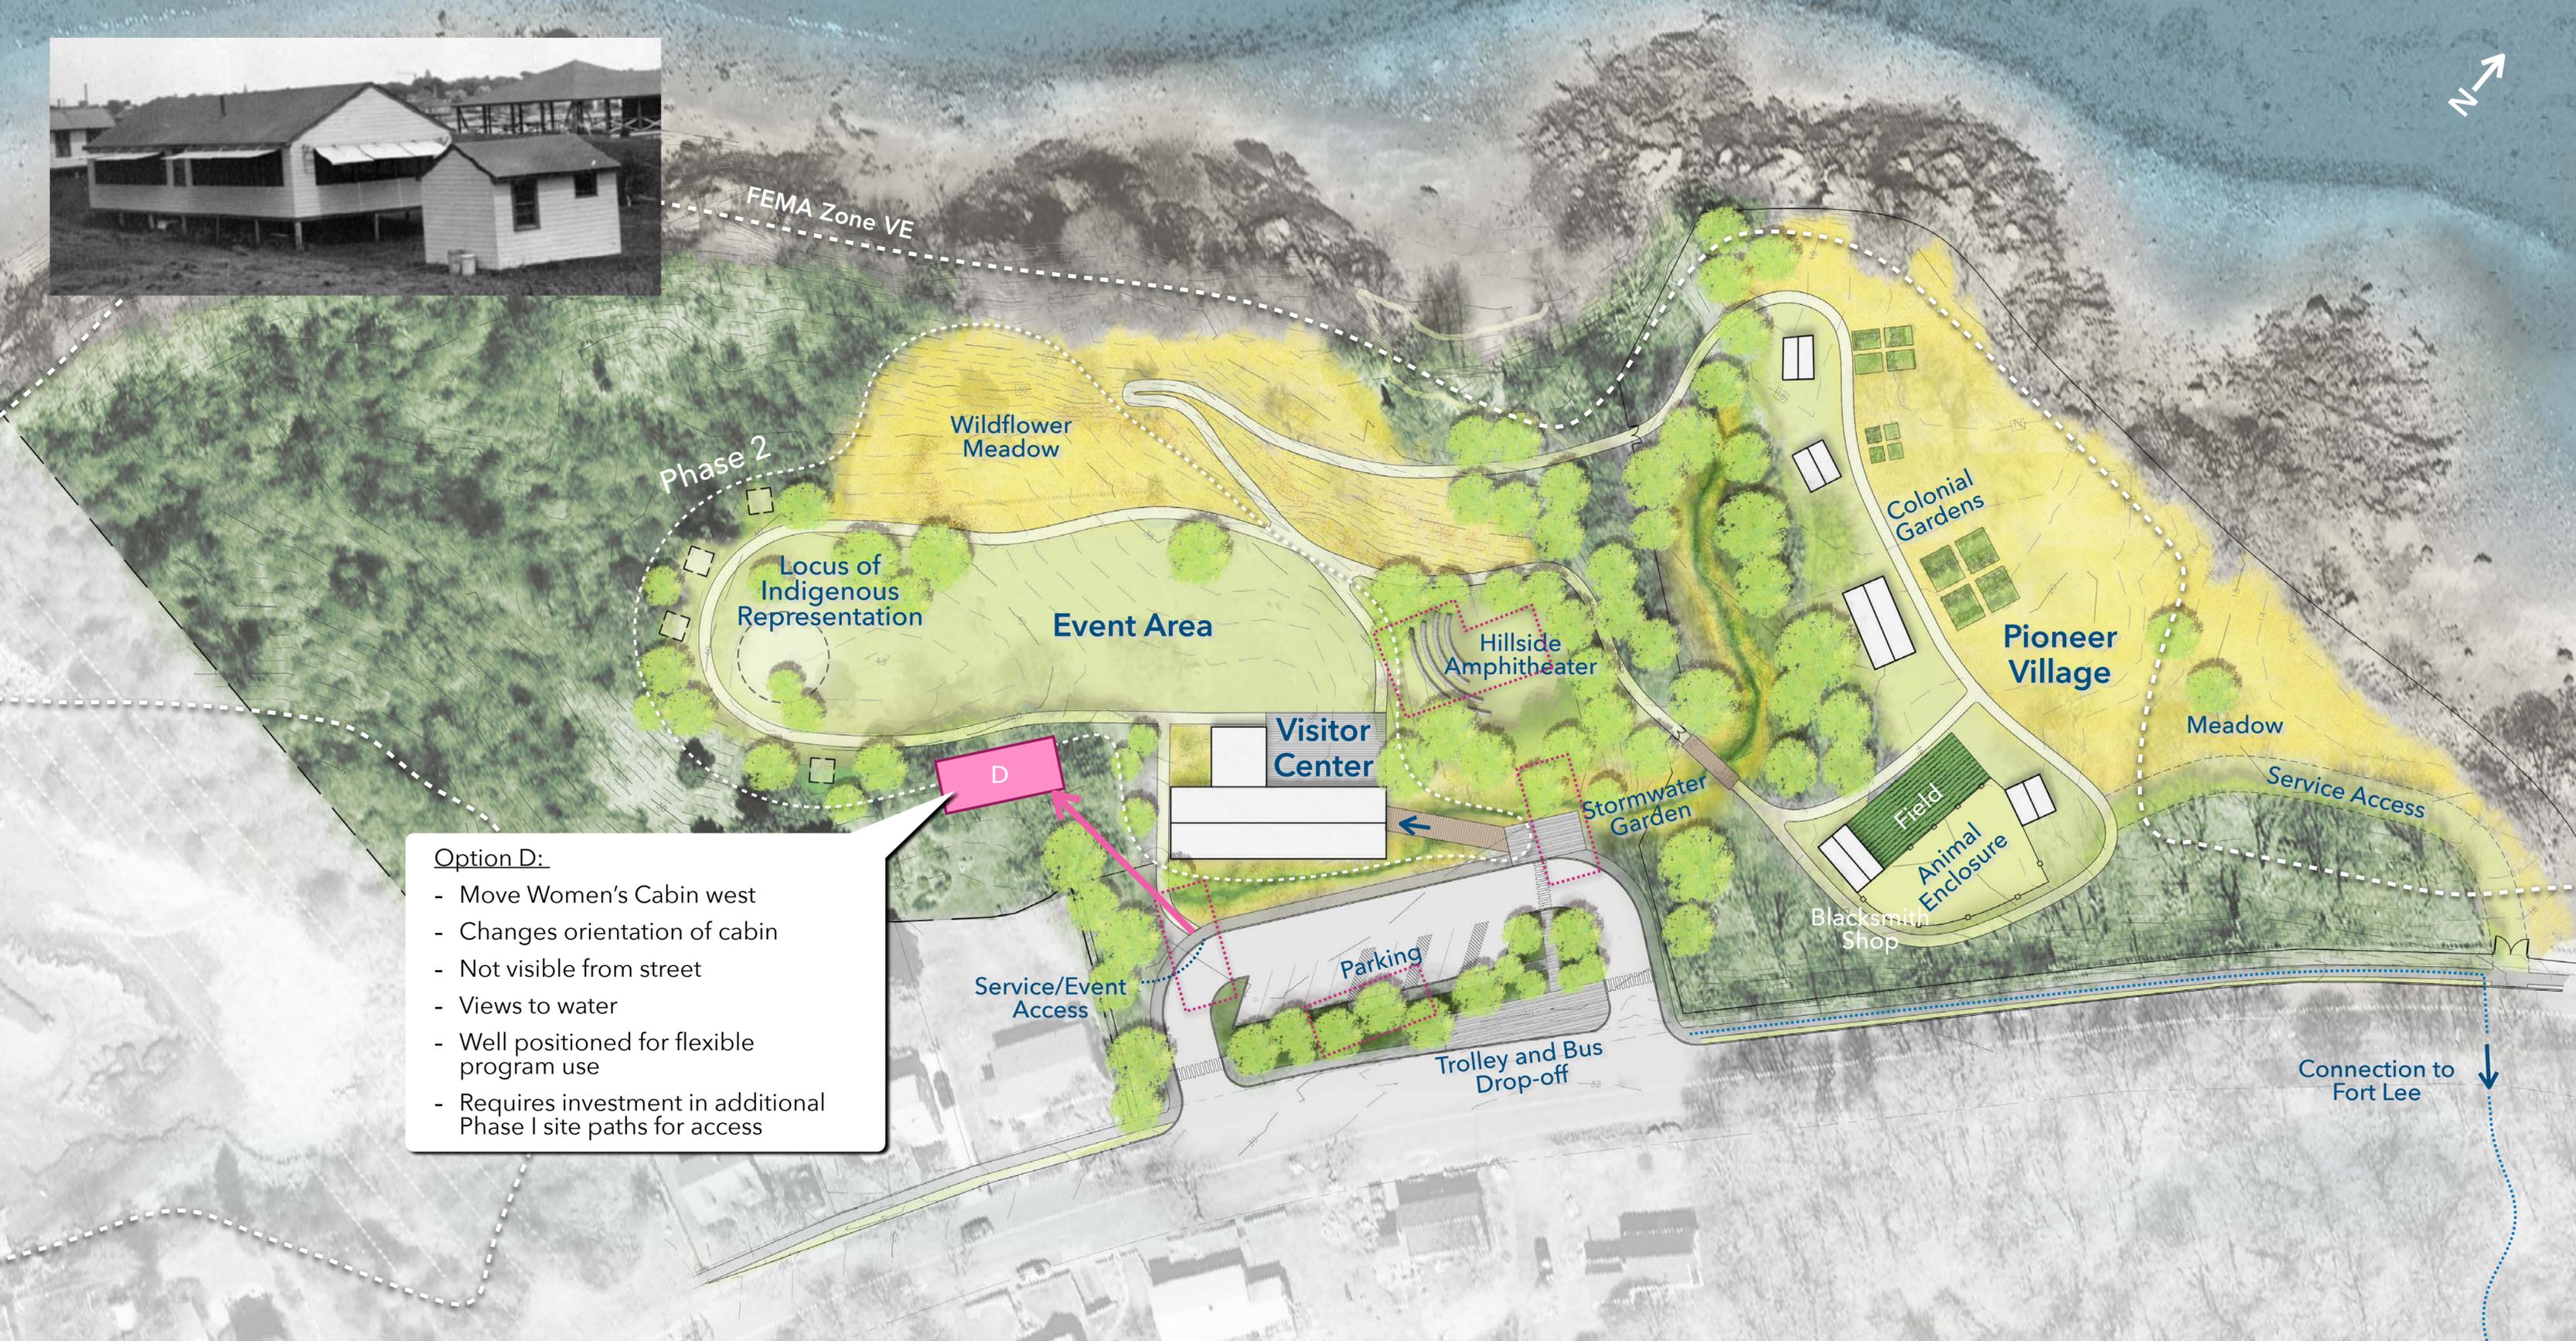
**Option D:**

- Move Women's Cabin west
- Changes orientation of cabin
- Not visible from street
- Views to water
- Well positioned for flexible program use
- Requires investment in additional Phase I site paths for access

- Move Women's Cabin west
- Changes orientation of cabin
- Not visible from street
- Views to water
- Well positioned for flexible program use
- Requires investment in additional Phase I site paths for access

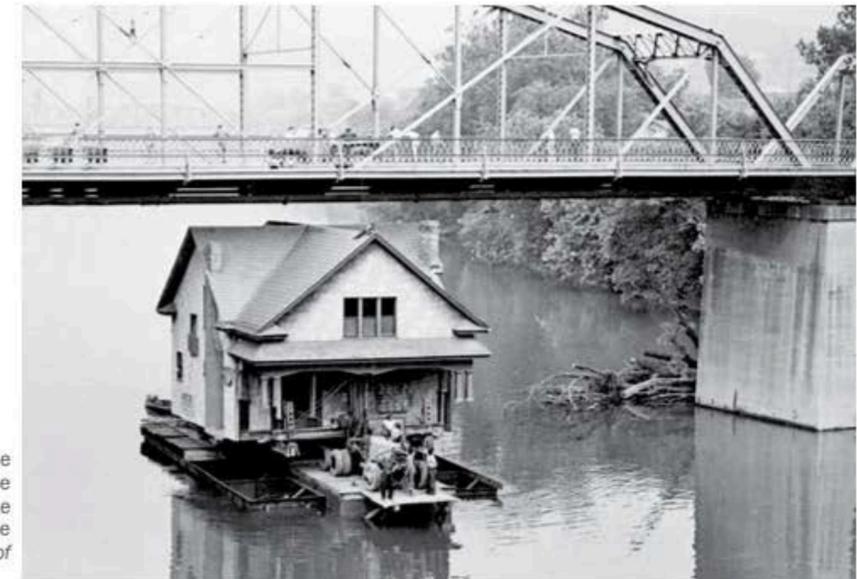
[109] At times, moving a house over water may provide more space to maneuver and facilitate keeping the building in one piece as it is moved. Photo: Courtesy of myvhome.com

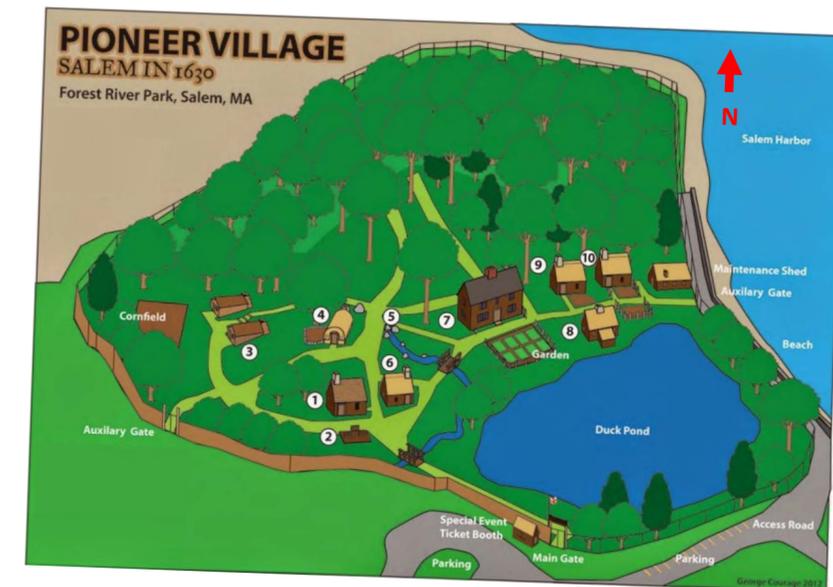
Figure 1: Overall view of the surveyed cottages

On July 27 we performed interior and exterior structural conditions evaluation of six structures at Pioneer Village in Salem, MA. The assessment also included a study of the feasibility of re-locating the structures to present site of Camp Naumkeag's near the Salem Willows. Figure 1 below shows the overall view of the cottage layout; please note that elevations facing Salem Harbor will be referenced as east facing throughout this report.

- Structures North evaluated four one-story cottages, the Governor's Fayre House, and the Blacksmith shop in July 2022
- Identified structural deficiencies and recommended repairs
- Governor's Fayre House, Blacksmith Cottage, Lady Arabella Cottage are sturdy enough to be moved whole with structural repair prior to move. Chimneys would be dismantled and reconstructed at new site.
- Blacksmith shop and Admissions and Gift Shop buildings would be dismantled into wall and roof slabs and re-assembled at new site
- Woodbury cottage is not stable enough to be moved in one piece and is inaccessible because a large tree is growing through the front foundation wall. It should be completely dismantled and reconstructed at new site
- Recommended methods for lifting structures from foundations and for moving via barge to new site

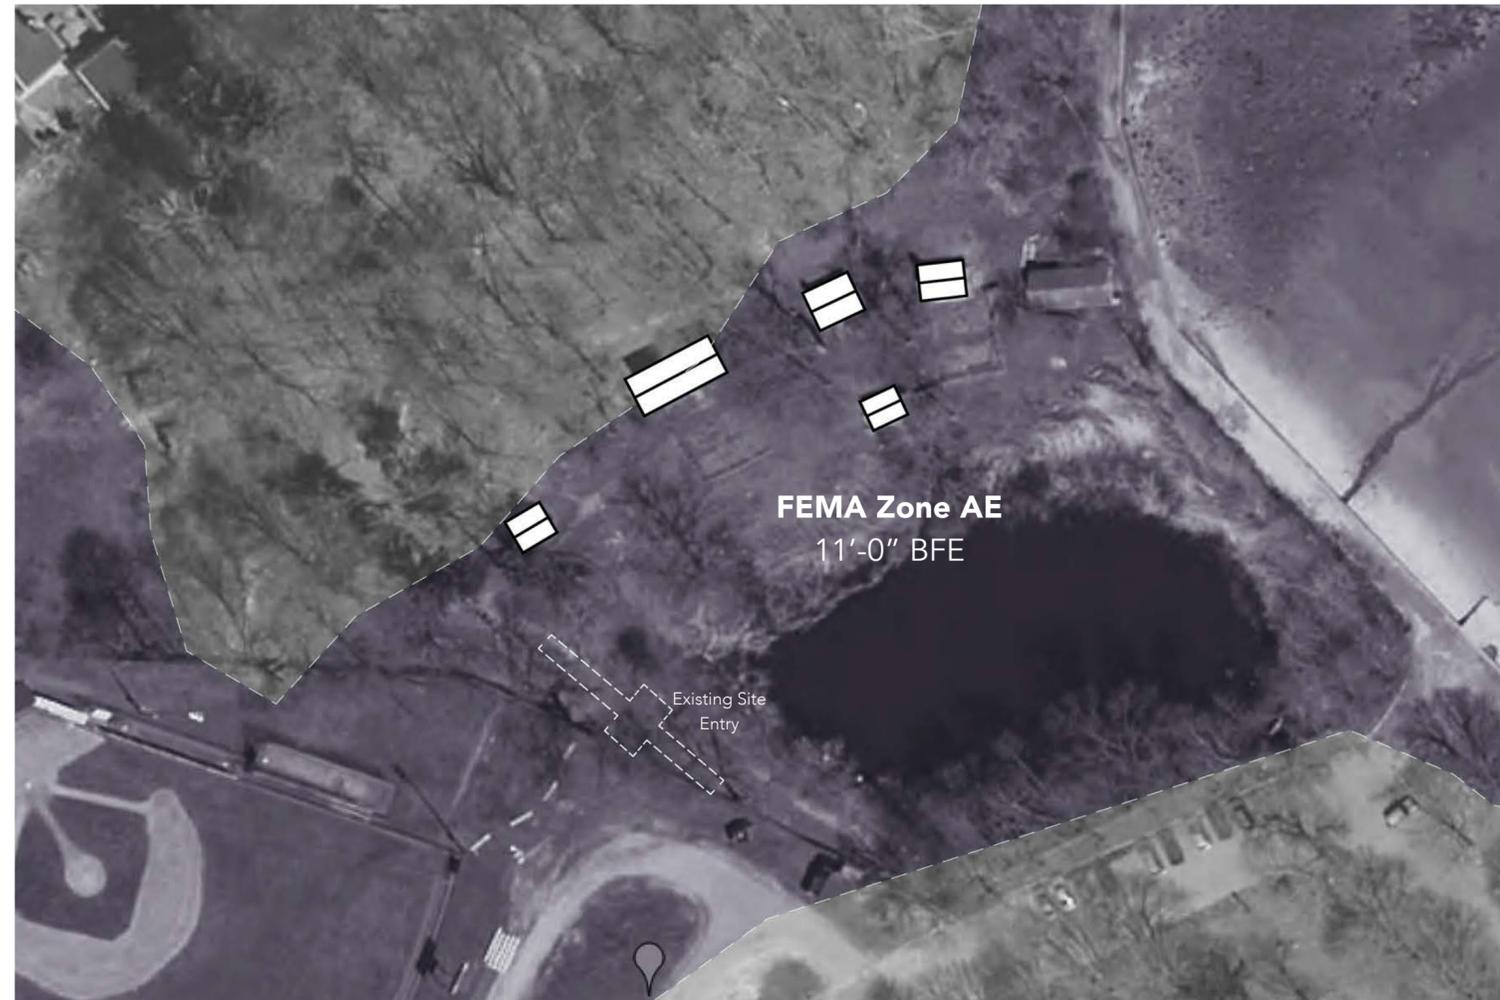
### Forest River Park (Existing)

\* Data from Massachusetts Office of Coastal Zone Management's Massachusetts Sea Level Rise and Coastal Flooding Viewer

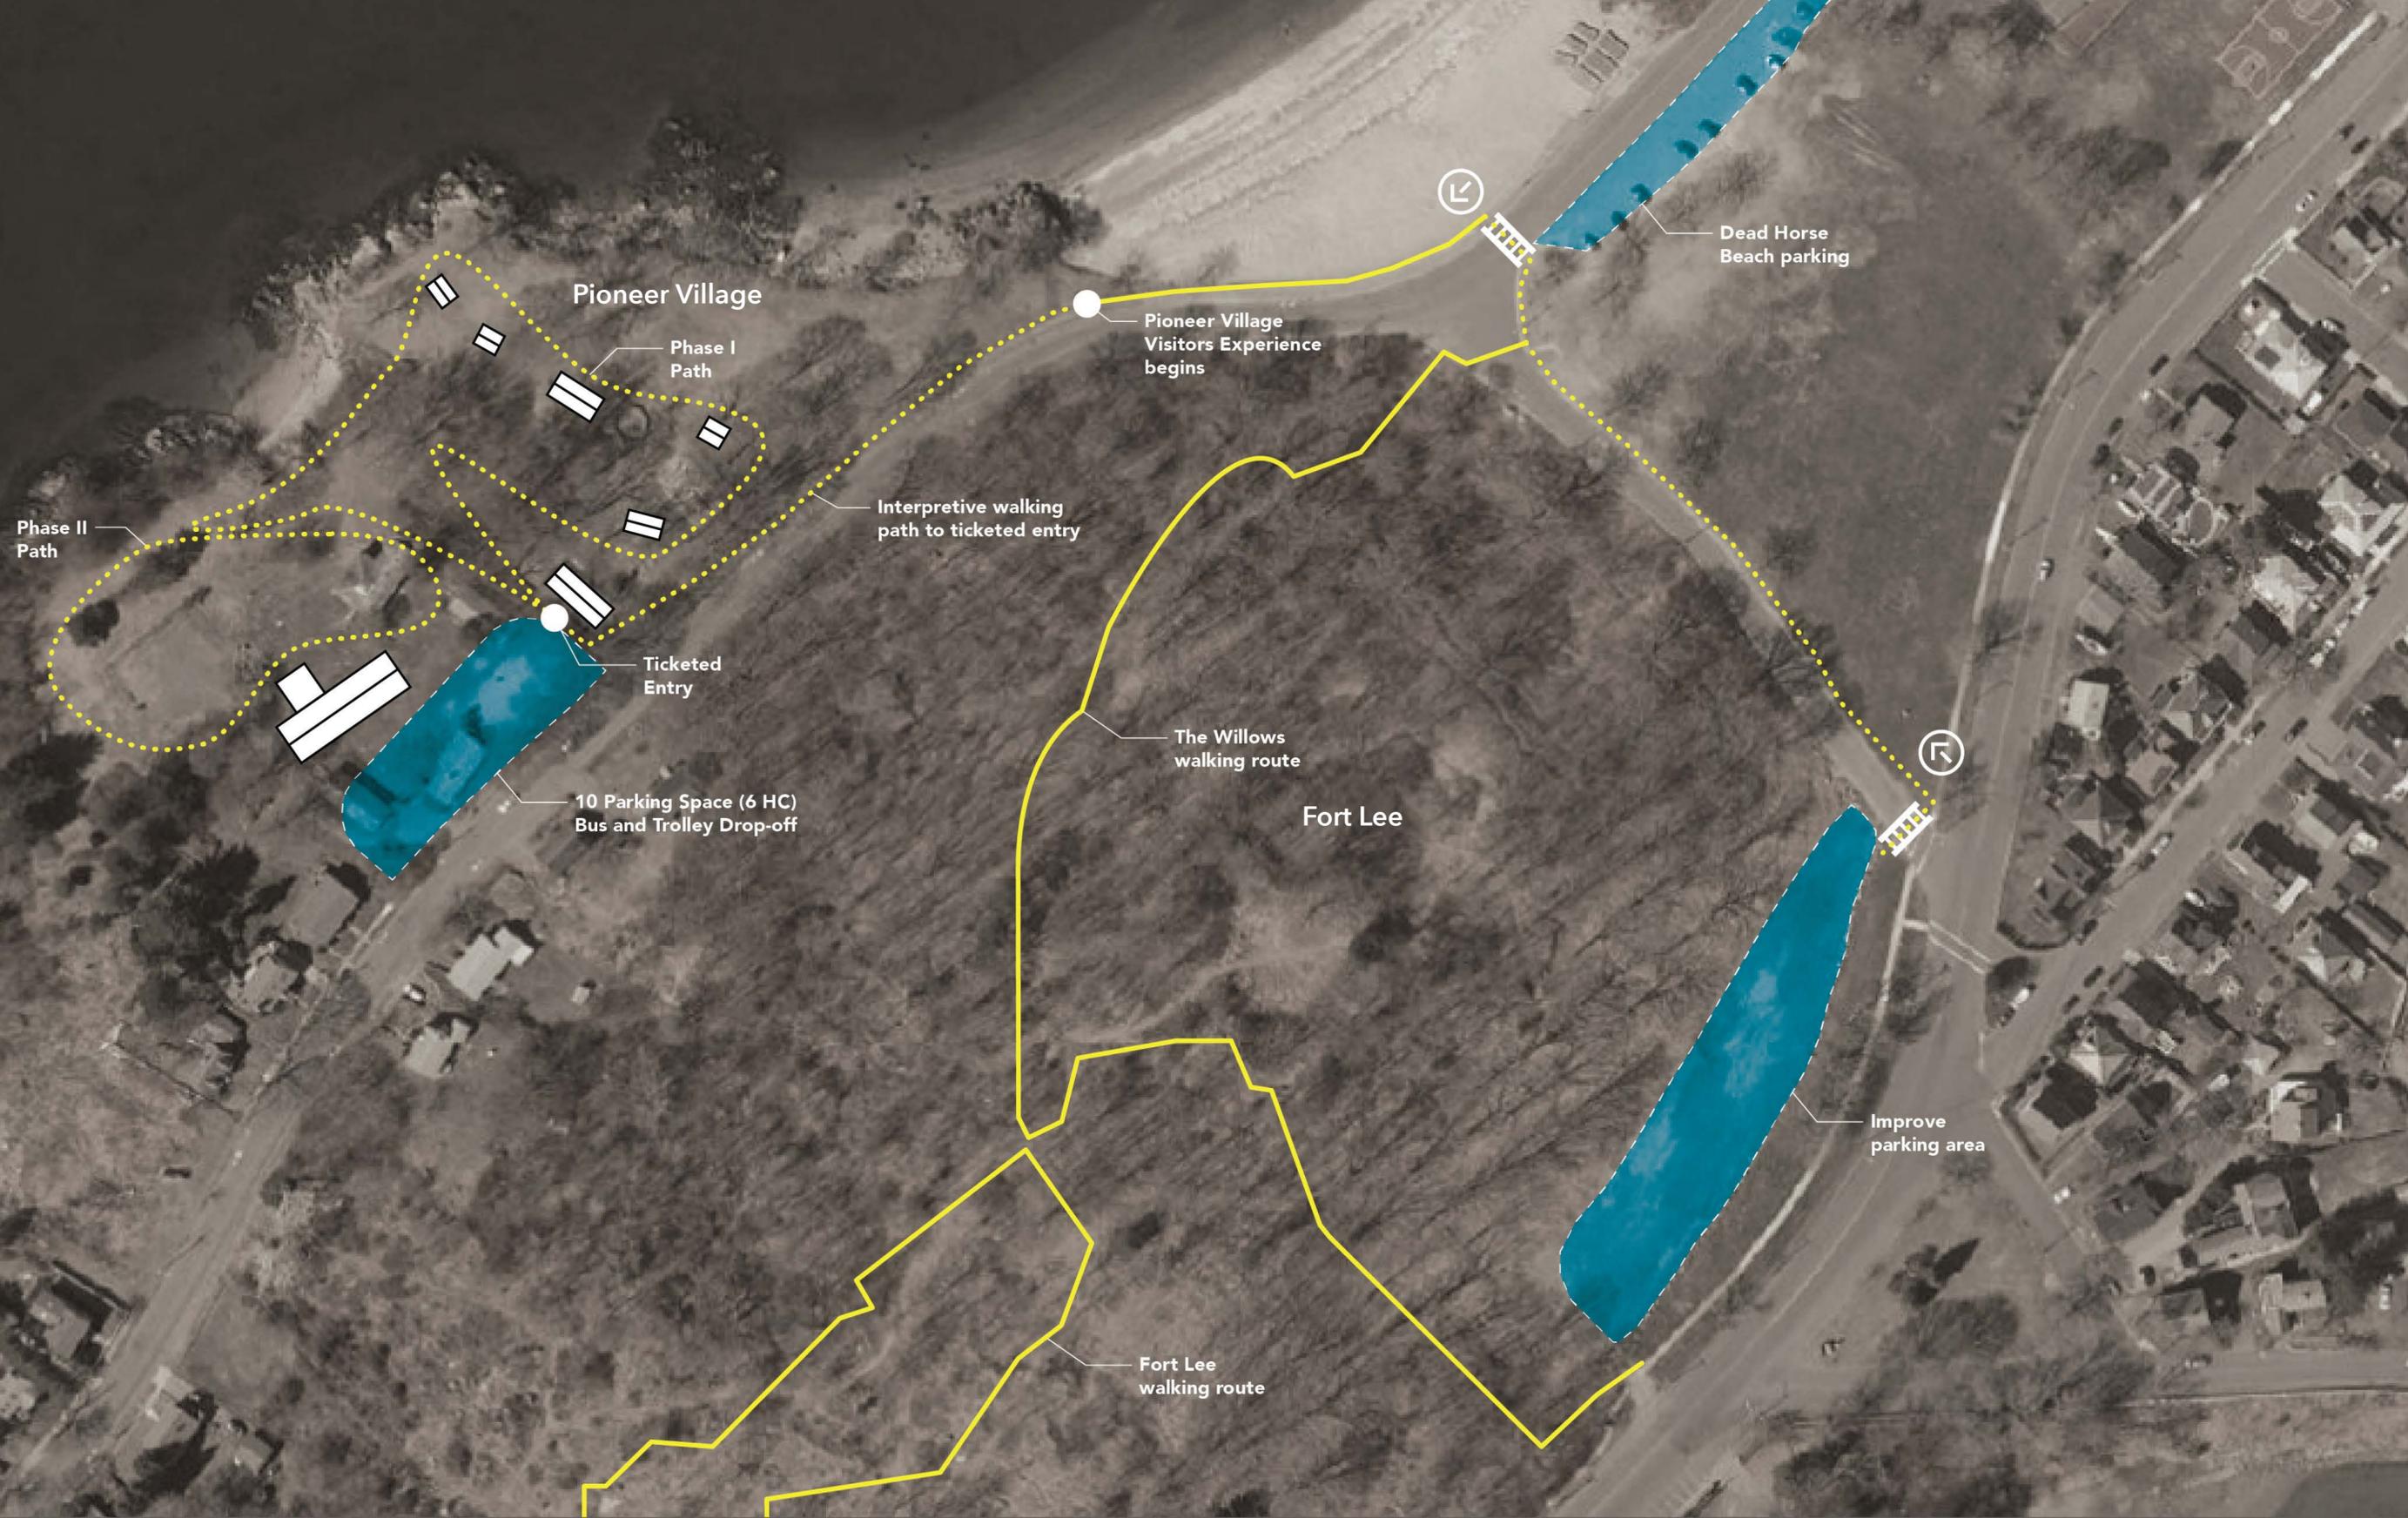
**KEY**

- Existing Paths
- New/Improved Paths
- Parking Lots
- Proposed Directional/Interpretive Signage
- Proposed Crosswalks
