PLAYGROUND

STUDY REPORT 2022:

Prepared for: Salem Public Schools

2022 Playground Study Report

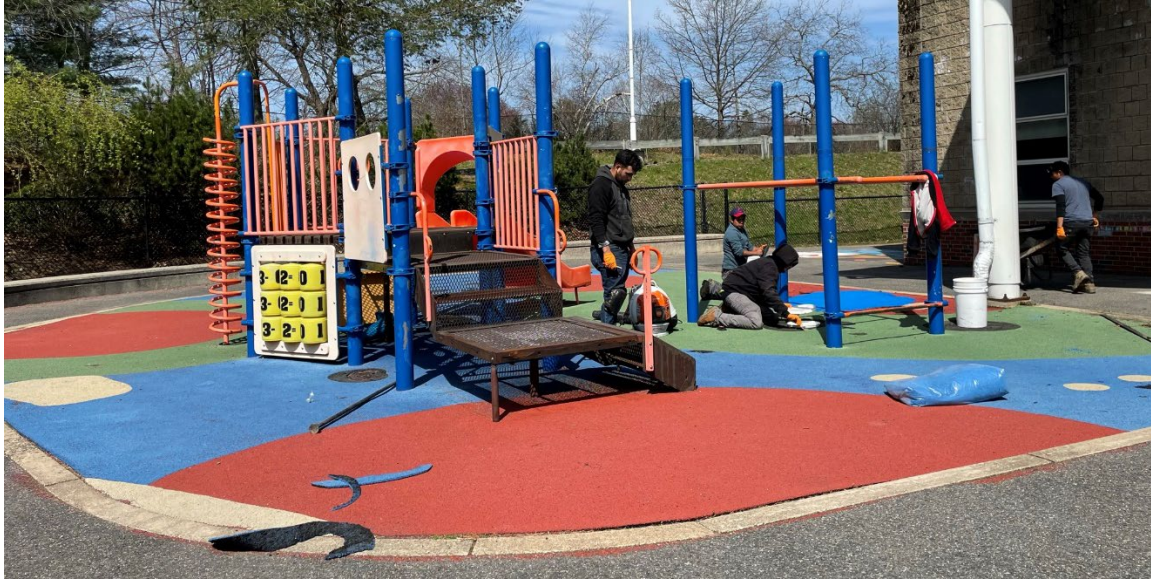
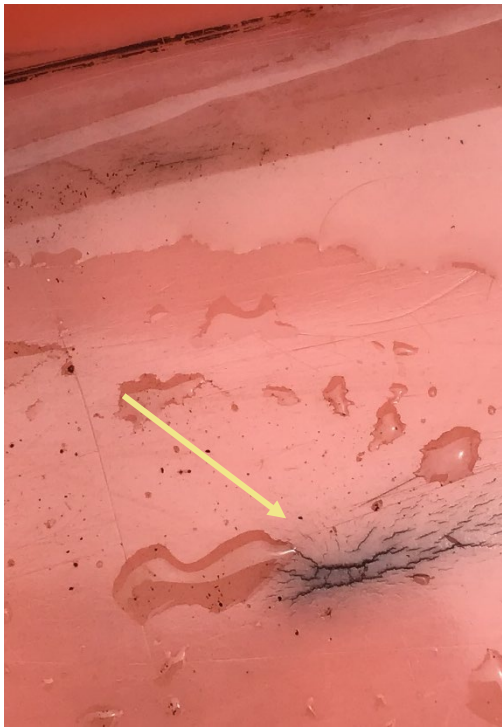
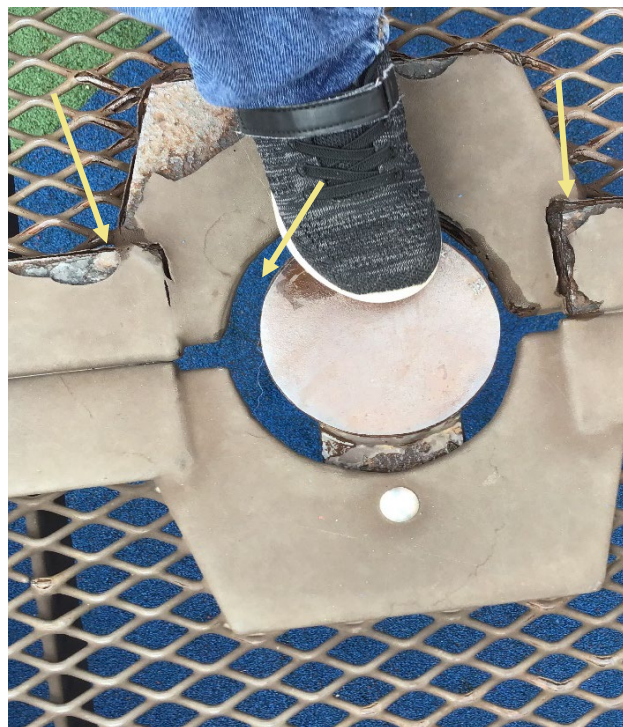
7. PLAYGROUND PHOTOGRAPHS

- *PIP Surfacing needs to meet the edge of concrete.*
- *PIP has recently been patched; however, there are areas that still need patching and are cracking.*
- *The surfacing may not pass the Head Drop Test (due to patching).*
- *The PIP is rated as fair, due to missing and incomplete edging. This will allow weeds to grow and creates tripping hazards.*

- *The slide bed has a stress crack.*
- *Age-appropriate structure, except for the 'corkscrew event'.*
- *The middle of structure with deck joint is open which will allow fingers to pass through.*
- *The decks are all peeling and there is a good deal of missing PVC coating. Needs immediate repair or replacement.*
- *The structure has rust setting in on painted steel welds.*
- *The transfer station needs immediate repair or replacement.*

- *It is NOT cost effective to retrofit this structure.*
- *Remove and add new equipment; there are an overwhelming number of **hazards**.*
- *PIP will have to have a new subbase, SBR rubber cushion and EPDM top layer. Thus, the entire area will need to be rehabilitated.*
- *May consider using a 50% black and 50% color PIP, as it is less expensive.*
- *Suggest using play panels in the next design to expand the play value.*
- *The site is small, but a moving piece of equipment would be advised (if there is room).*
- *If new playground is to be designed, entry ramp may be reconsidered to provide a better/safer and ADA compliant circulation.*
- *Touch up paint at benches.*

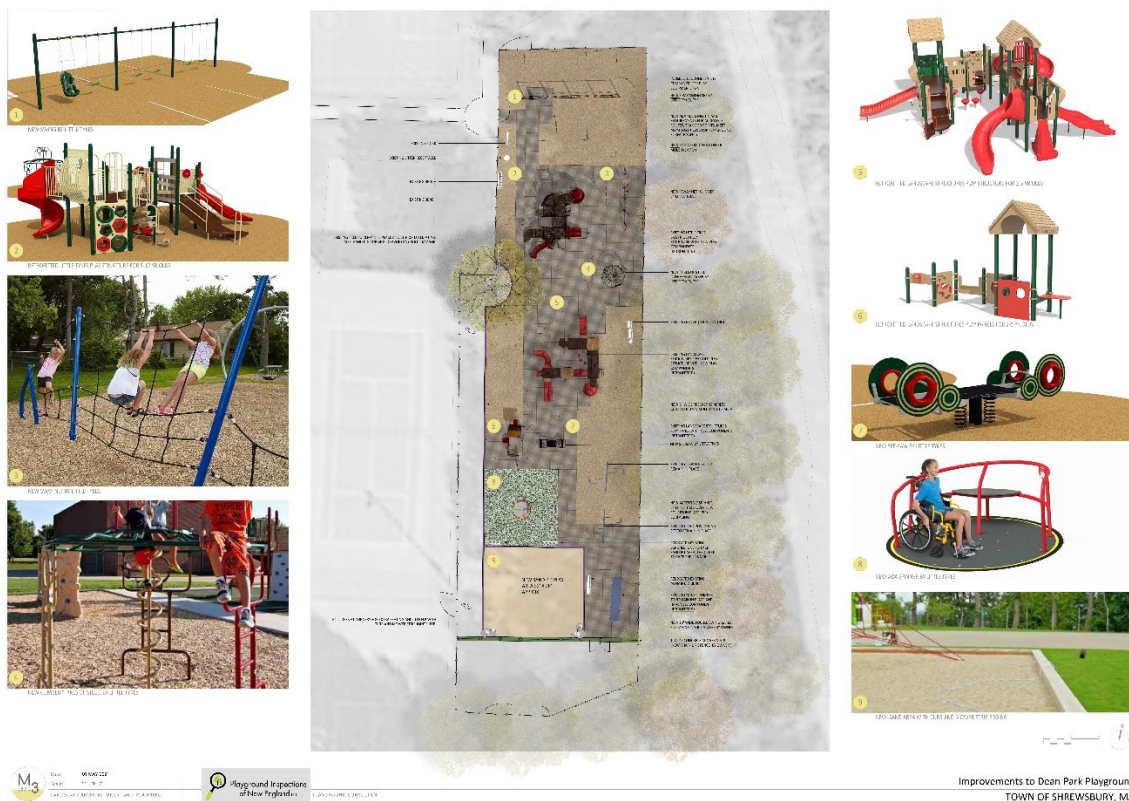
Figure 1: Example of Playground Master Plan developed for the Town of Shrewsbury. Design By PINE and M3 Land Studio, Rendering by M3 Land Studio

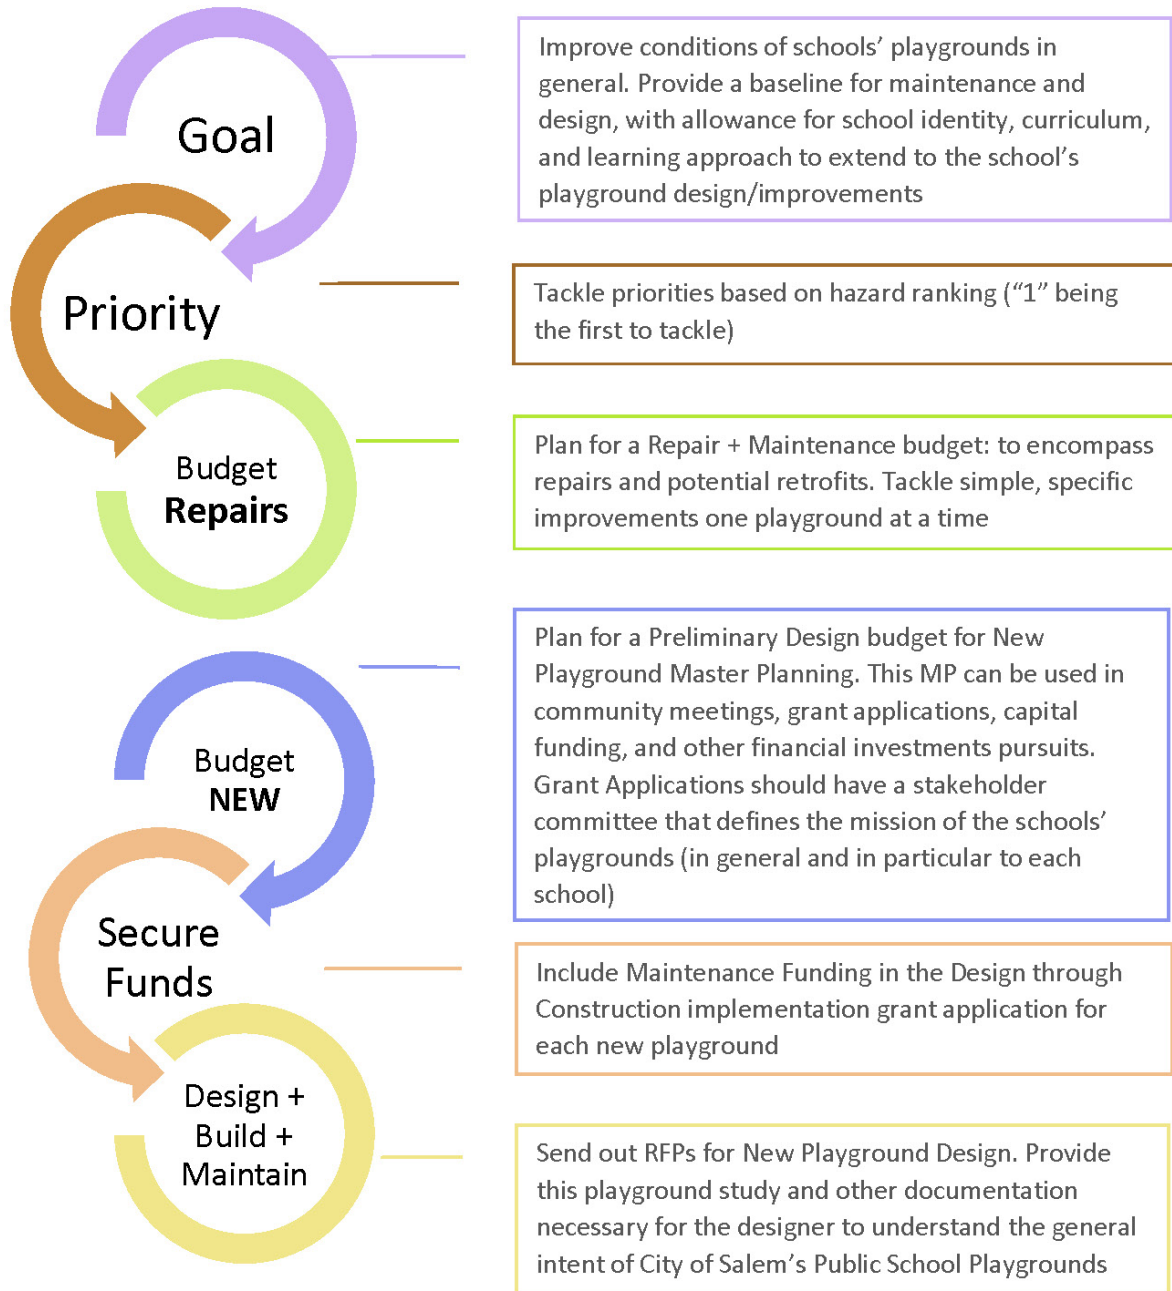
Figure 2: General Planning Recommendations for Existing School Playground Improvements diagram by M3 Land Studio

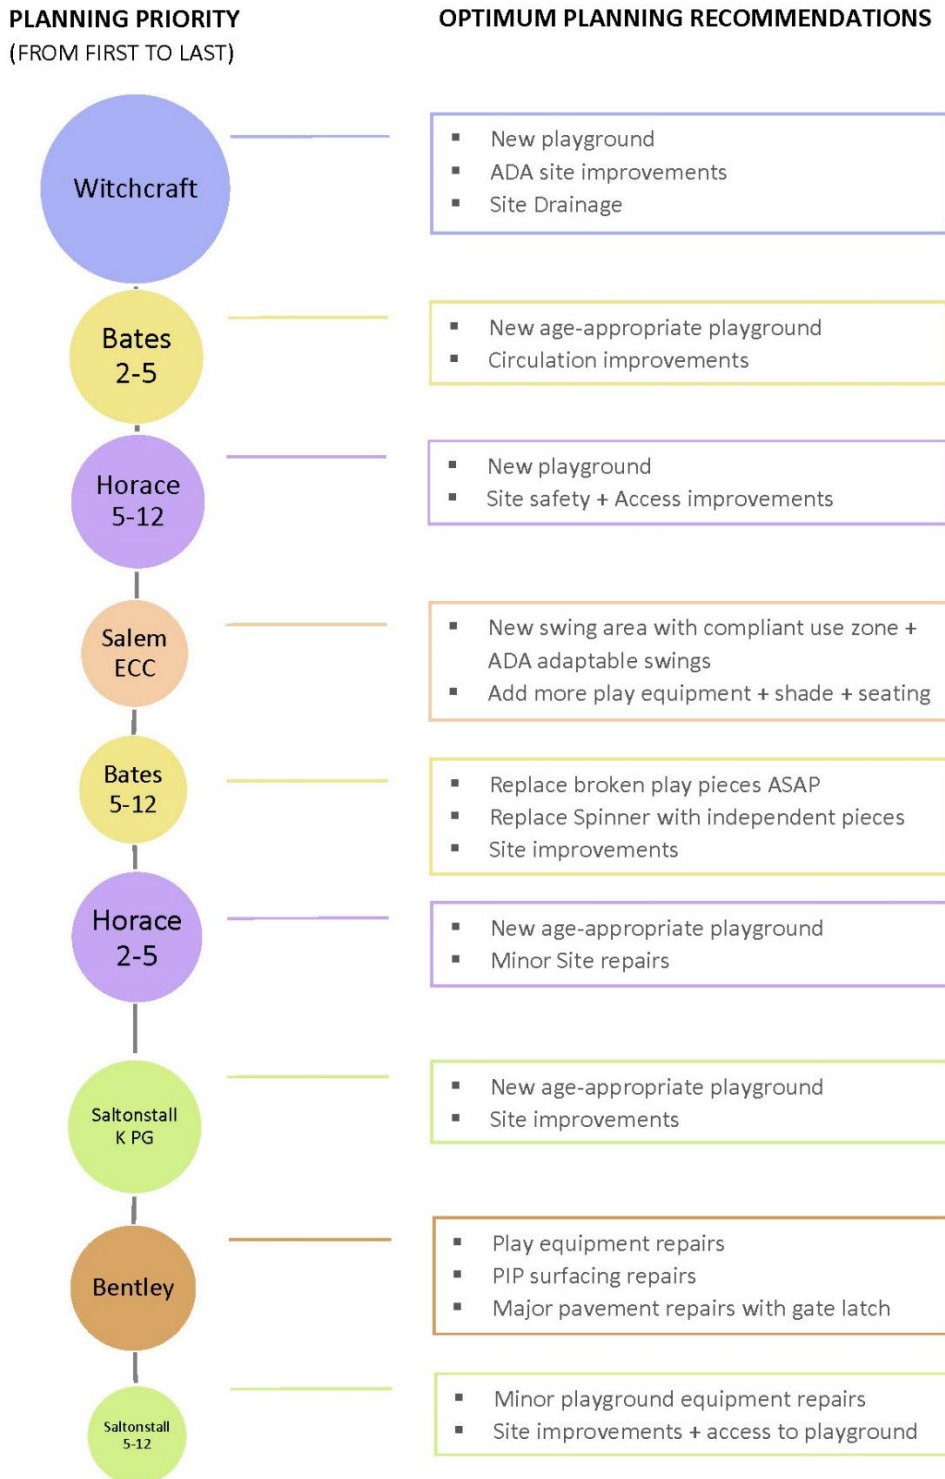
Figure 4: Planning Recommendations per Existing School Playground, diagram by M3 Land Studio

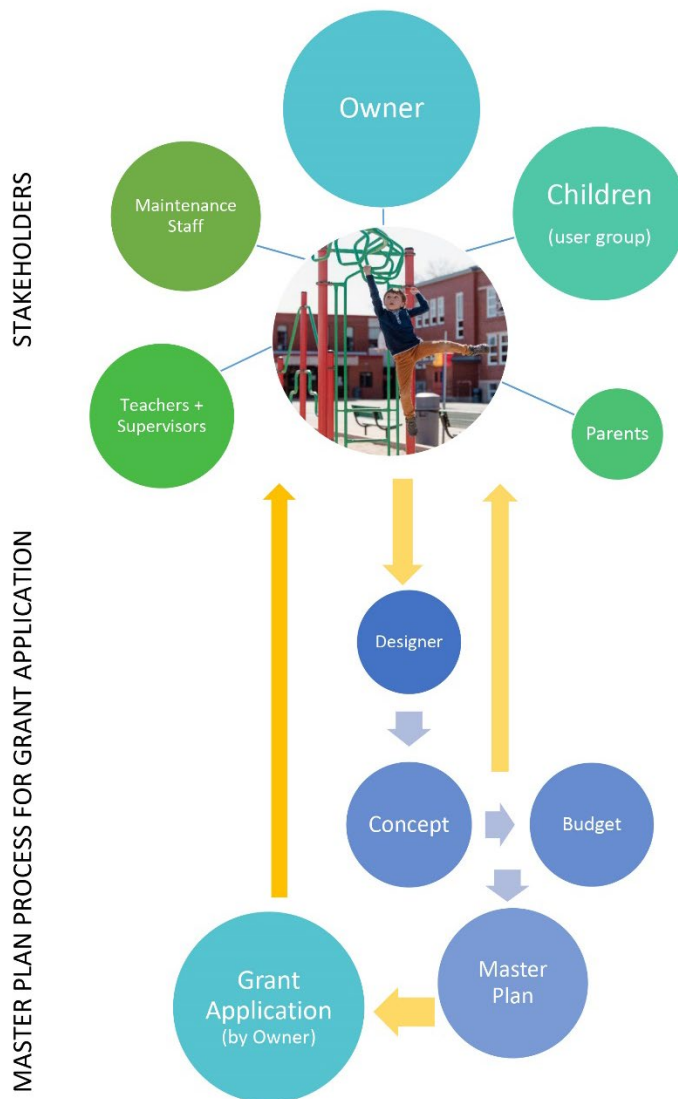
Figure 5: Planning for a New Playground, diagram by M3 Land Studio

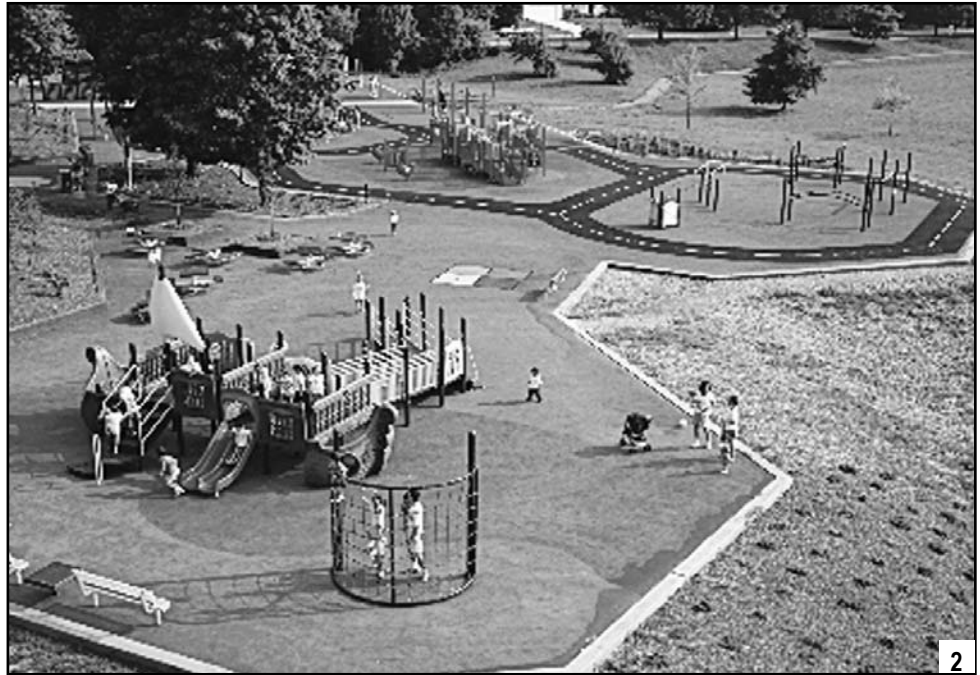
This large play area designed for the same age group is part of a public park system. The total of all the play components in this play area - which includes multiple composite structures - must be counted when applying the play area guidelines.

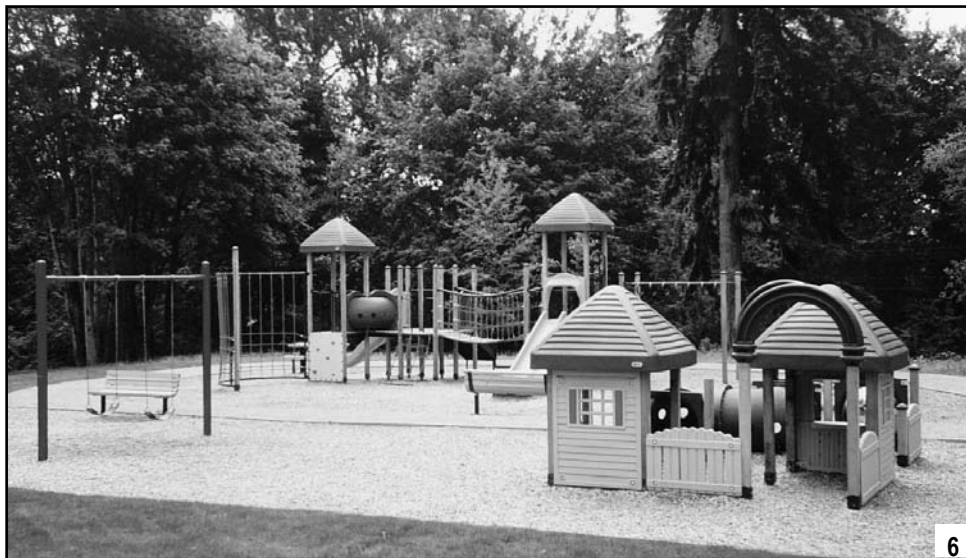
This dual play area designed for 2 to 5 year-olds and 5 to 12 year-olds shares resilient surfacing. Each section must be evaluated separately.

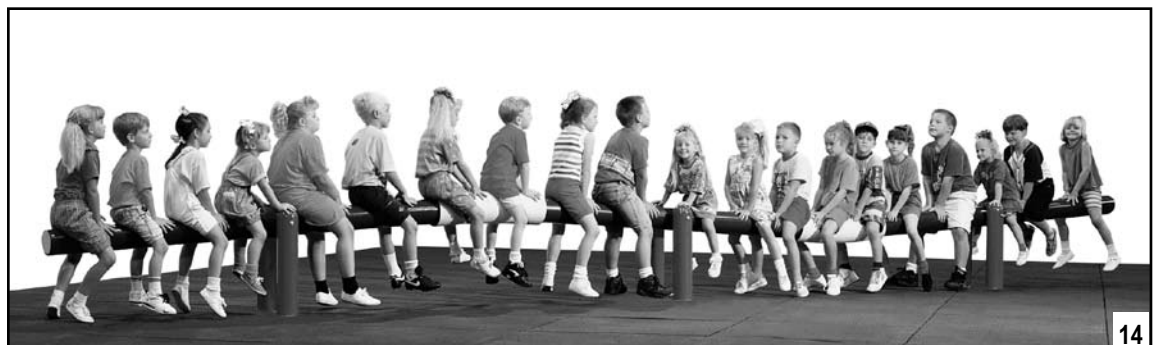
This single play component provides one type of play experience for multiple individuals.

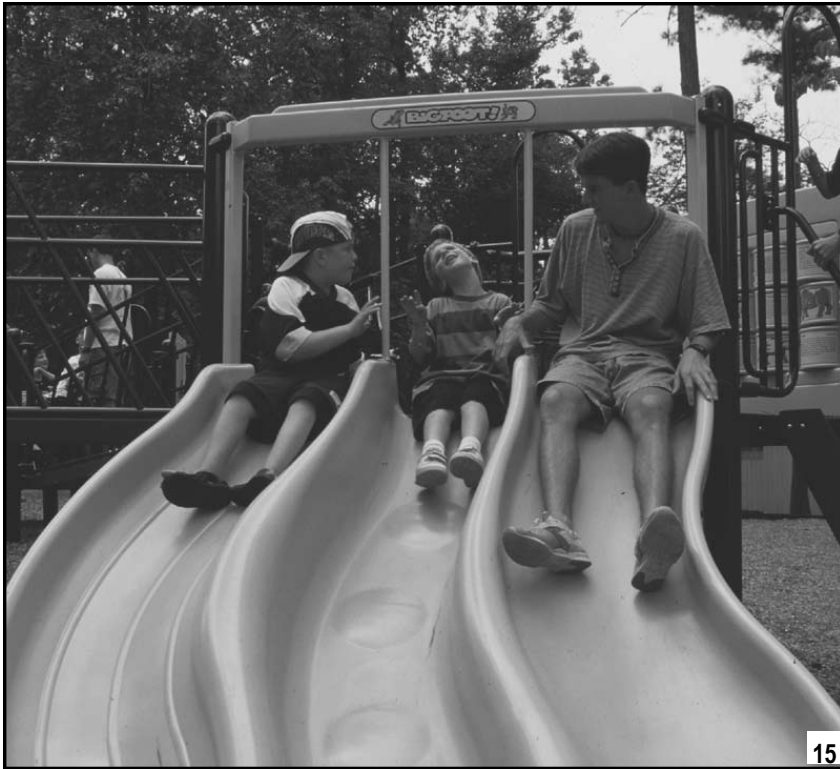
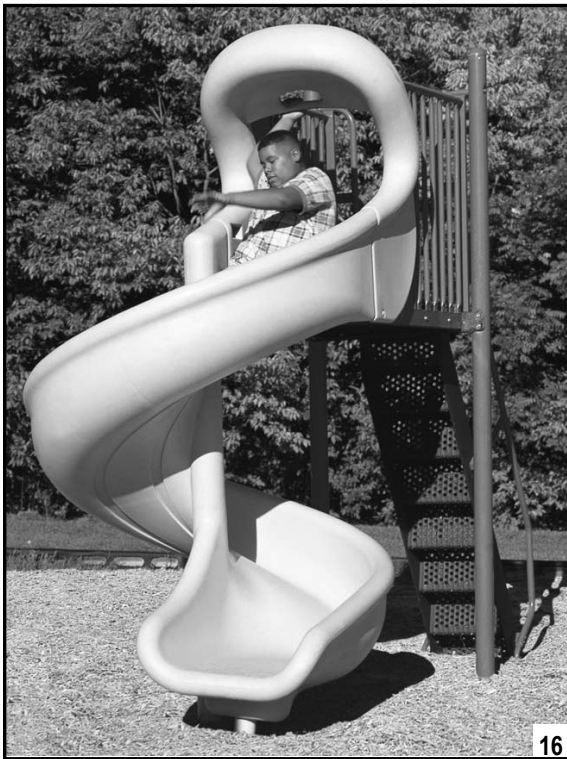
Examples of Sliding Types

While a spiral slide provides a slightly different experience from a straight slide, the primary experience - a sense of rapid descent or sliding - is common to both activities. Therefore, a spiral slide and a straight slide are considered one “type” of play experience.

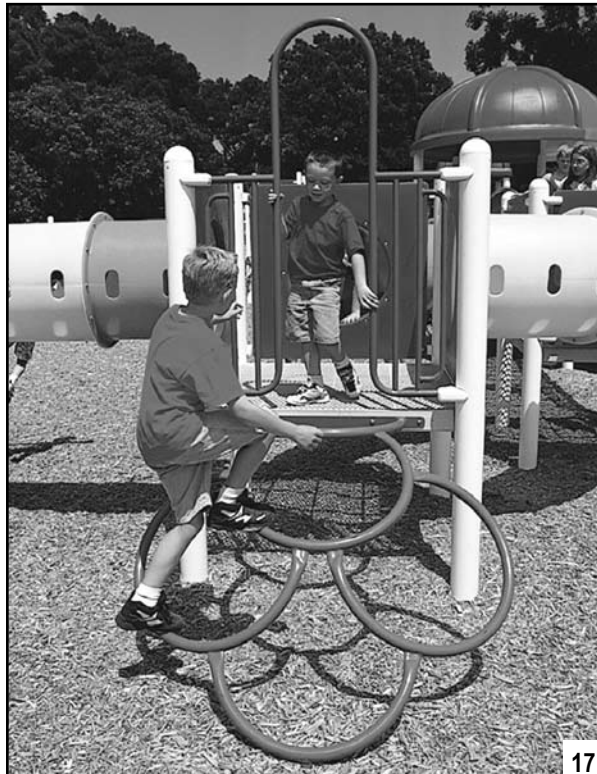
This climber is considered an elevated component, since it can be approached or exited from the ground level or above grade from a platform or deck on a composite play structure.

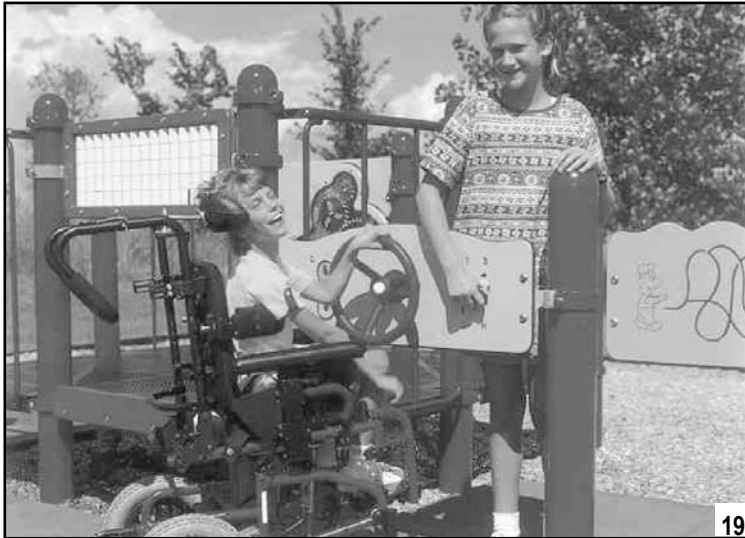
Ground-level play components may be part of a composite structure.

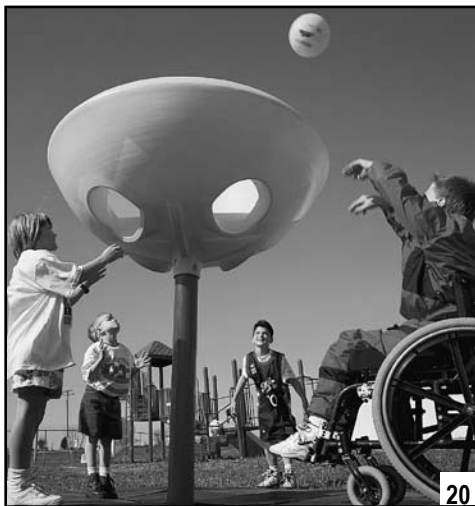
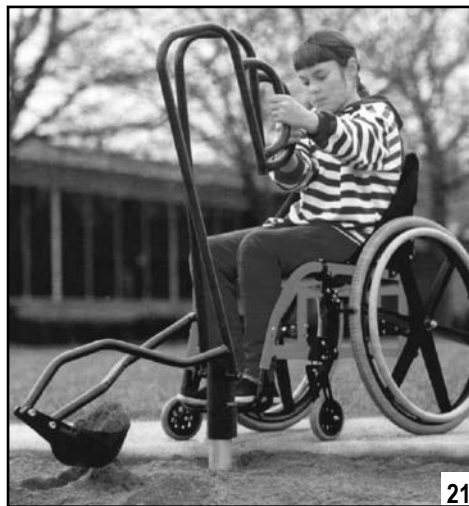
Ground-level components may also be free-standing in a play area.

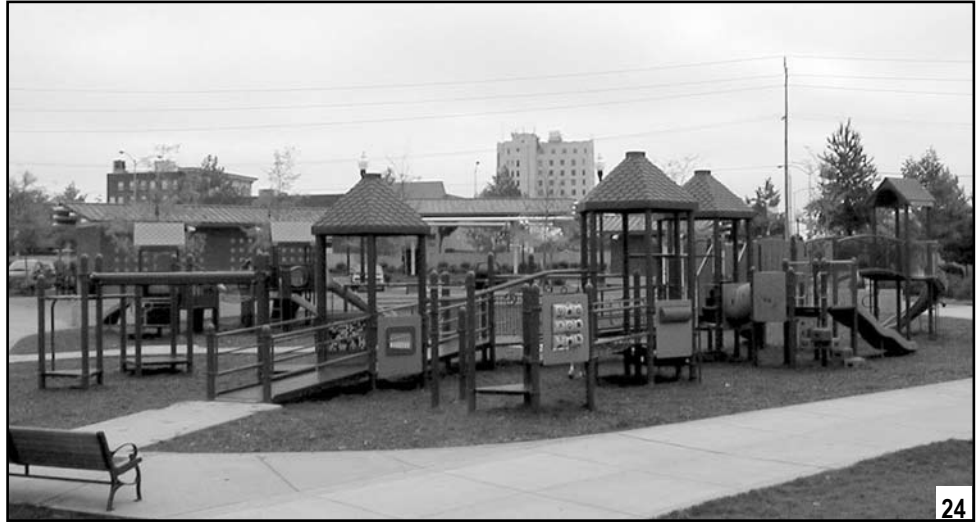
Play areas with 20 or more elevated components must use ramps to connect a minimum of 25 percent of those components. A transfer system or ramps may connect the other elevated play components required on an accessible route.

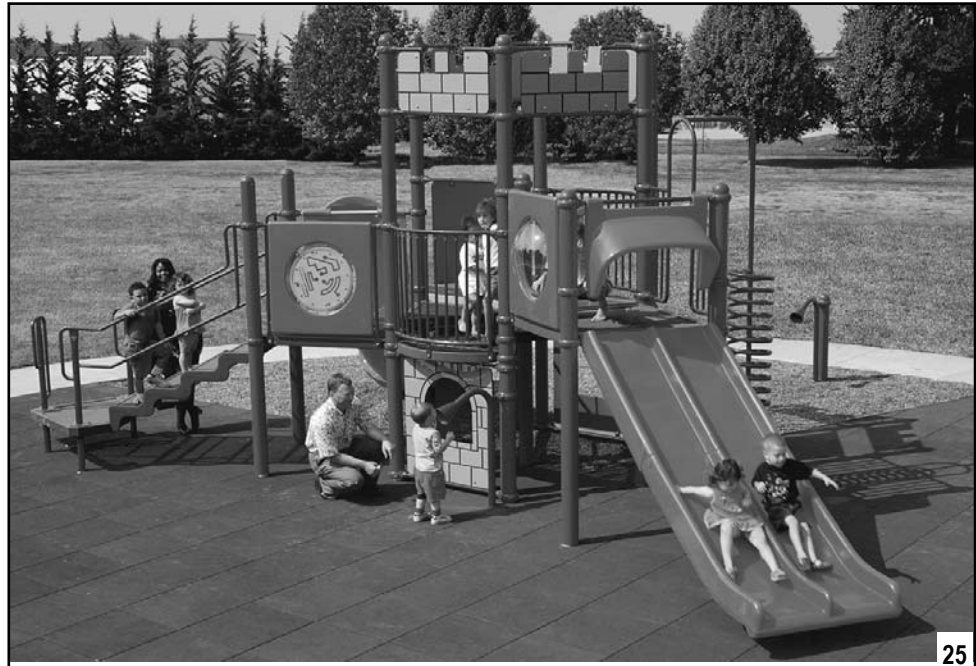
Play areas with less than 20 elevated play components may use a transfer system instead of ramps to connect at least 50 percent of the elevated components.

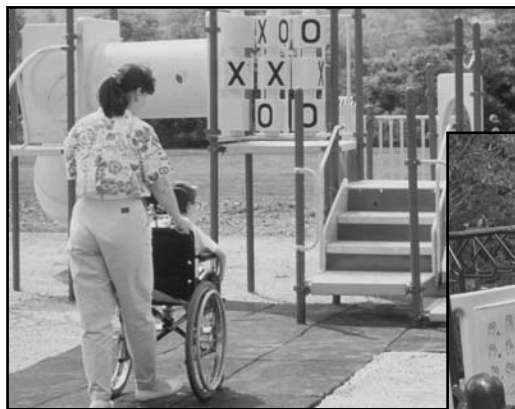
This ground-level route connects ground components and the transfer system which connects elevated components.

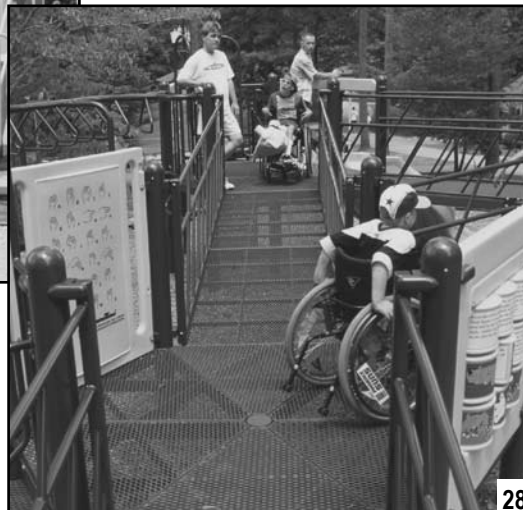
This elevated route connects elevated play components on a composite structure.

The accessible route must connect all entry and exit points of accessible play components.

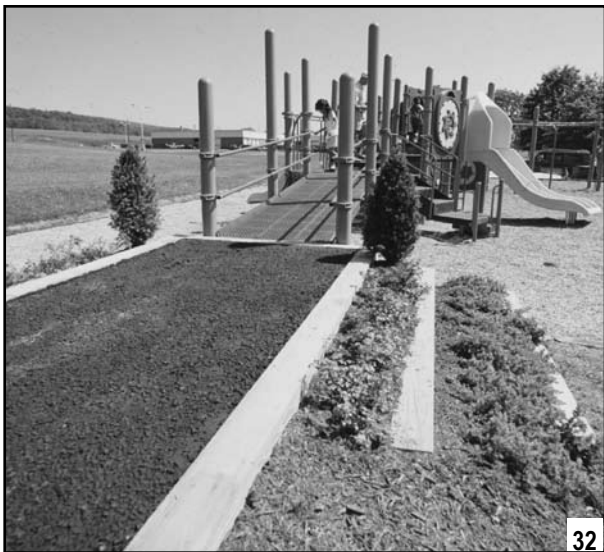
This play area provides a bermed accessible route.

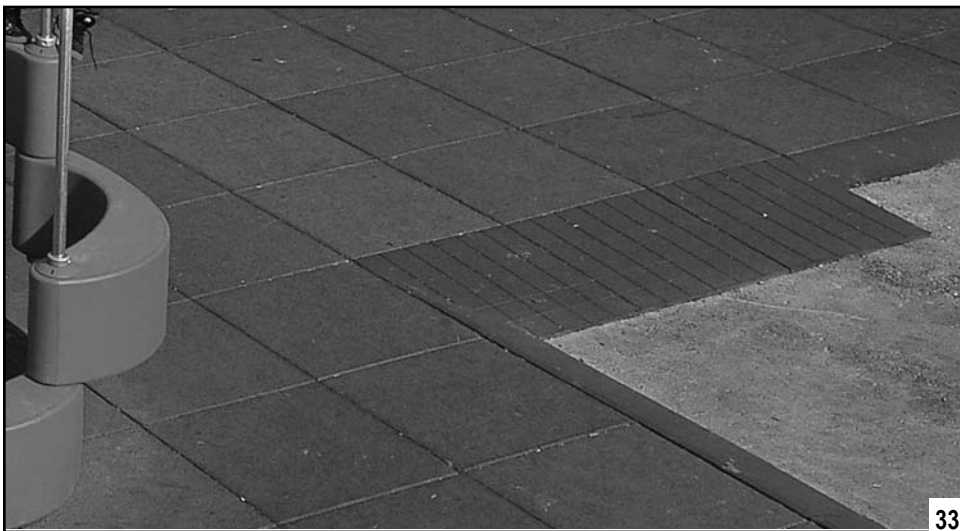
To accommodate a height change along the perimeter of a play area - like these rubber safety tiles placed on an asphalt surface - an allowable 1:12 slope is utilized for the transition at the boundary of the play area.

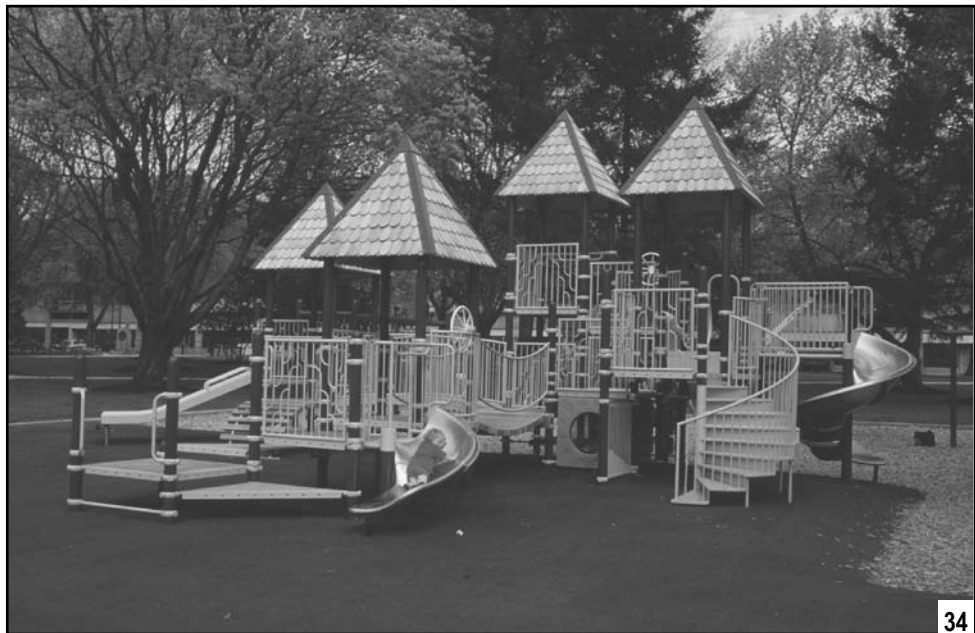
Accessible surfaces can include impact-attenuating tiles made of recycled rubber and engineered wood fiber that meet the ASTM requirements for accessibility and safety. The design can be created so safety is not compromised for individuals using the play area where both standards are applied.

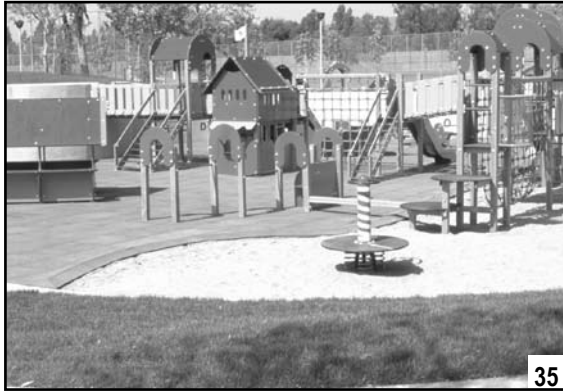
Accessible and non-accessible surfaces can be combined to provide variety and excitement in the play area.

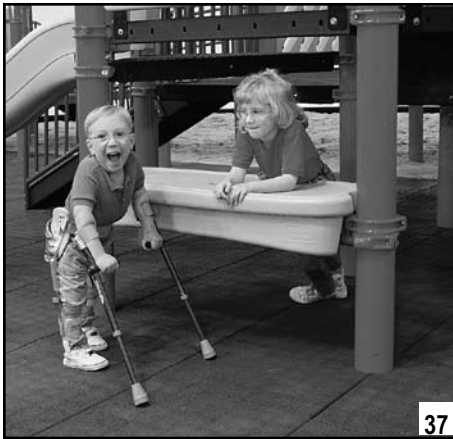
Rubber surfacing tiles facilitate access in this play area.

Ground surfaces must be inspected and maintained regularly and frequently to ensure continued compliance with the ASTM F 1292-04 standard. The frequency of maintenance and inspection of resilient surfacing depends on the amount of use and the type of surfacing installed.

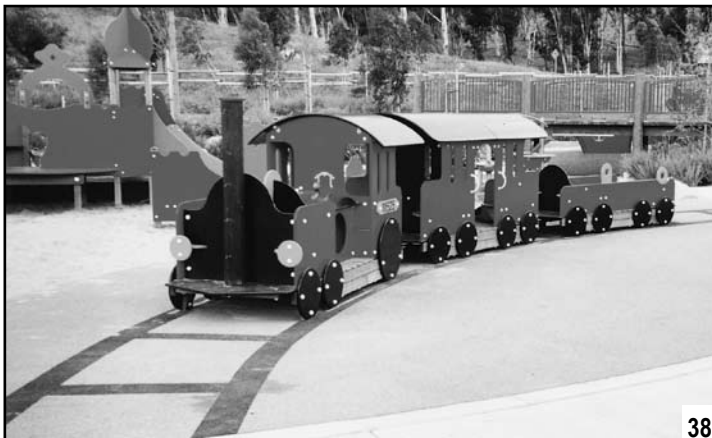
Accessible surfacing can be designed to complement the theme of the play area, while providing full access and visually integrating the surface into the overall design. Individuals of all abilities will enjoy the added benefits of an imaginative design.

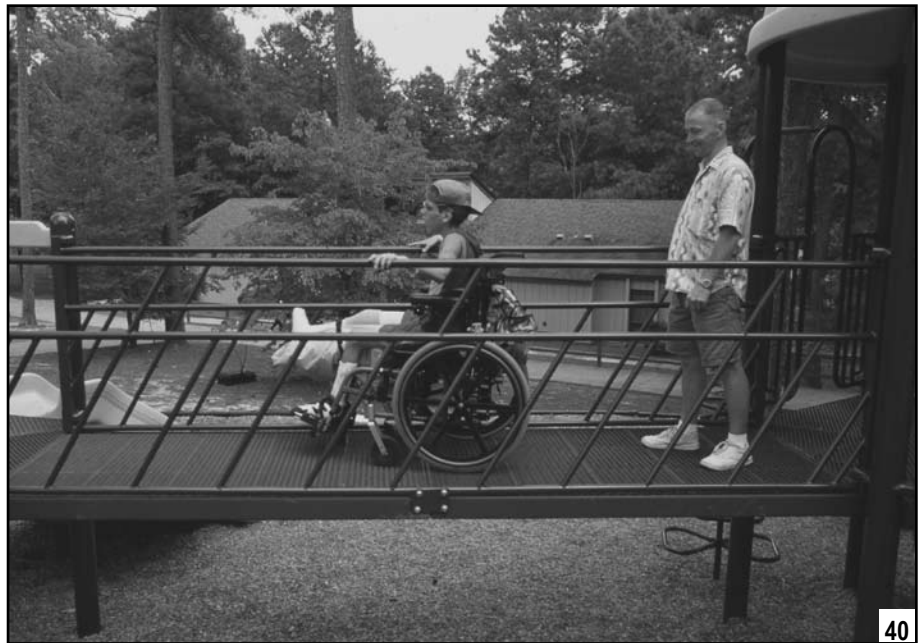
This photo illustrates an elevated accessible route:

- 36-inch (915 mm) clear width
- 32-inch (815 mm) narrowed width permitted for 24-inch (610 mm) length to accommodate features in the composite structure
- 12-inch (305 mm) rise maximum per ramp run
- Top of handrail gripping surfaces shall be 20 inches (510 mm) minimum to 28 inches (710 mm) maximum above the ramp surface

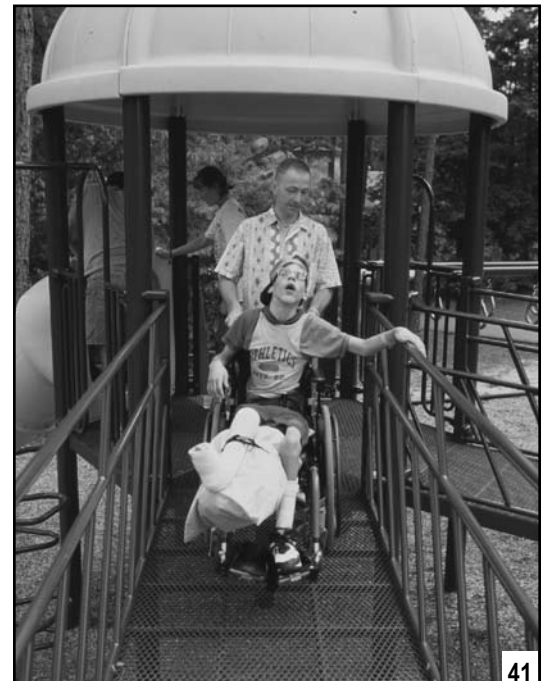
The 80-inch vertical clearance height does not apply to elevated accessible routes. This allows for the use of features such as roofs and sun shelters.

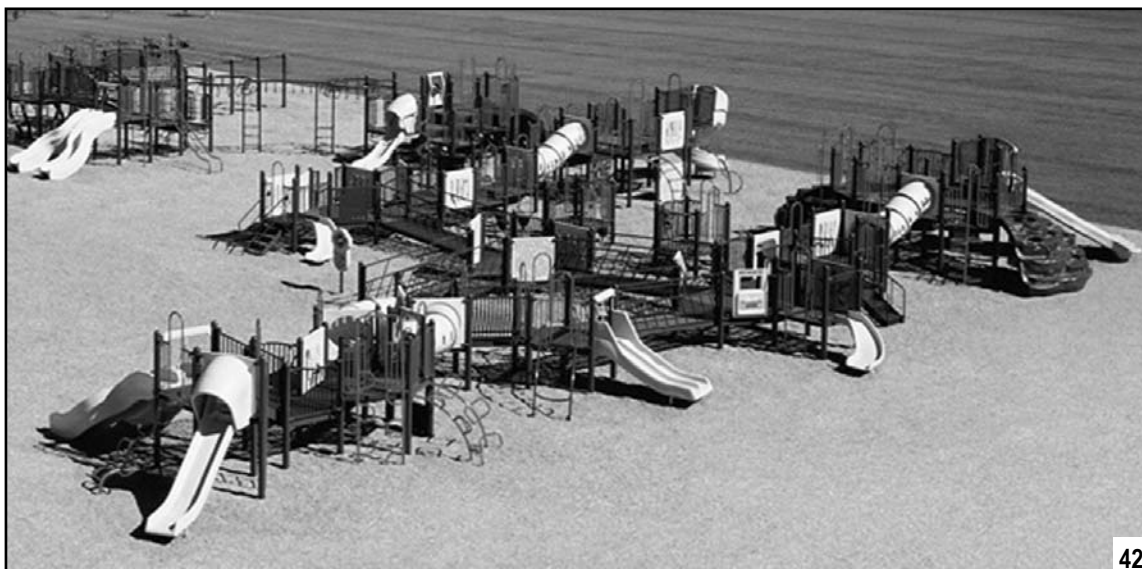
This play area has more than 20 play components and provides ramp access to elevated play components. The ramp system, consisting of ramp runs and landings, must connect at least 25 percent of the elevated play components. The balance of the elevated play components required to be on an accessible route may be connected by the ramp system, or by a transfer system.

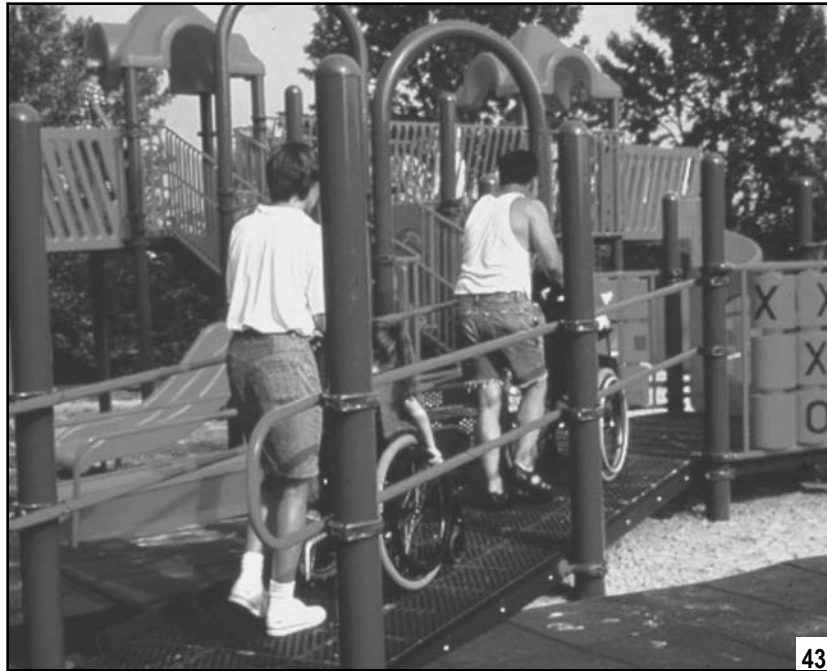
For each elevated ramp run:

- 12-inch (305 mm) maximum rise
- 1:12 maximum slope
- 36-inch (915 mm) minimum clear width

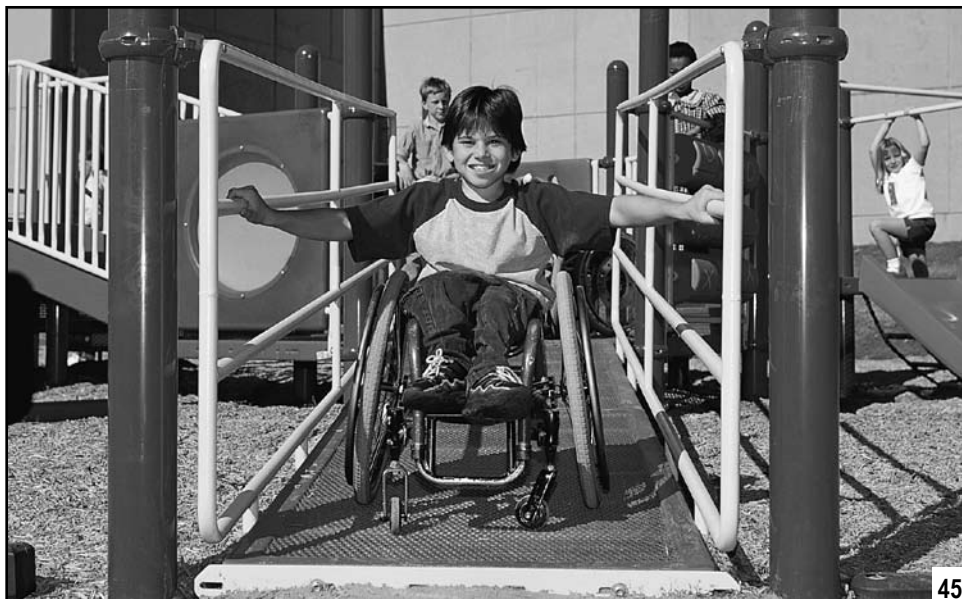
In this case, additional handrails have been provided.

Handrails are required to comply with ADA/ABA 505. However, extensions on handrails in the play area are not required. This is to prevent children running into protruding rails in the play area.

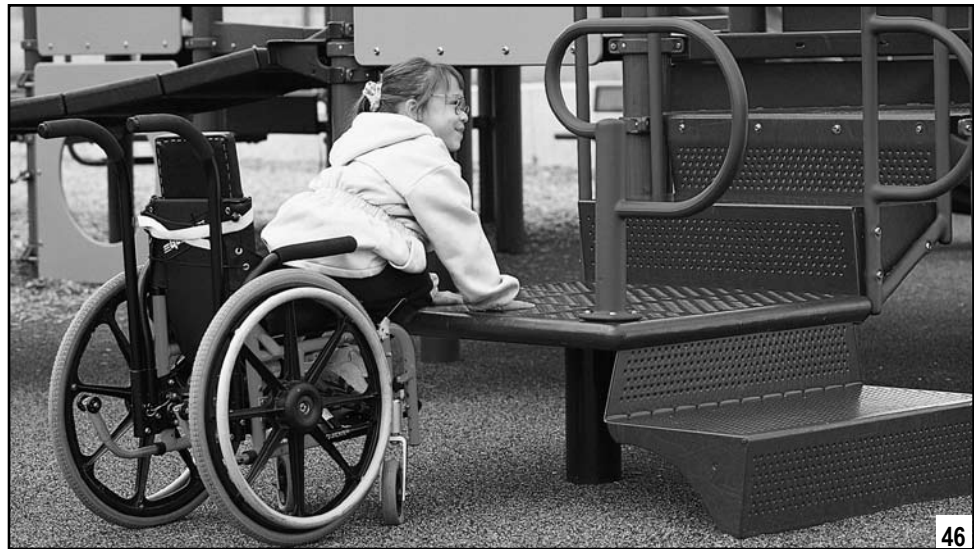
A transfer system typically consists of a transfer platform, transfer steps, and transfer supports.

Where a transfer system is provided, a combination of transfer platforms and transfer steps provide a continuous accessible route to elevated play components. A transfer system provides individuals the space necessary to physically transfer up or down in a composite play structure. Where provided, a 24-inch (610 mm) minimum width is necessary for individuals moving around a structure.

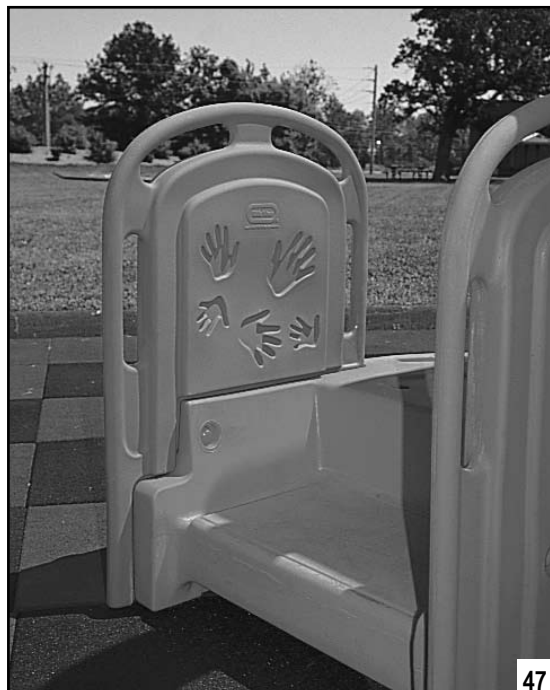
Playful features can be part of the transfer system, providing interactive experiences from both an elevated or ground level approach.

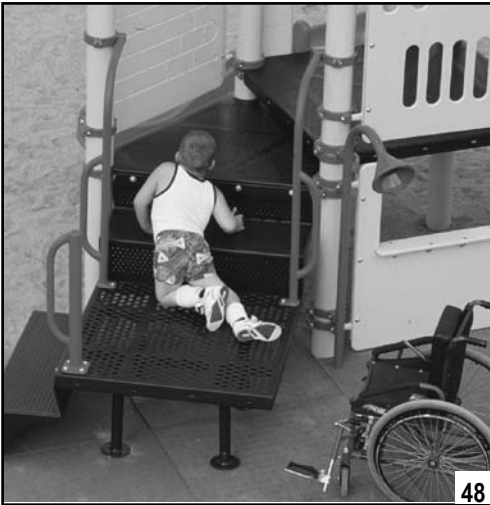
A transfer platform is a platform or landing that an individual who uses a wheelchair or mobility device can use to lift or *transfer* onto the play structure and leave the wheelchair or mobility device behind at ground-level.

- 11 inches (280 mm) to 18 inches (455 mm) height of top surface
- Minimum 24 inches (610 mm) wide
- Minimum 14 inches (355 mm) deep
- Unobstructed side

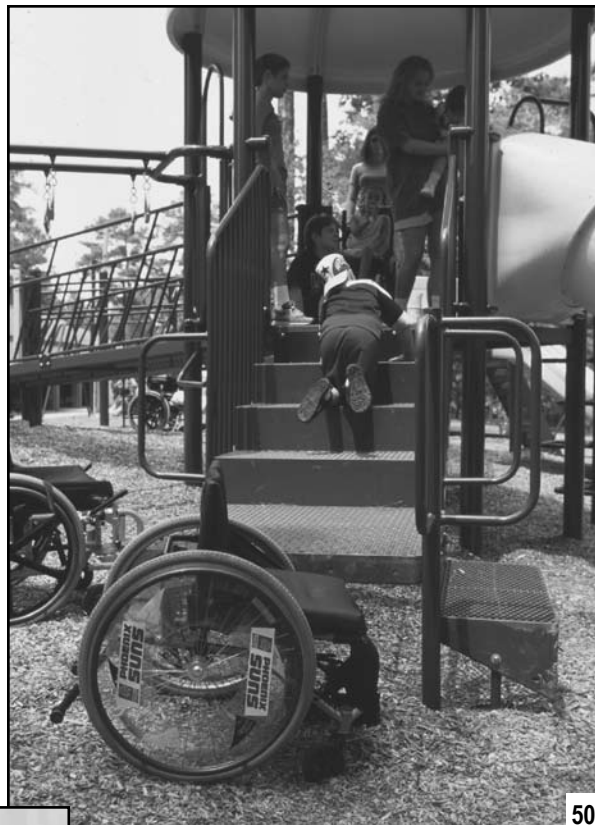
- Minimum 24 inches (610 mm) wide
- Minimum 14 inches (355 mm) deep
- 8 inches (205 mm) maximum height

Play areas intended for smaller children should provide steps at smaller height increments. This will accommodate smaller sized children who must lift or “bump” up each step.

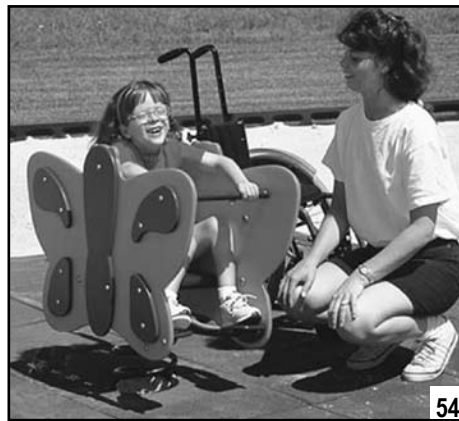
Aesthetically pleasing cut-out shapes and other design enhancements can provide hand supports for transferring.

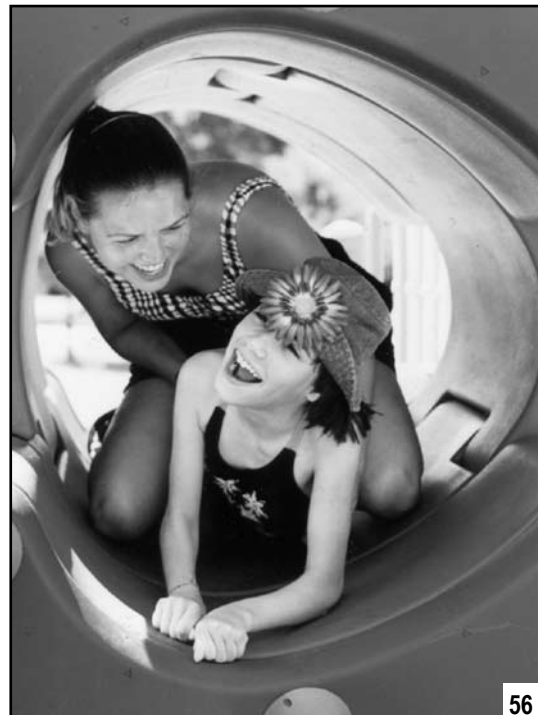
A crawl tube is an elevated play component in this composite structure. Going through the tunnel provides access to additional activities on the other side.

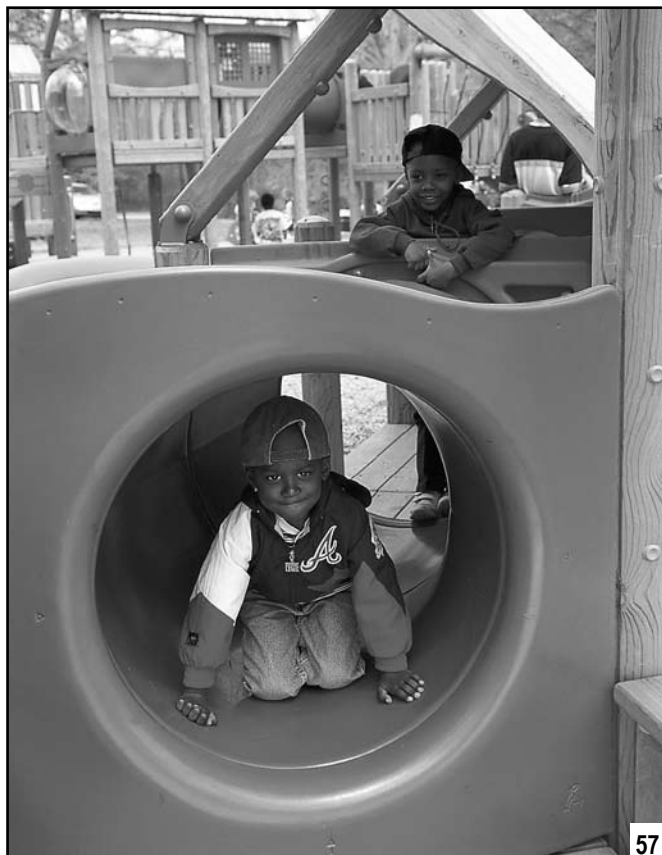
Consideration should be given to how a play component is utilized when it is selected to connect to other elevated play events. When a transfer system is provided, children move through a play component like this crawling tube, using their own strength without a mobility device.

Providing variety and excitement through elevated play spaces benefits all children. Tunnels and tubes make “getting there” an activity in itself.

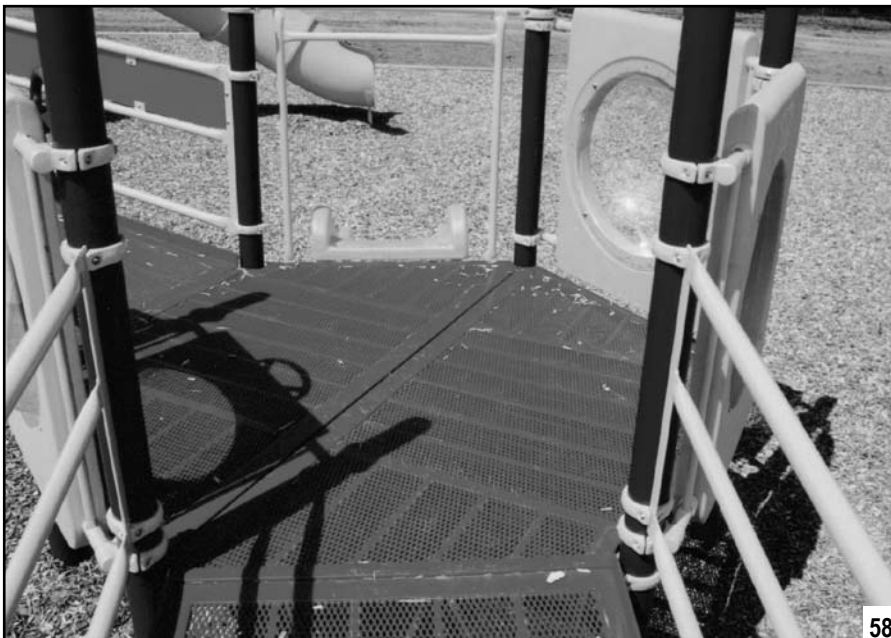
The clear floor space is permitted to overlap onto the landing area to provide access to this elevated window activity.

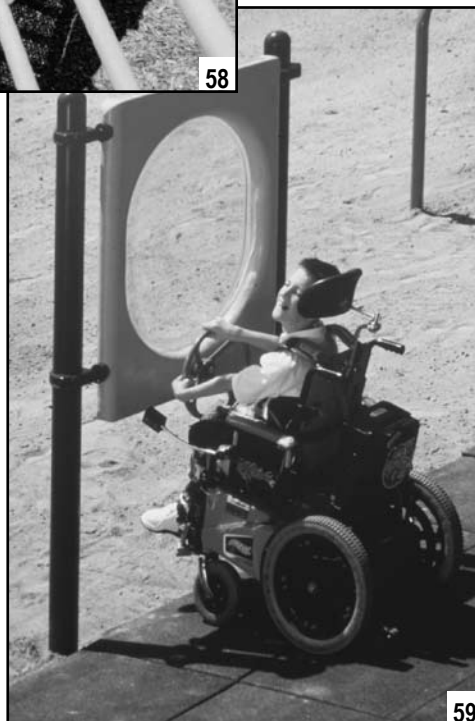
This interactive play component has a clear ground space that allows front or side reach interaction.
