PLAYGROUND

STUDY REPORT 2022:

Prepared for: Salem Public Schools

2022 Playground Study Report

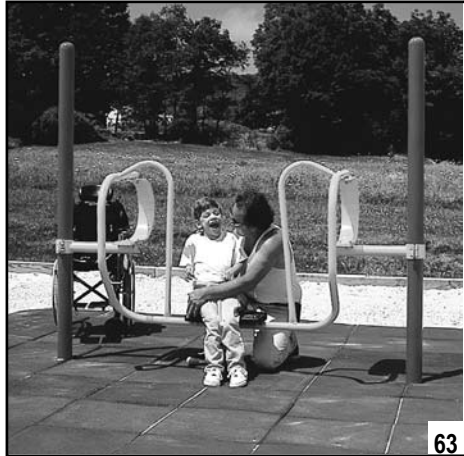
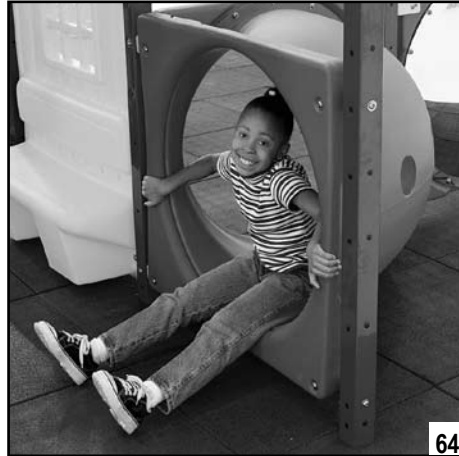
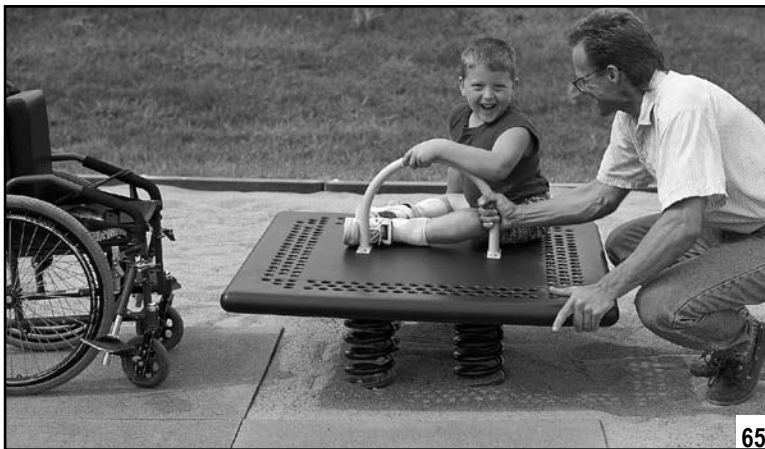
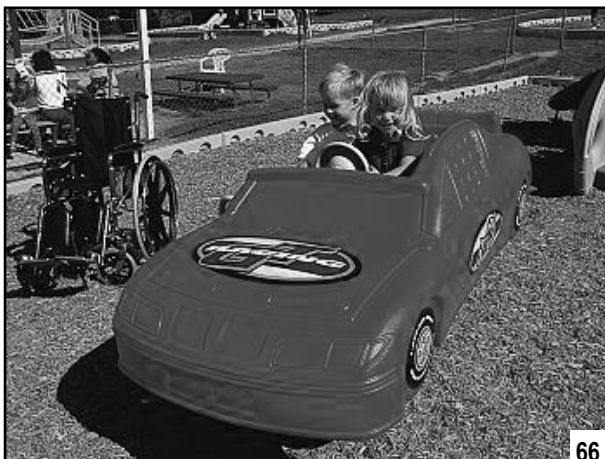
Entry points and seats are features of play components where individuals would transfer, sit, or gain access. When play components are located on an accessible route, the height required to transfer directly to the entry point or seat of a play component has a minimum of 11 inches (280 mm) and a maximum of 24 inches (610 mm). A mid-level height of 18 inches (455 mm) is recommended.

Examples of entry points and seats include swing seats, spring rocker seats, and crawl-tube openings.

Consider design features like open sides, back supports, and hand supports to help facilitate easy transfer and access.

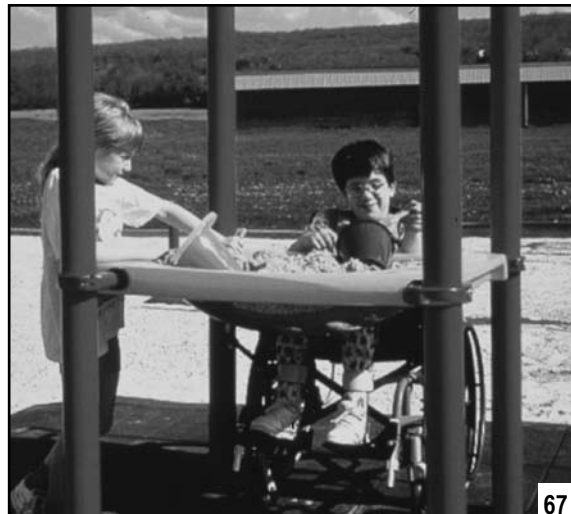
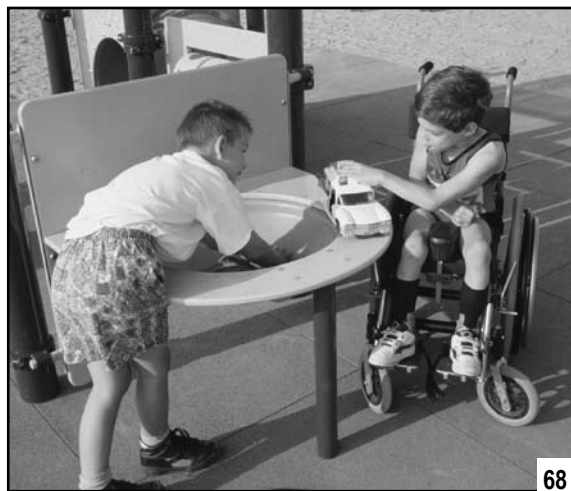
Play tables designed primarily for children under 5-years-old, may provide a parallel approach instead of knee clearance if the rim is a maximum of 31 inches (785 mm) high.

The edge of this elevated sand table has been designed to provide access by providing a generous opening. The tops of rims, curbs, or other obstructions that would prevent access to a table surface should be 31 inches (785 mm) maximum in height.

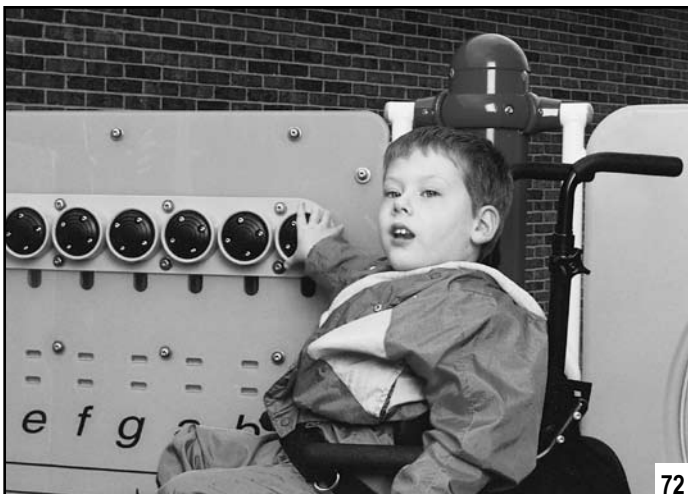
Appropriate reach range heights will vary depending on how the play component is accessed. This interactive panel is mounted at a height appropriate for a child who uses a wheelchair.

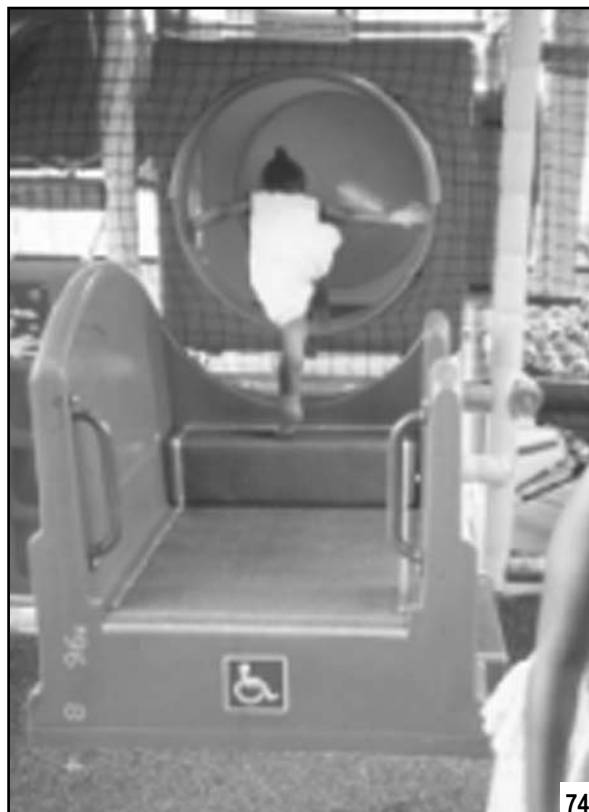
Soft contained play environments typically have limited entrance and exit locations, with play components integrated into the system design.

Transfer systems or platform lifts can serve as a part of an accessible route connecting entry points on soft-contained play structures.

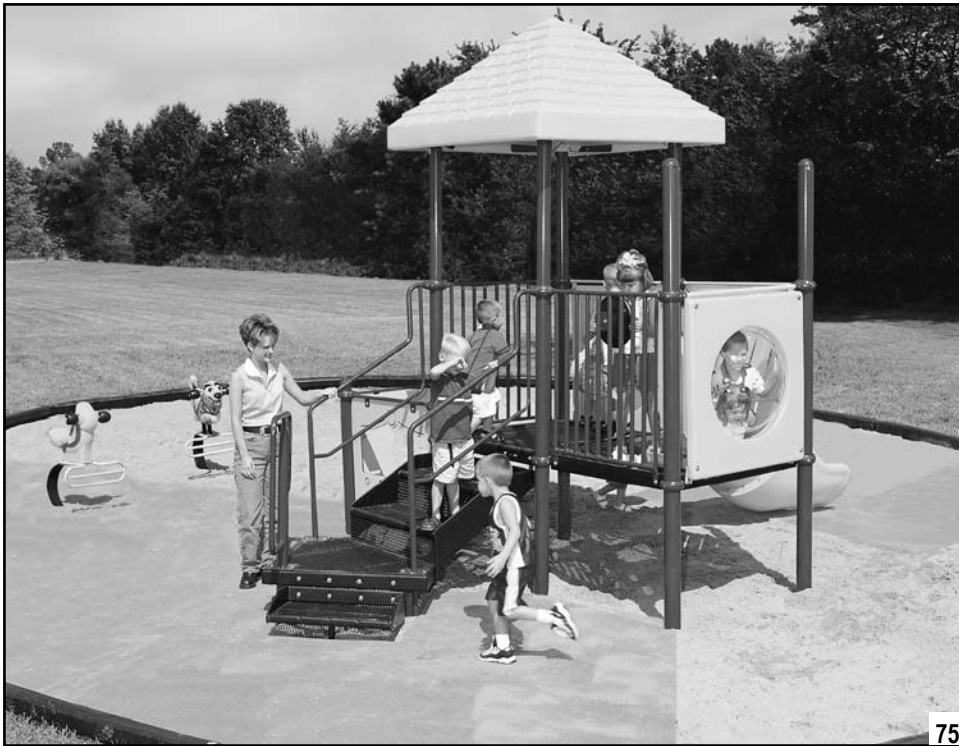
This play area was altered by adding two spring rockers. The seat of at least one spring rocker is between 11 inches (280mm) and 24 inches (610mm) maximum, and clear floor or ground space and maneuvering space is provided. If the ground surface is replaced in the future, an accessible route would have to be provided to the spring rocker.
