# NEW ENGLAND CIVIL ENGINEERING CORP.

## Municipal Street Tree Assessment Project - Phase II City of Salem

### January 2018

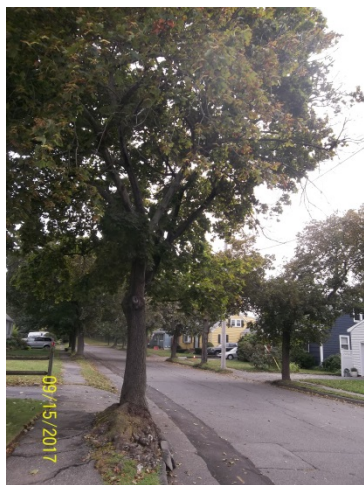
**Photo 1: Typical Tree Survey Photo**

The outline for the data collection is based on the I-Tree format used by the US Forest Service. As each street tree was GPS located, an overall photo was taken, and various

attributes about the tree condition and the surrounding sidewalk were populated into the GIS database with a link to the geodatabase (See Figure 1 for description of data collected.). In addition to tree descriptive data a photo was taken of each tree

surveyed and is included in the GIS. (See Photo 1.) As part of the Pilot program, a spreadsheet of previous tree observations was provided by the Tree Warden was incorporated into the database. Although the dataset in the spreadsheet is not as robust as the tree assessment project database, the data was valuable in determining the extent of current needs such as pruning needs and empty pit locations throughout the city. (See Attachment C for an example of the GIS Dataset.) The attached disc contains the complete table and ArcMap street tree shapefile.

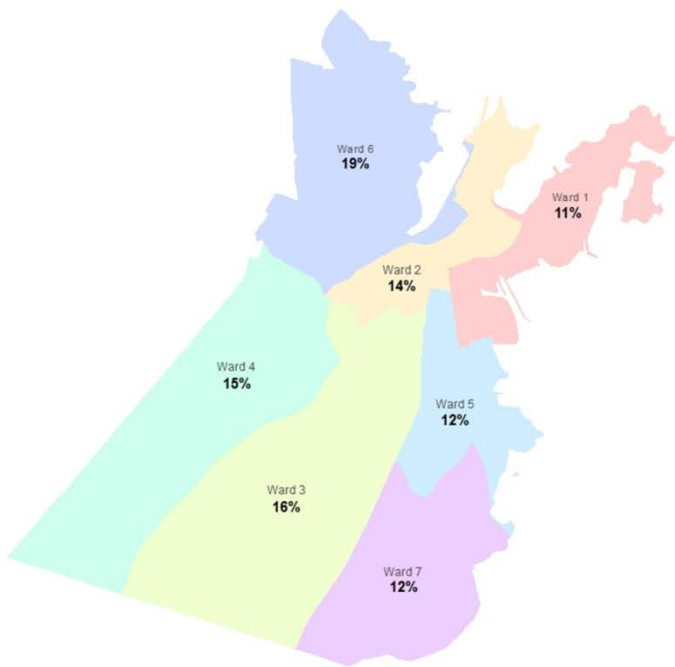
**Graphic 1: Ward % of City Street Miles**

(98 Street Miles, not including Private or State)

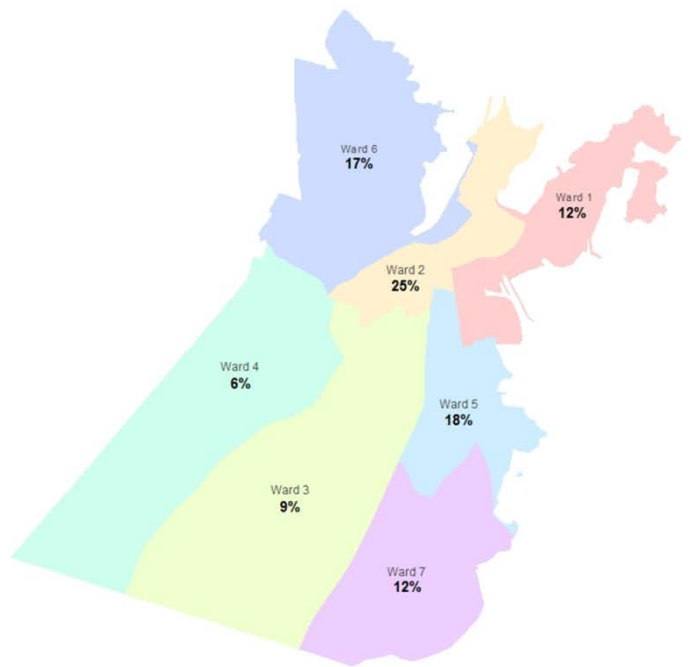
**Graphic 2: Ward % of City Street Trees**

(4,812 City Street Trees in 2017)

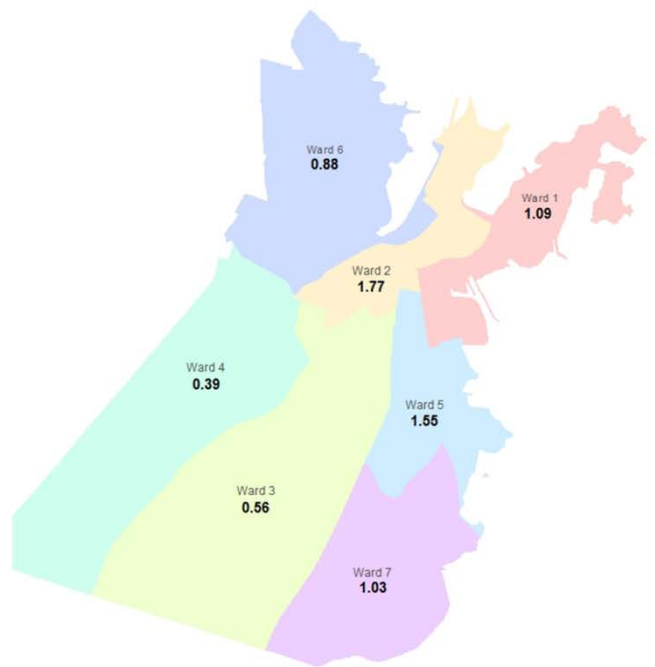
**Graphic 4: Ratio of % City Trees to % City Streets**

(Average Trees/Mile relative to City average, Ratio >1.0 represents greater than average trees per mile)

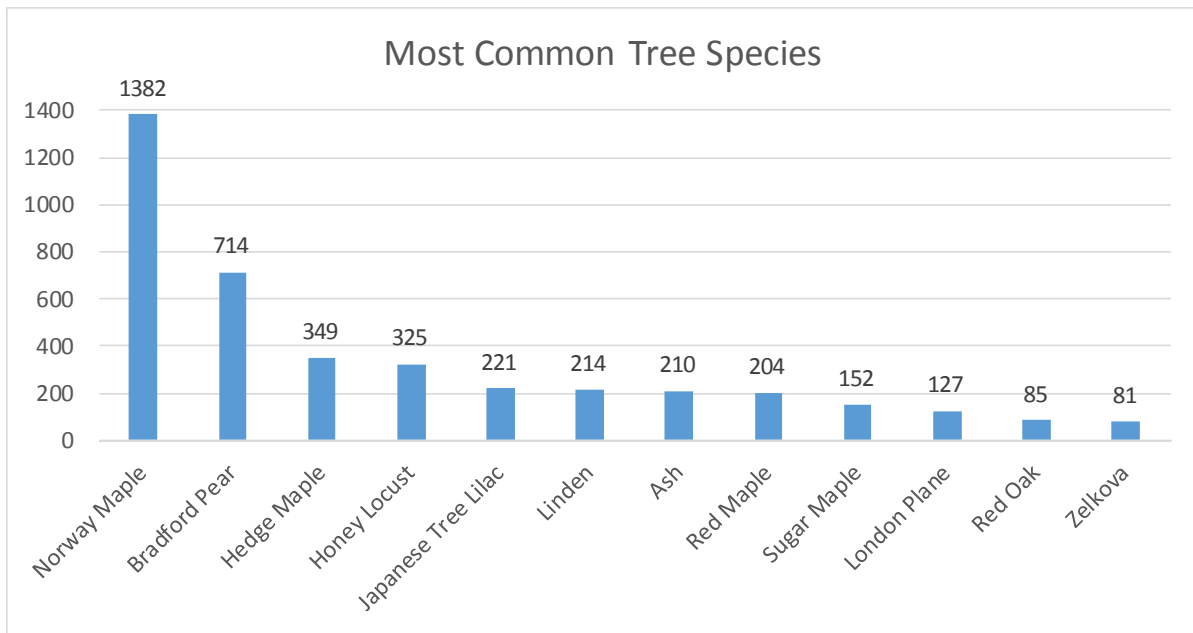
**Figure 4: Citywide Common Tree Species**

The majority of the trees surveyed are Norway maple, Bradford pear, Hedge Maple and Honey Locust. The Norway maple is now listed as an invasive species. The lifespan of the Bradford

pear is 20-30 years. The branches tend to break easily in winter storms and often are caught in power lines. The emerald ash borer and Asian long-horned beetle have already been observed in nearby communities. These invasive insects target many types of trees but have been reported to affect the Norway maple and Ash more often than other tree species.

Refer to Figure 4 for a graph illustrating the most common types of tree species observed. The majority of trees are greater than 6-inches at breast height indicating an aging population of trees which will require increased maintenance and

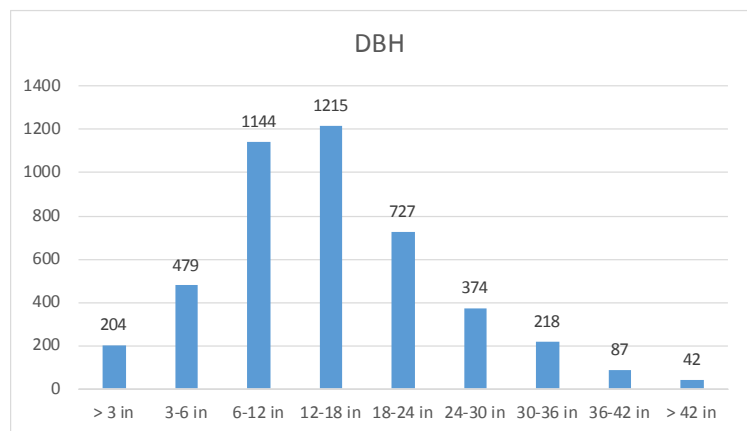
**Figure 5: Diameter at Breast Height**

replacement in the coming years. Refer to Figure 5 for a graph illustration of trees by size based on observed diameter at breast height.

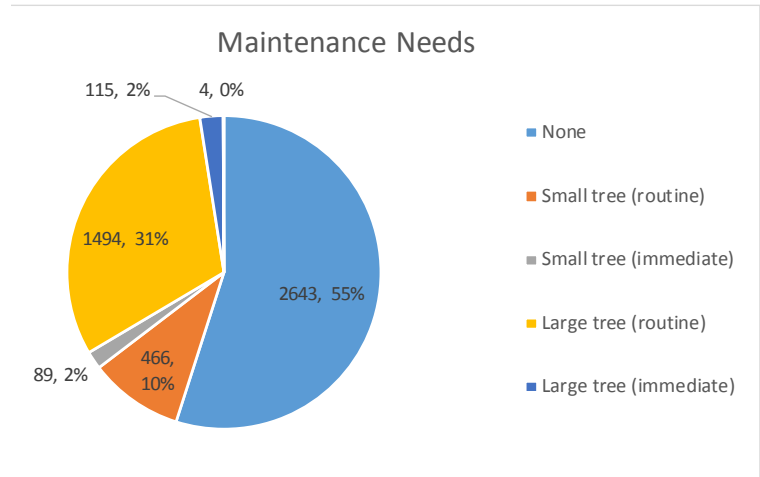
**Figure 6: Citywide Maintenance Needs**

In total, 4,812 trees and 377 empty tree pits/stumps were GPS located and assessed as part of the project. No maintenance is currently needed on 2,643 or 55% of the trees; see Figure 6. The majority of maintenance needed

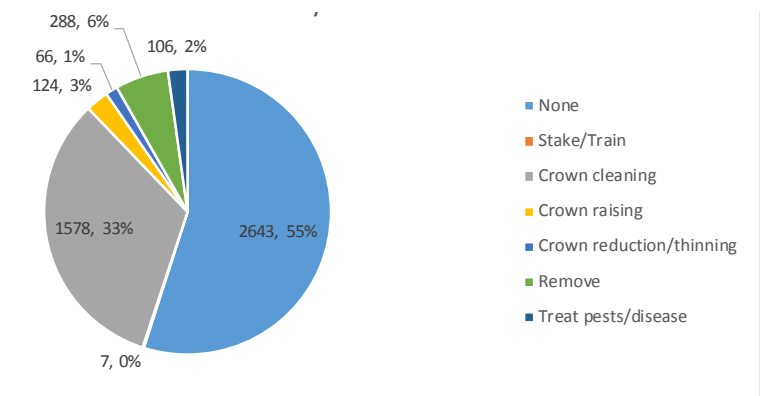
**Figure 7: Citywide Priority Tasks**

is either deadwood removal or pruning of 1702 trees, see Figure 7. “Routine” maintenance is not considered an immediate public danger while “immediate” may pose a threat to pedestrians, homes or vehicles. See Figures 7 and 8 for a breakdown of maintenance needs and priority tasks. The field “wood condition” in the GIS was used to account for tree health and

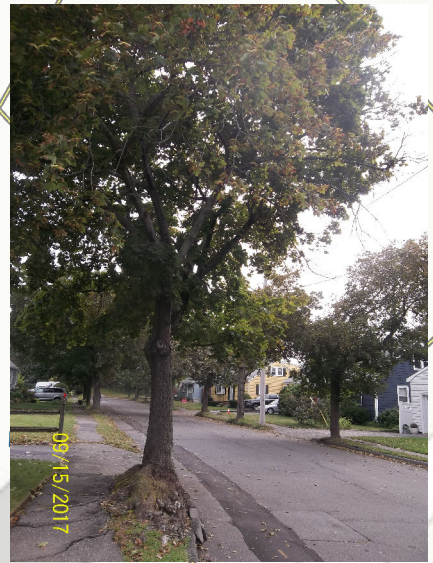
## **Street Tree Data Collection Example**

Field	Value
Photo_Lnk	H:\Clients\Salem\Street Tree Survey\...
Street #	3
Street Name	Larkin
Comments	black staining on trunk
ID	Larkin-2
Wire Conflict	No Lines
Land Use	Single family residential
Site Type	Planting strip
Tree Name	Norway Maple
Wood Cond	Poor
Leaf Cond	Poor
DBH	18.0-24.0 in
Maintenance Recommendation	None
Priority Task	None
Sidewalk Damage	0 - 3/4 in
Sidewalk Material	Asphalt
Tree Pit Cover	Soil
Dieback	<null>
Epicormic Sprouts	No
Foliage Wilted	No wilt
Environmental tress	Broken branches
Human Stress	Poor/restricted planting/mulching
Defoliation	None
Discolored	None
Abnormal Foliage	None
Insect Signs	None
% Foliage Affected	None
Insect Signs on Branches	Sawdust
Insect Present	Carpenter Ants
Disease Signs	Other
Problem Location	Branches
Loose Bark	Loose bark only
Pest Name	None
Mark Tree for Followup	Yes
