29 November 2022

Reference: Pioneer Village Evaluation Reference: Pioneer Village Conditions Assessment

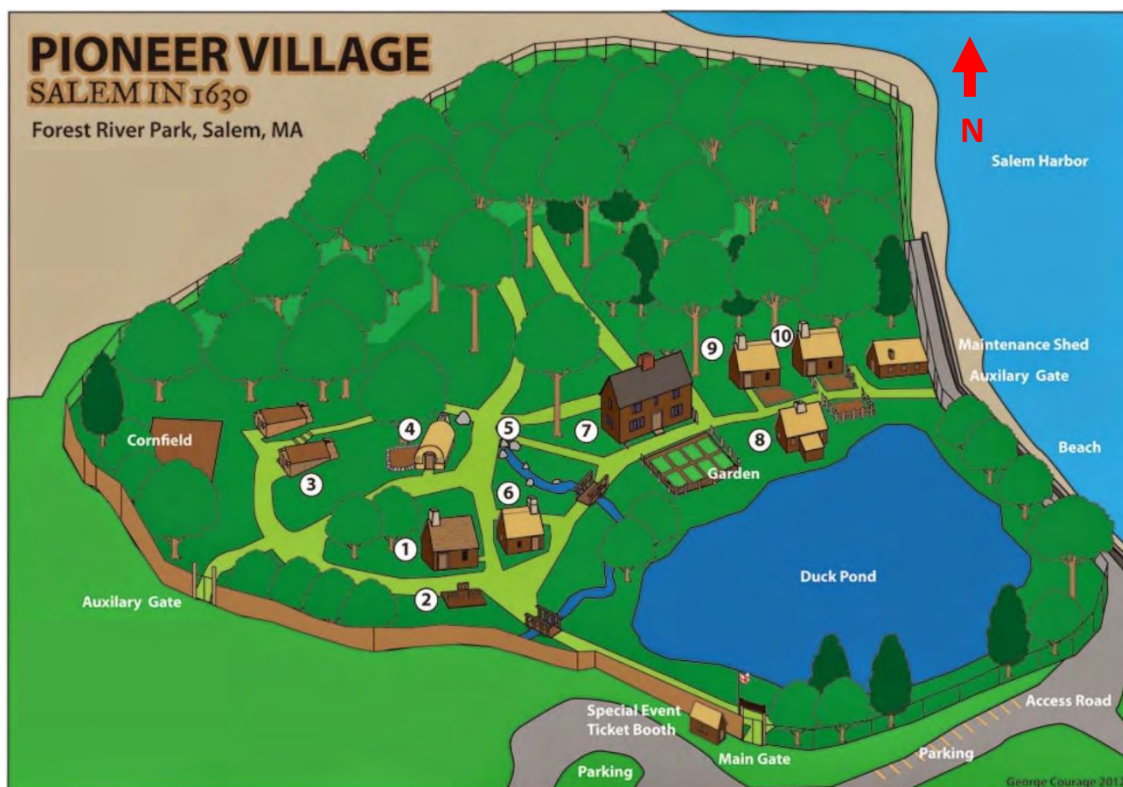
Figure 1: Overall view of the surveyed cottages

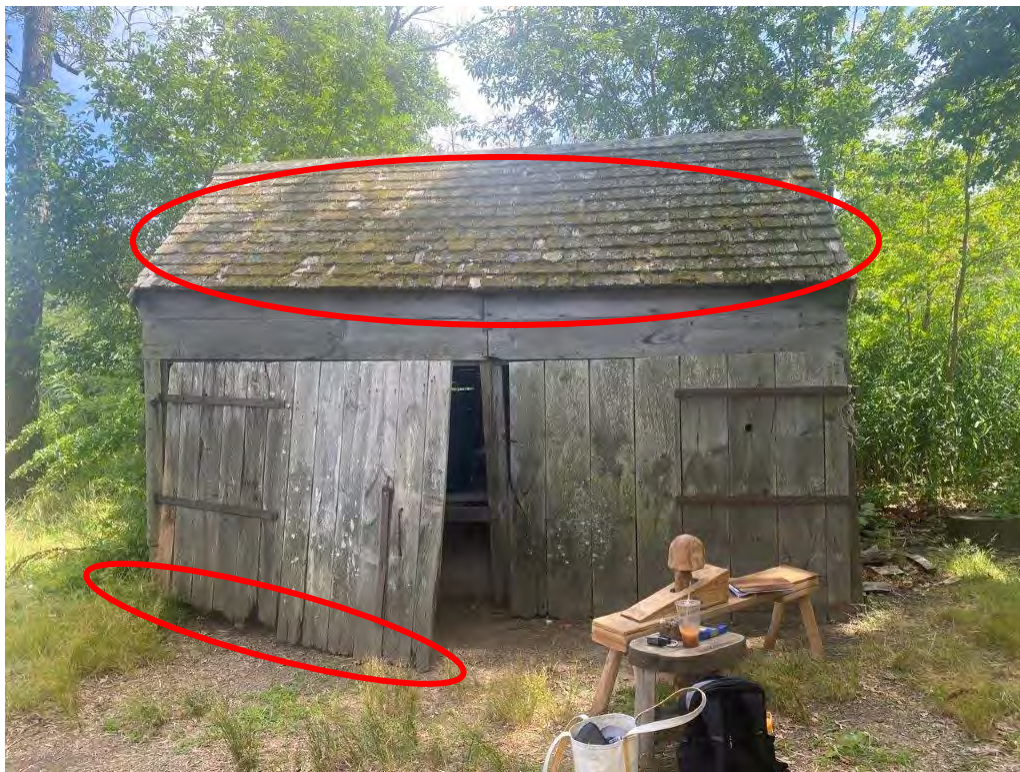
Photo 25: Structure (8), north facing exterior elevation conditions

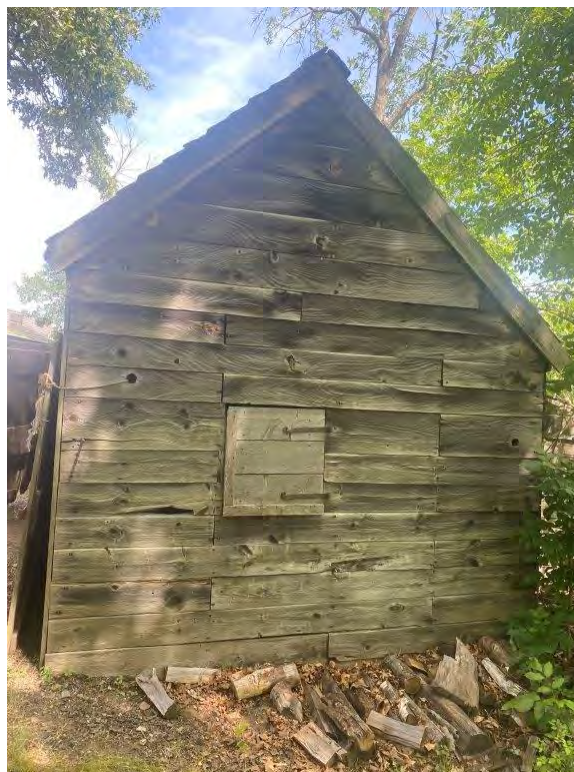
The west elevation has one window and is covered by the siding boards. There are several areas where the top or bottom edges of the siding board is rotting away, exposing the interior framework to the outside elements. The rot is most severe where the northwest bottom corner of the addition’s siding boards meets the bottom south face of the shop. Not only is this area in direct contact with the soil, but it does not receive a lot of sunlight and the water that runs off the roof collects at this corner. The constantly wet environment is causing accelerated deterioration of the boards (Photos 26 & 27).

Photo 26: Structure (8), north end of west facing exterior elevation conditions

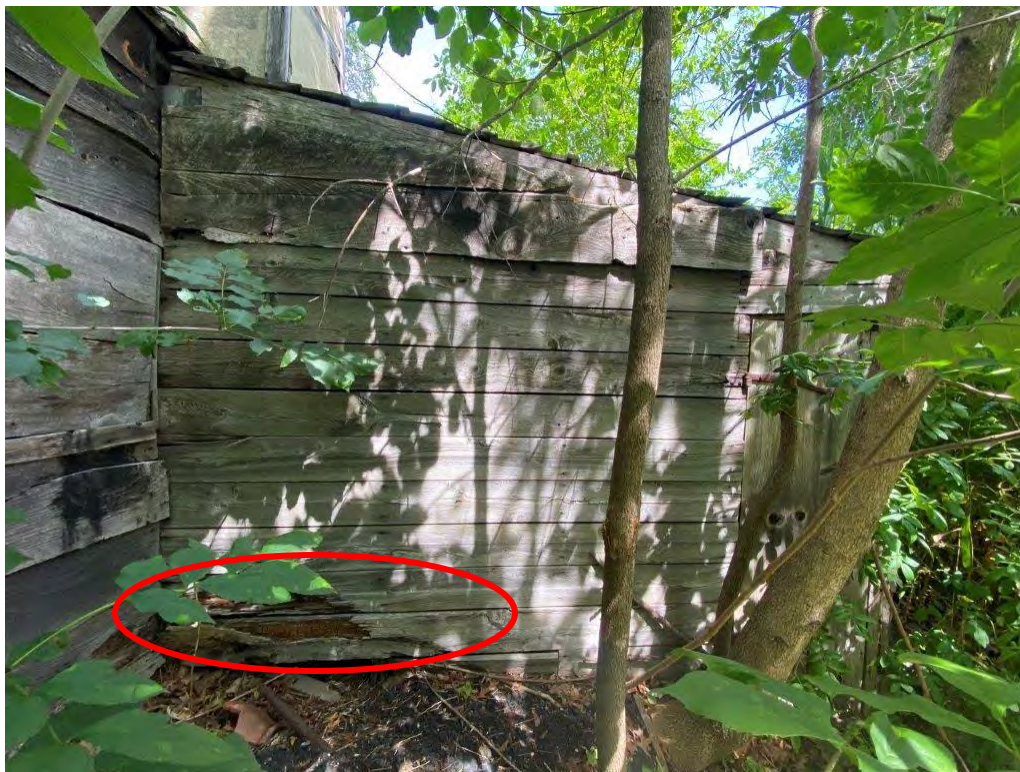
Photo 27: Structure (8), south end of west facing exterior elevation conditions

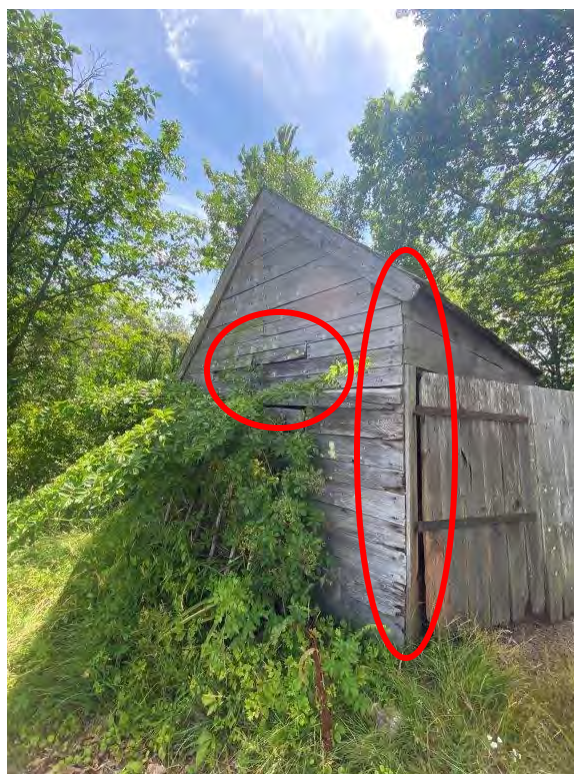
From what could be observed behind the brush, the siding boards of the main part of the shop are experiencing deterioration not only at their top and bottom edges, but also at their end grain with the rake boards included. The east elevation of the addition just has some gaps between the siding boards, likely from the way it was constructed (Photos 28 & 29).

Photo 28: Structure (8), north end of east facing exterior elevation conditions

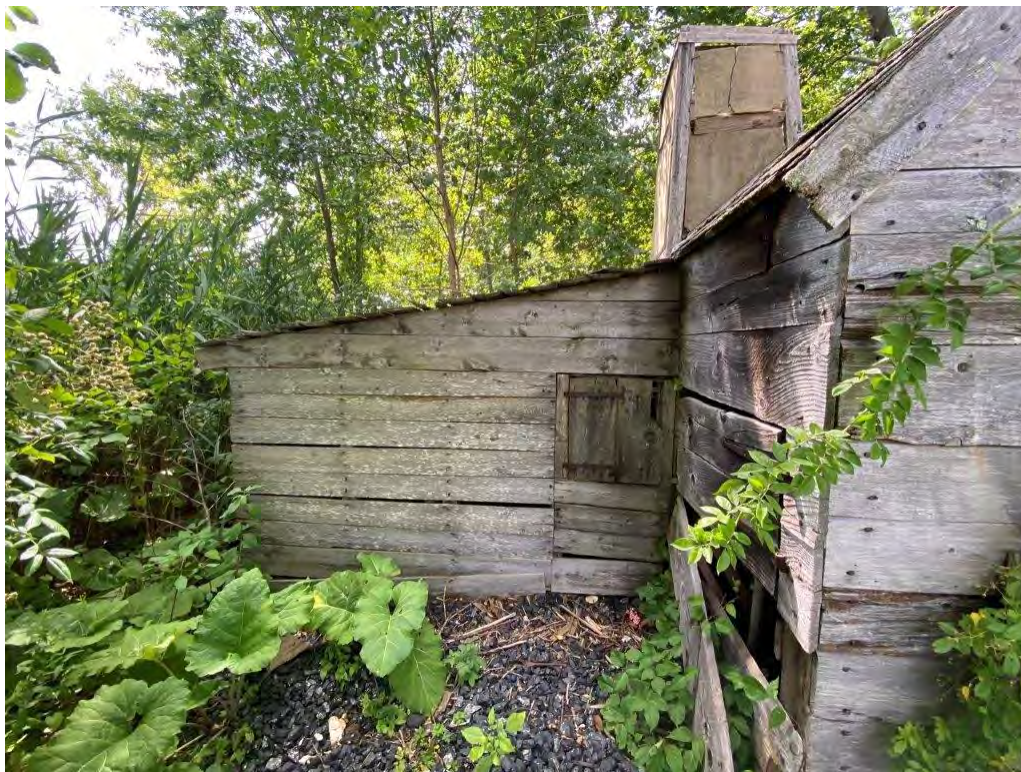
Photo 29: Structure (8), south end of east facing exterior elevation conditions

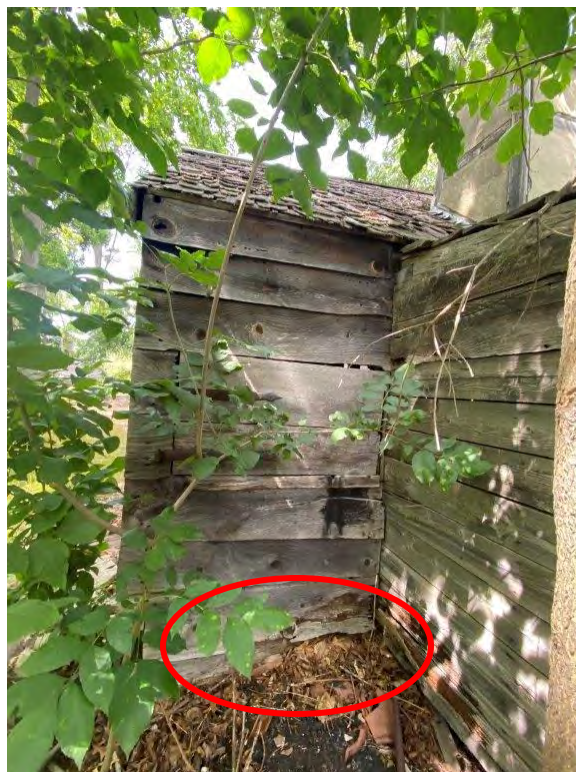
There is loose and missing siding at both the east and west ends of the south elevation. We understand that some of this damage is from vandalism, while the remainder is from water damage (Photos 30, 31, & 32).

Photo 30: Structure (8), west end of south facing exterior elevation conditions

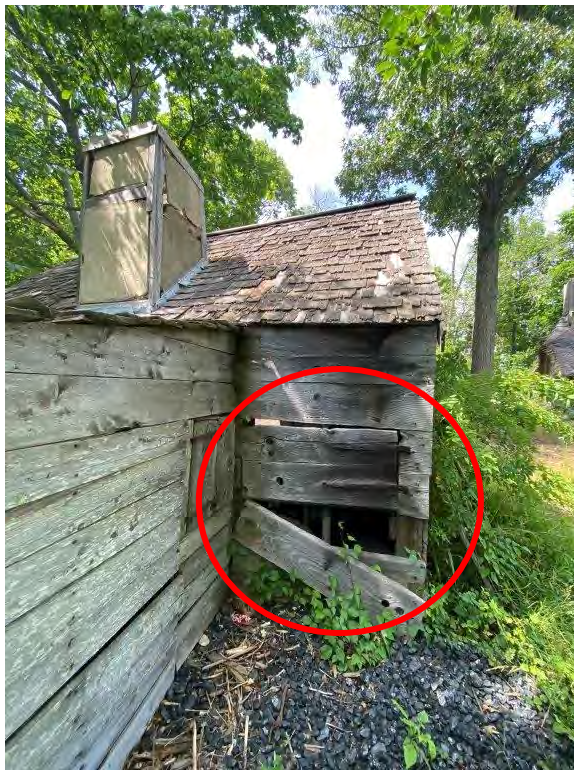
Photo 31: Structure (8), east end of south facing exterior elevation conditions

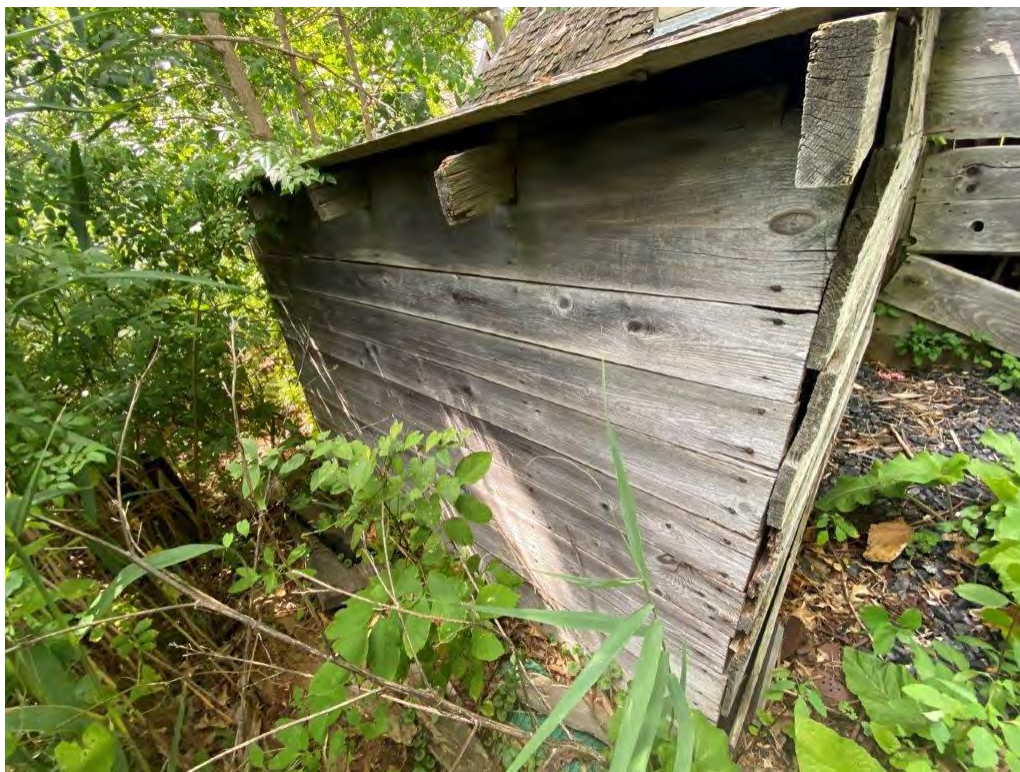
Photo 32: Structure (8), south facing exterior elevation conditions of addition

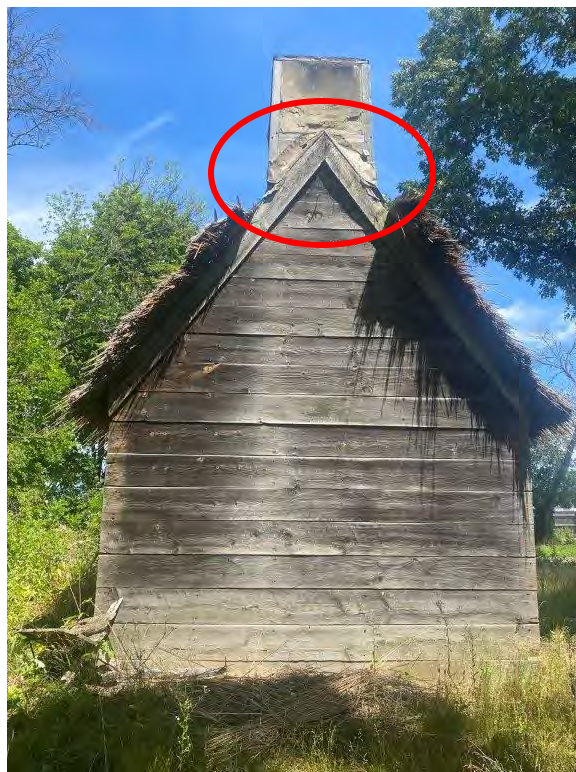
The main concern at this face is at the roof level. The cement stucco is starting to spall off which means it is a safety hazard while it is deteriorating. The flashing at this side of the chimney is also insufficient considering there are two large holes in its sky-facing surface, allowing water to penetrate through the roofing system (Photo 39).

Photo 39: Structure (9), west facing exterior elevation conditions

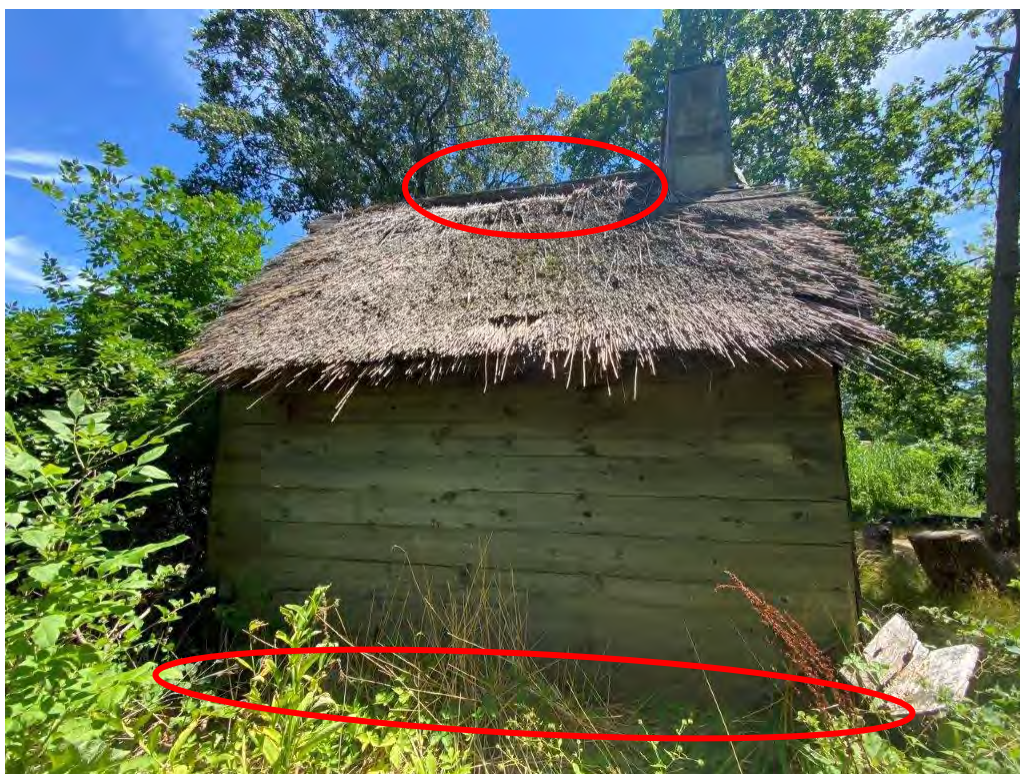
The grade rises up and over the base siding board along the north elevation, along with some built up plant growth. Though not visible at the time of our inspection, the siding board will be prone to deterioration in the moist environment (Photo 40).

Photo 40: Structure (9), north facing exterior elevation conditions

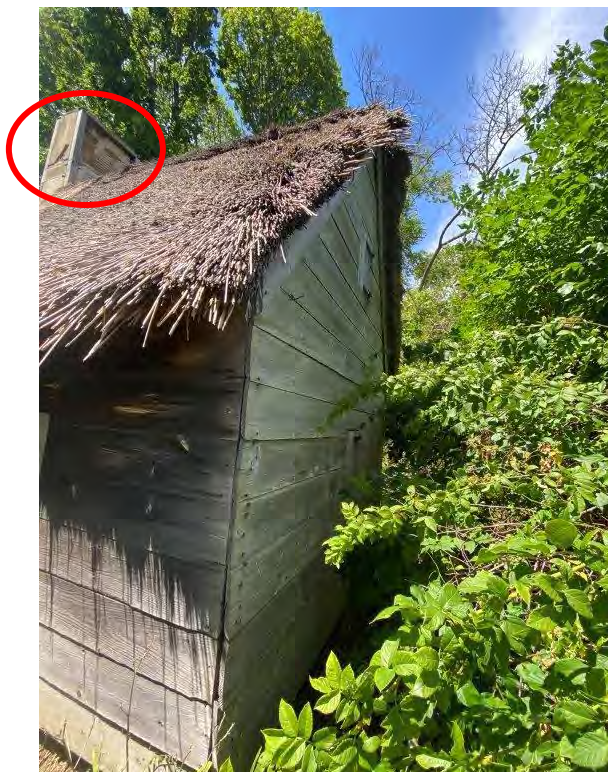
Some of the horizontal siding boards are loose at the southeast end of the wall face. There is an entire stucco panel missing from this side of the chimney, leaving it exposed to collect water (Photo 41).

Photo 41: Structure (9), east facing exterior elevation conditions

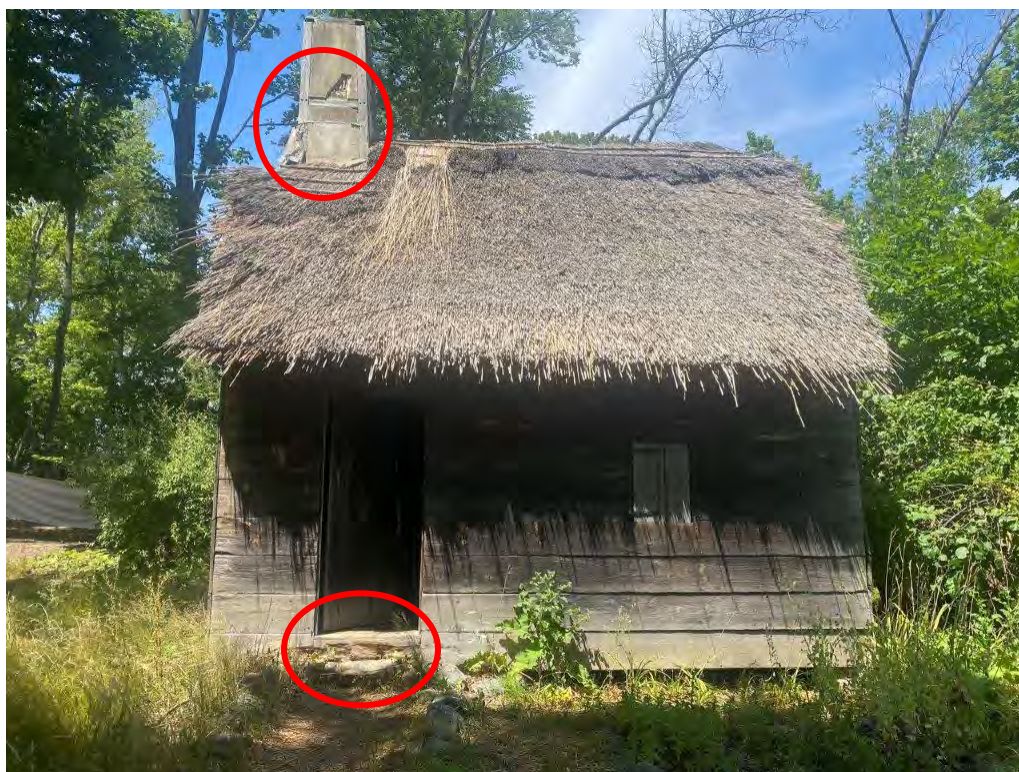
The south elevation is the point of entry into the cottage. There is severe rot of the siding boards beneath the doorway. At the roof level, the thatching is missing at the base of the chimney, there are holes in the flashing, and the cement stucco is cracked and spalling (Photo 42).

Photo 42: Structure (9), south facing exterior elevation conditions

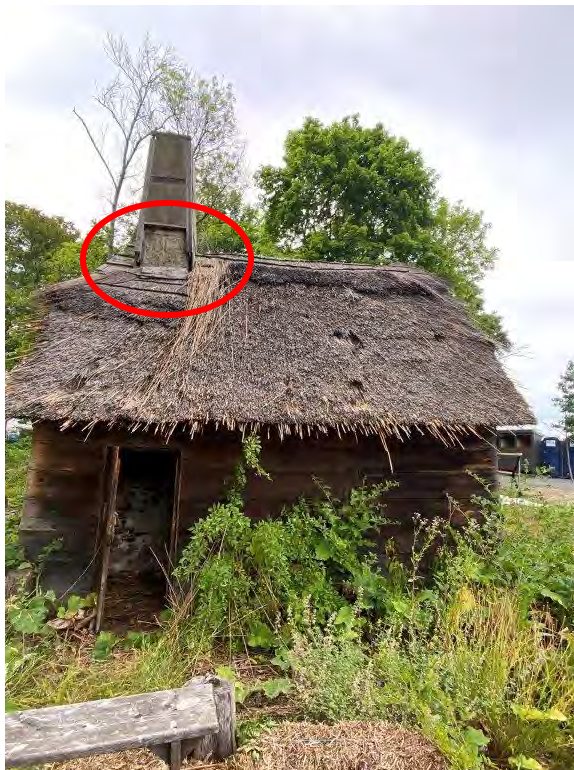
The main concern with the south face is the deterioration of the cement parging panels of the chimney. Parts of the panels have begun to fall off and the wood frame holding the panels in place are rotting at the ends in contact with the roof (Photo 43).

Photo 43: Structure (10), south facing exterior elevation conditions

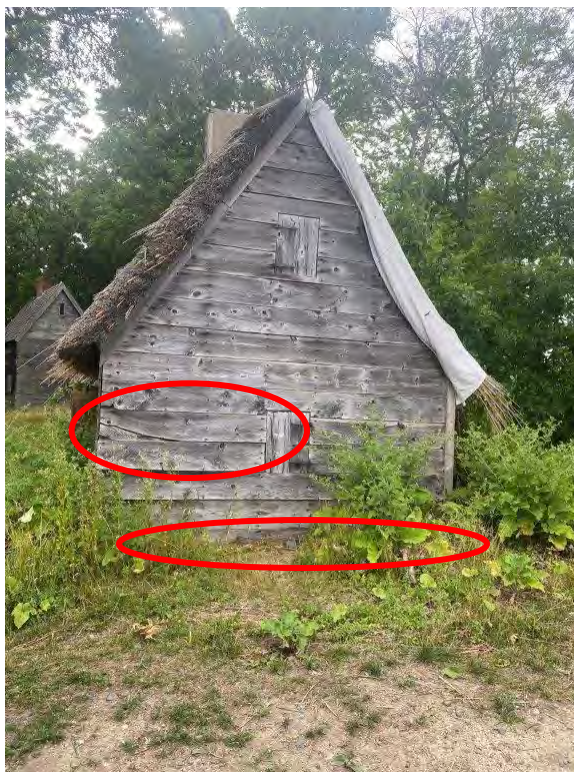
The siding boards near to the southeast corner of the cottage is seeing some warping and rotting, especially along the base board of the structure (Photo 44).

Photo 44: Structure (10), east facing exterior elevation conditions

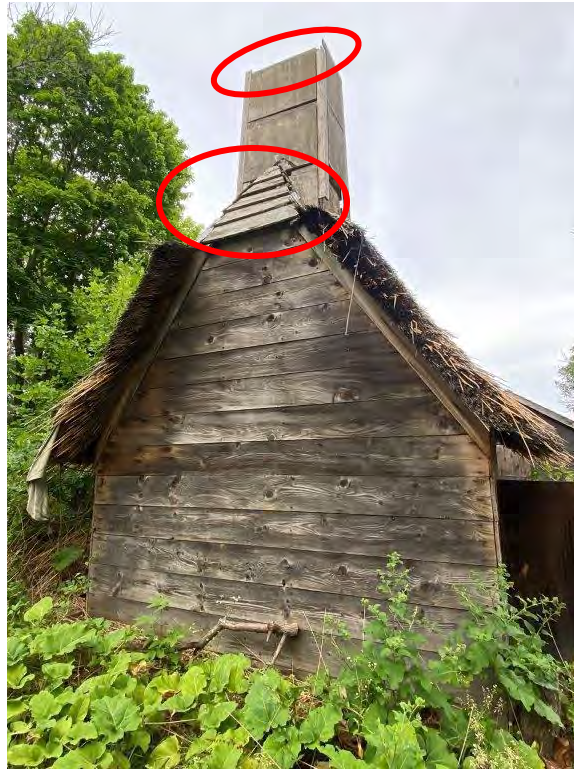
The wooden boards that slope outwards from the chimney are rotting at their ends. There is also some missing framing from the cement parging panels at this location (Photo 45).

Photo 45: Structure (10), west facing exterior elevation conditions

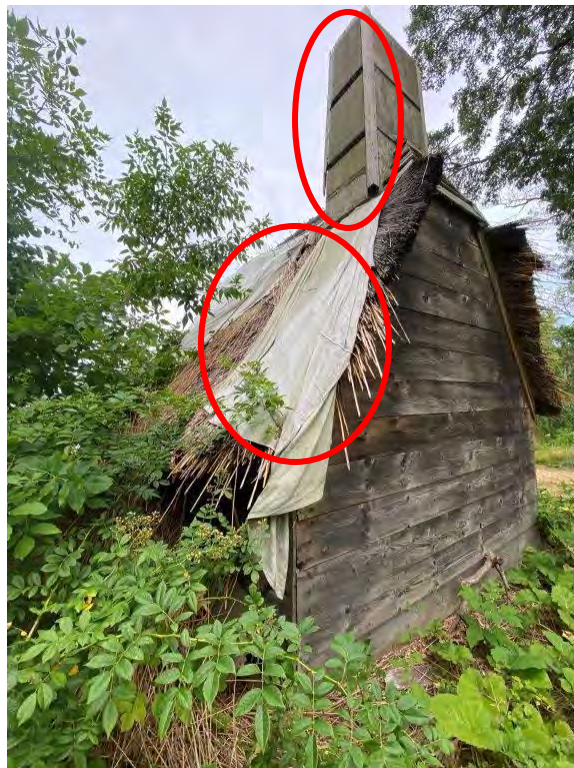
The majority of the thatching is missing and falling off from the north side of the roof. Currently, there is tarp over the damaged areas in an effort to keep water from entering the interior. The chimney is also missing some of its wood framing around the parged panels. The remainder of the siding was difficult to observe behind the overgrown brush and plants in this region (Photo 46).

Photo 46: Structure (10), northwest facing exterior elevation conditions
