SALEM'S PIONEER VILLAGE AND CAMP NAUMKEAG

Background Information for a Consultation with the Salem Historic Commission

June 2, 2021

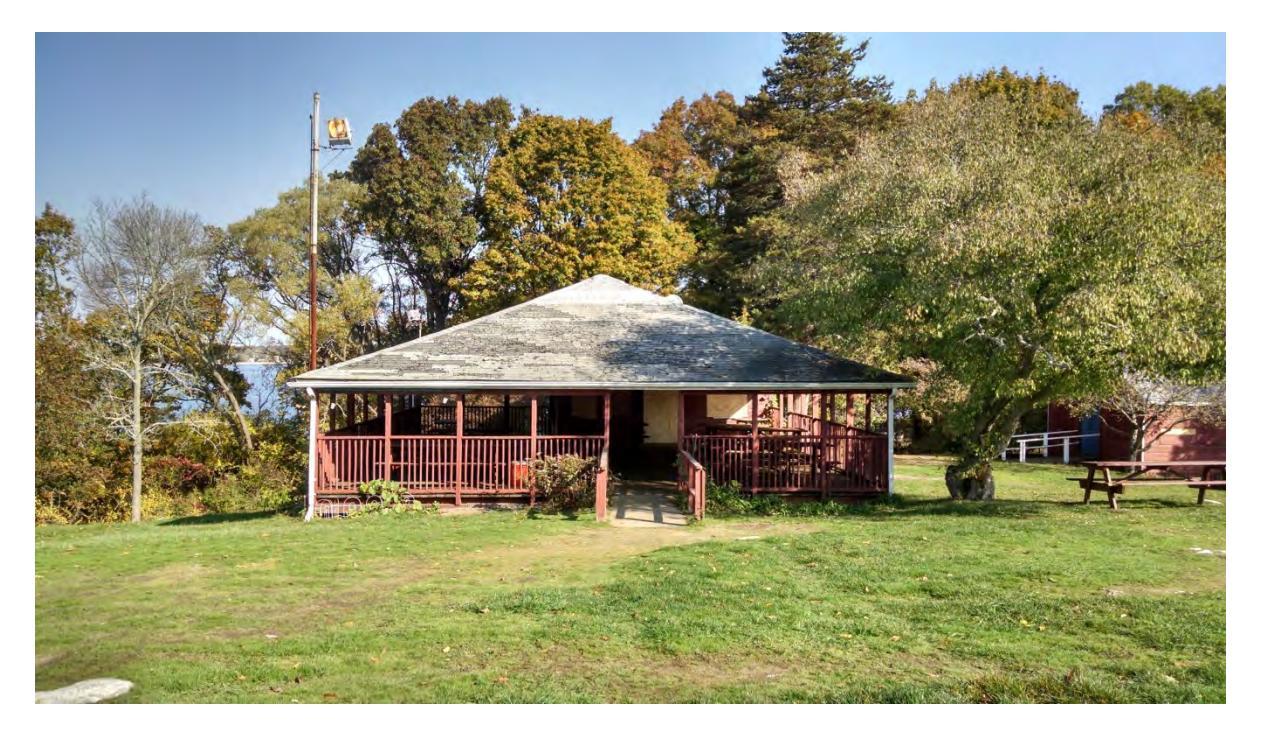
South facing elevation

Overall condition of the structure is fair. The wood framing and siding of the residence is not contact with grade, however the exterior dining structures south end is. There is no discernible differential settlement, however the porch structure appears to racking towards the west.

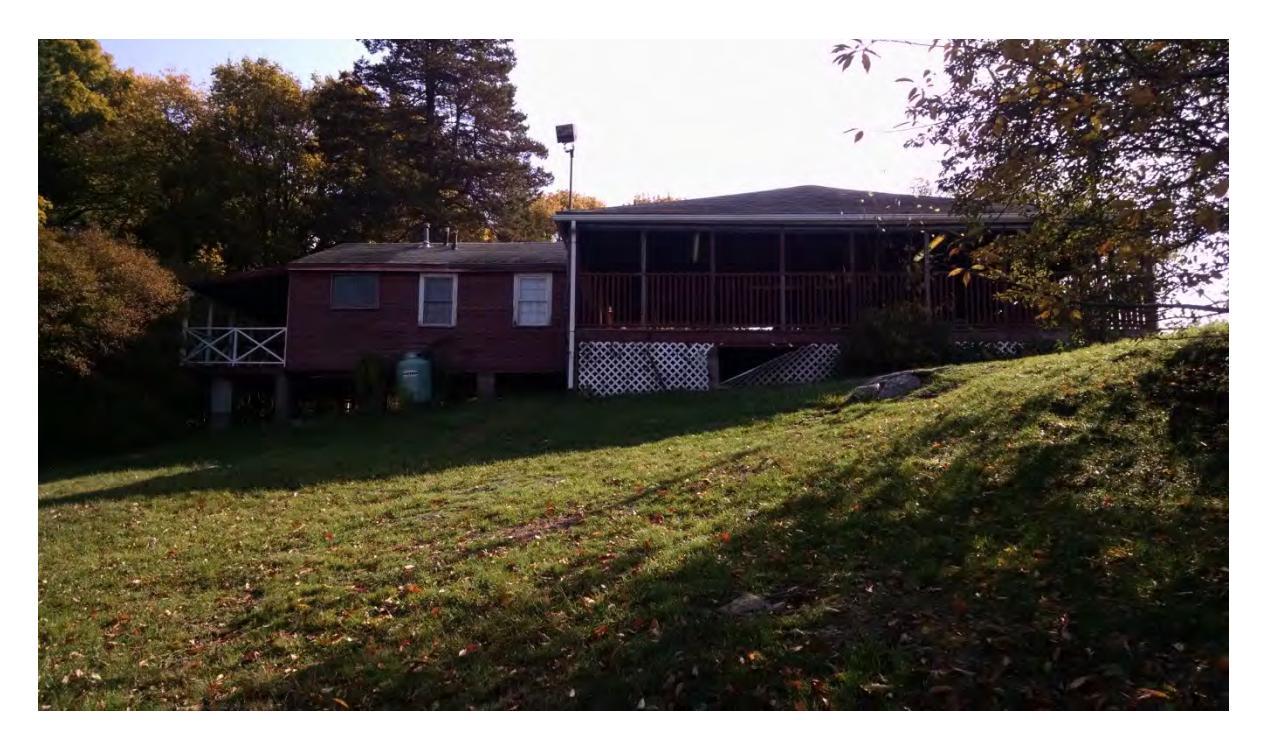
West facing elevation

Siding rot is evident along the west side of the building. There has been an attempt to prevent access to the space below the structure using wooden lattace panels. The panels are in contact with the ground and have failed or been removed altogether in numerous areas, allowing access to the underside of the structure.

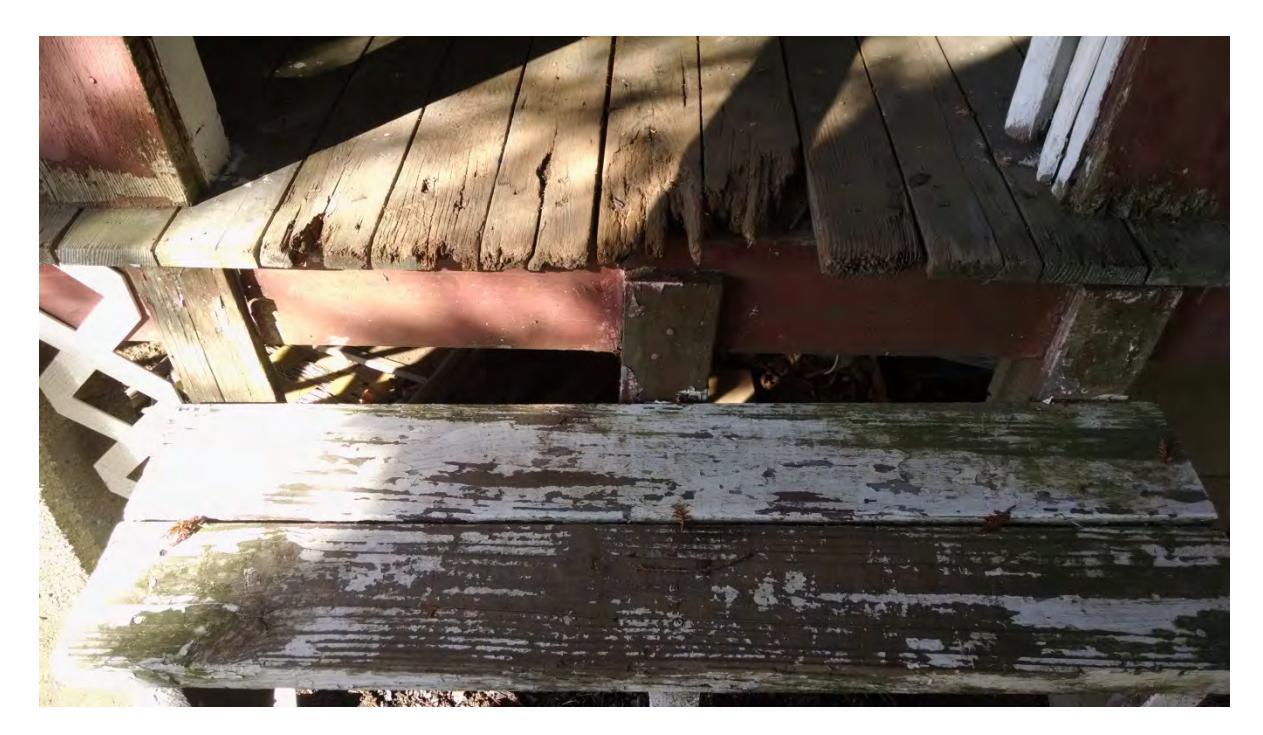
Main stair to porch

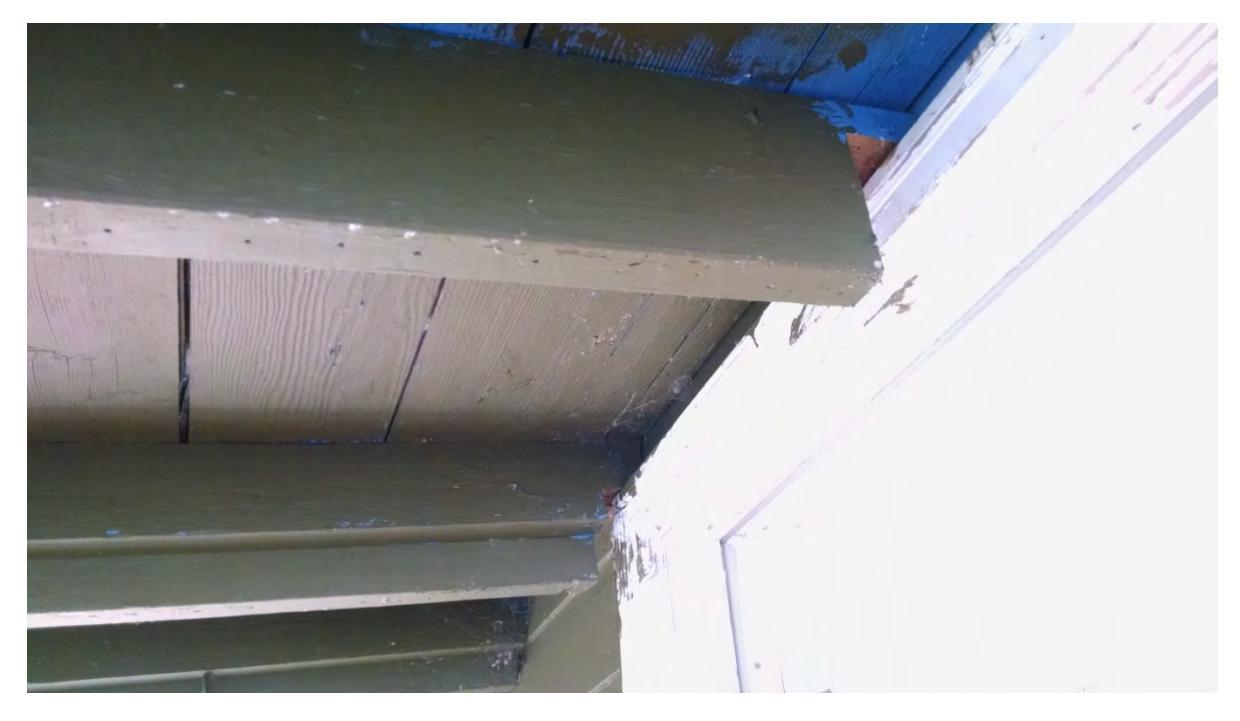
Notched rafters over doorway into caretaker's building

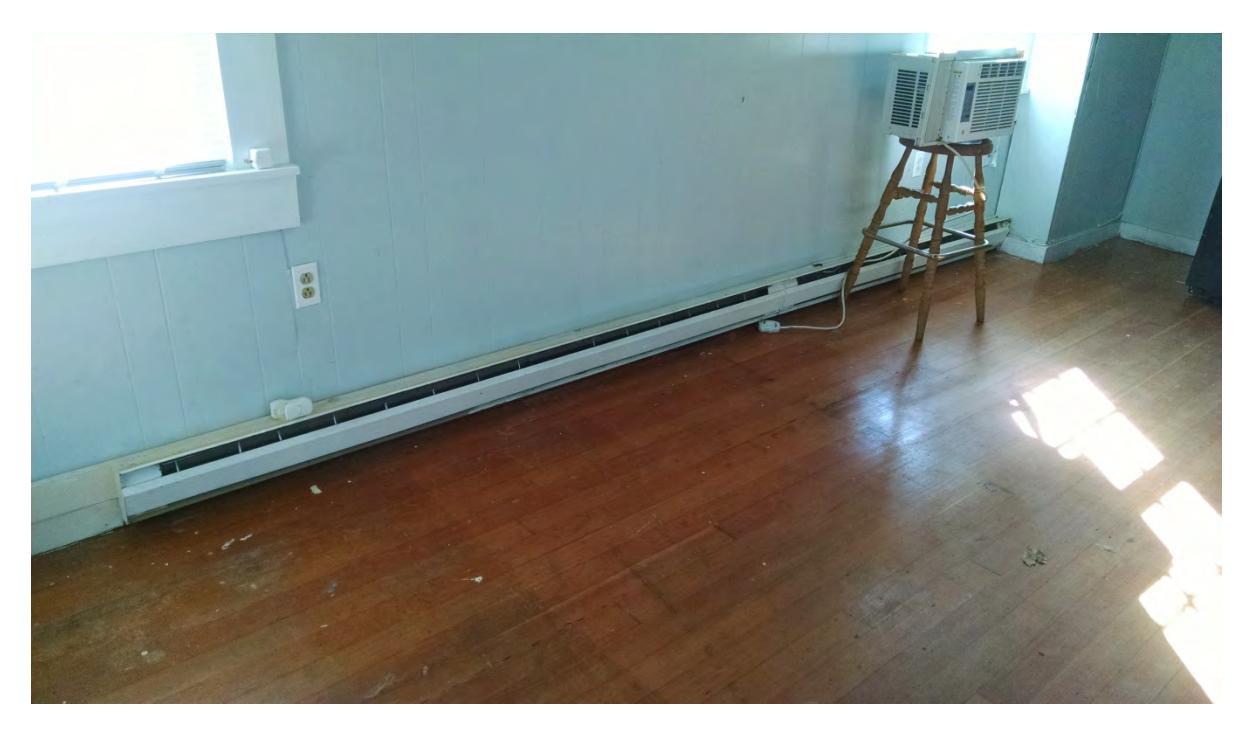
Living area with electric base board heat

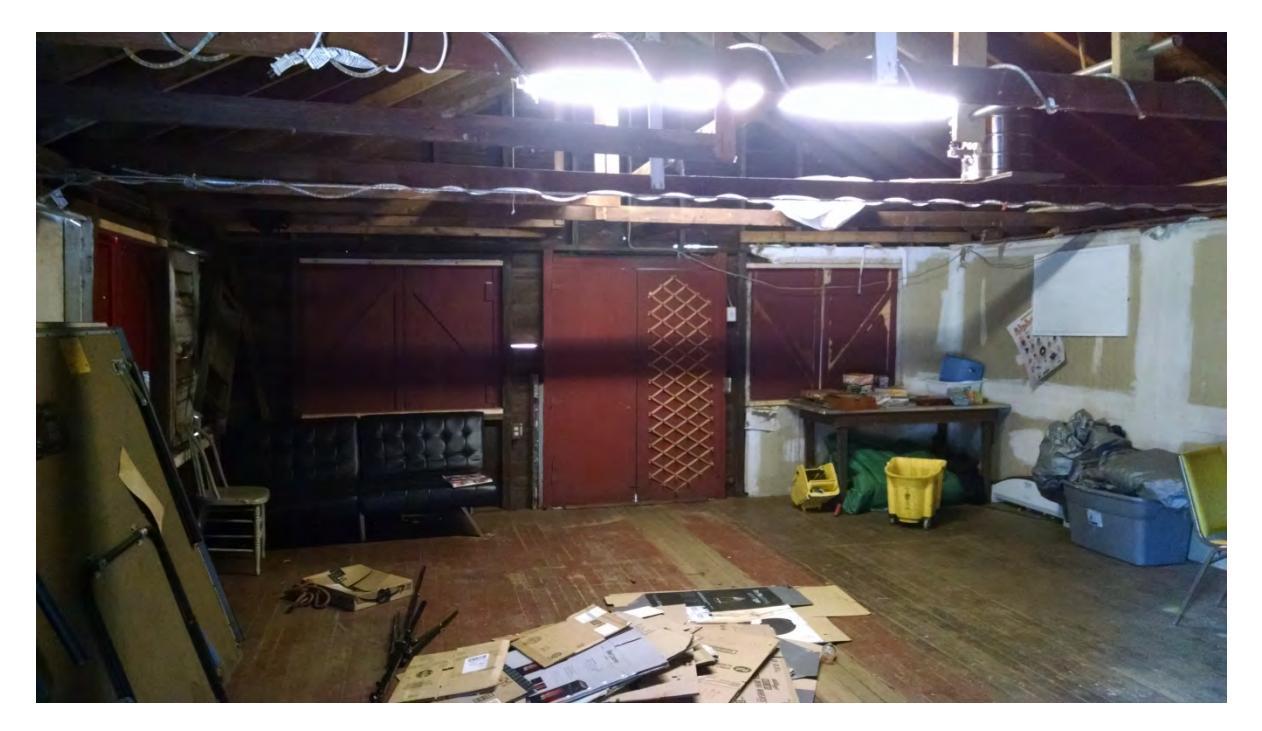
Activity area looking west.

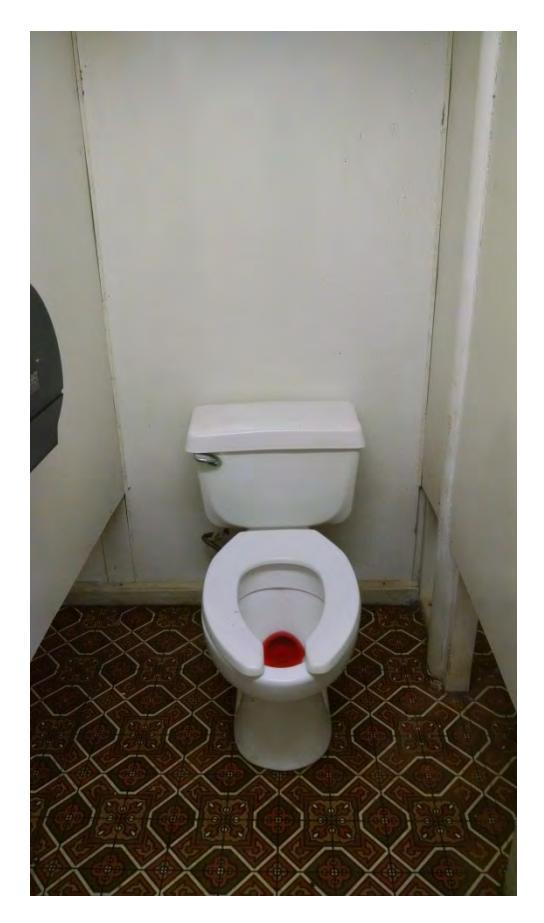
Boy's Room viewed toward accessible stall

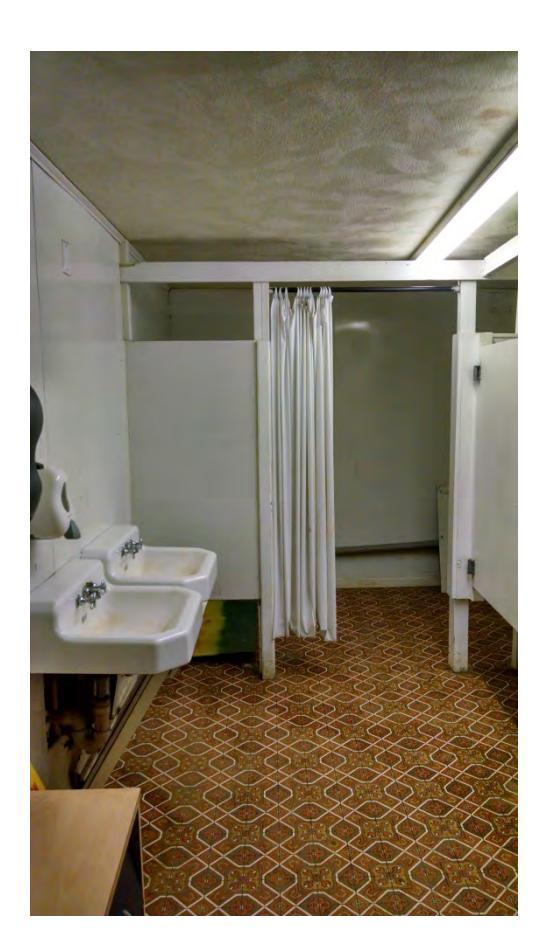
Standard toilet stall Note porous wood base

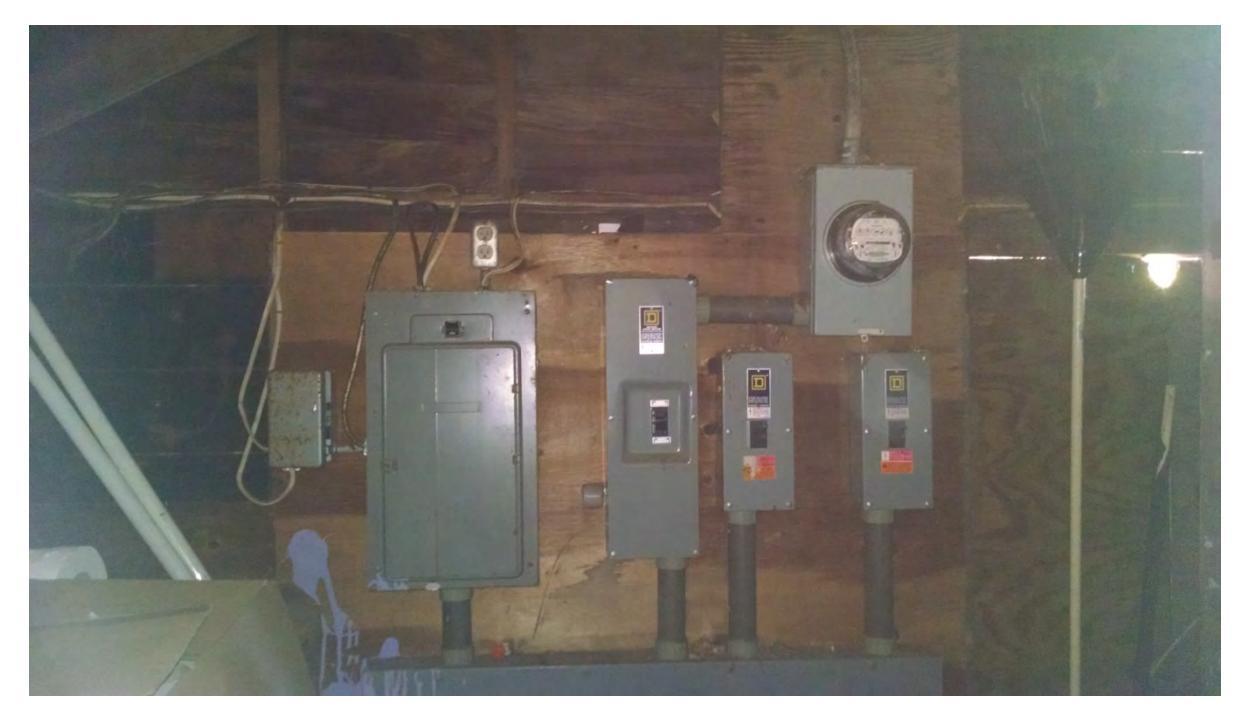
Primary electric service feeds Main, Boy's, Girl's and Caretakers buildings.

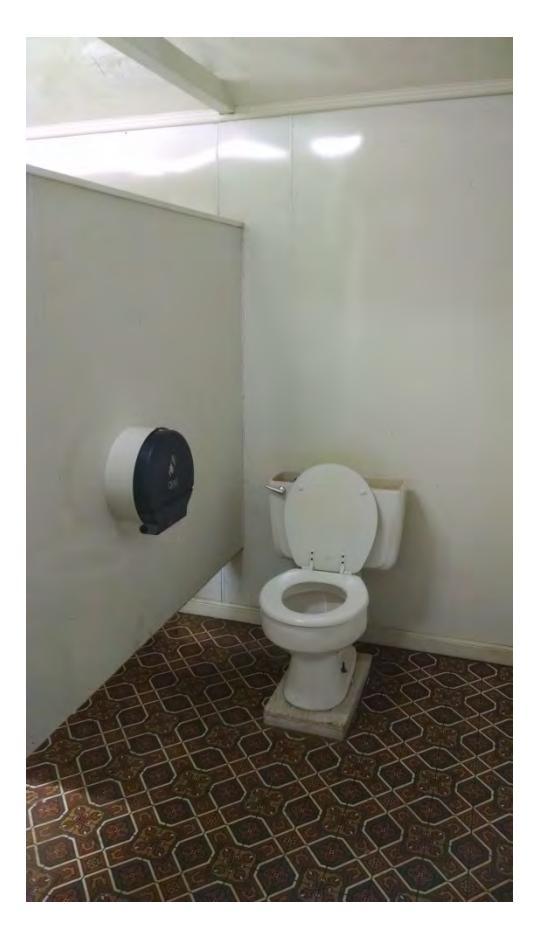
Non-compliant accessible toilet stall
