EXECUTIVE SUMMARY

OLD TOWN HALL RENOVATIONS

32 Derby Square / Salem MA

PHOTOGRAPHS OF EXISTING CONDITIONS

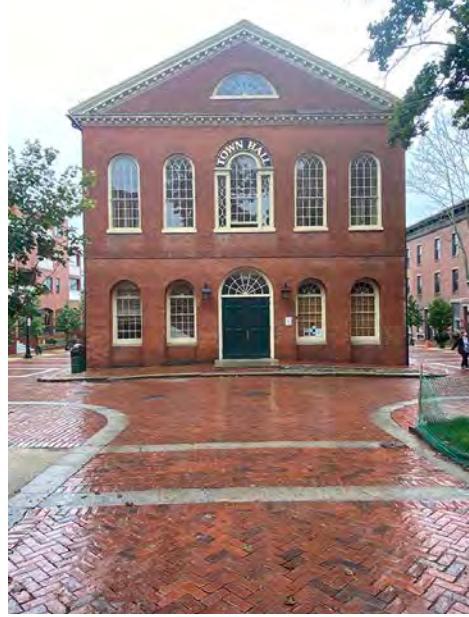
Essex Street Facade at North Elevation Now Serves as the Primary Entrance and Sole Accessible Entrance

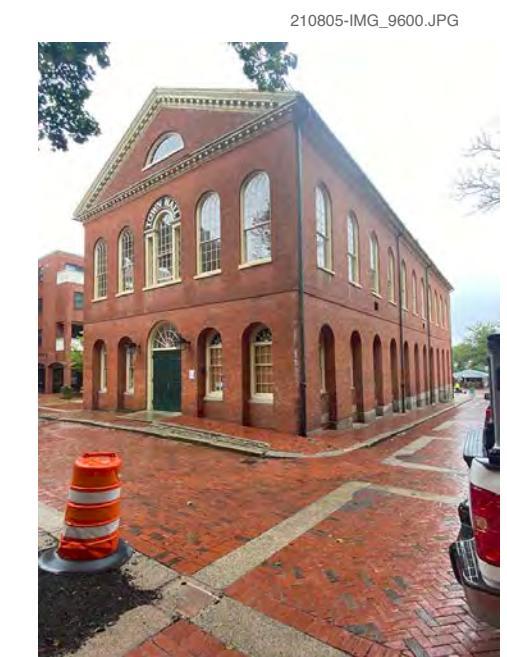
View of North and West Facades Surrounded by Pedestrian Way; Sitework Improvements Circa 1972-73

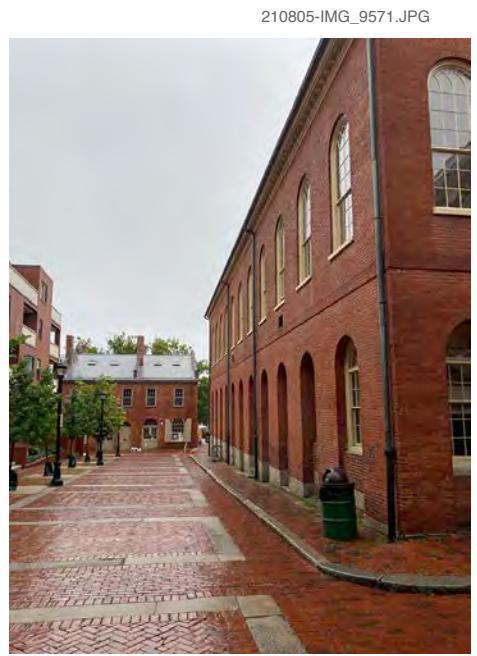
View of East Facade with Adjacent Pedestrian Way

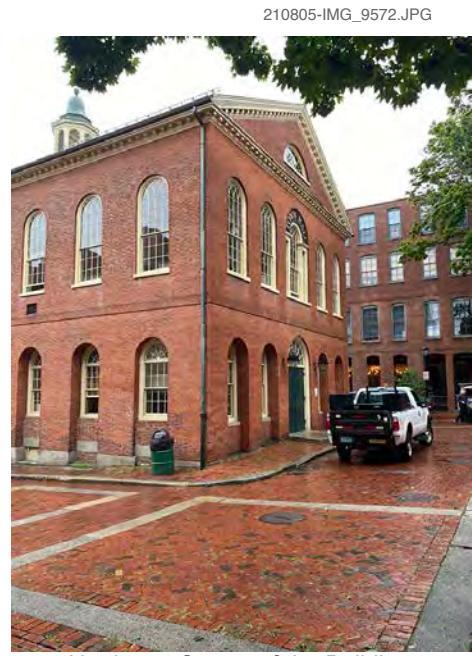
Northeast Corner of the Building; City Services Pickup Truck at Entrance

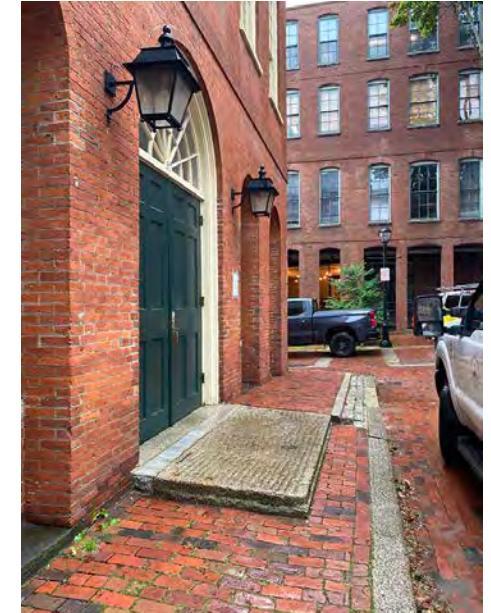
210805-IMG_9569.JPG

North Entrance with Granite Stoop; Accessible Walkway from Northwest Corner to Door; Landing Cross Slope Exceeds Allowable Pitch; Outswing Door Impedes Maneuvering Clearance

- Improve north entrance for conformance with current accessibility regulations.
- Provide a secondary accessible entrance to the basement via the southeast corner.
- Retain and preserve the three south exterior stairs and repair original iron railings.
- Provide replacement utilities for water, sewer, and electrical services as needed.
- Provide new fire suppression water service for an automatic sprinkler system.
- Provide an underground piping network to drilled and grouted boreholes for GSHP.

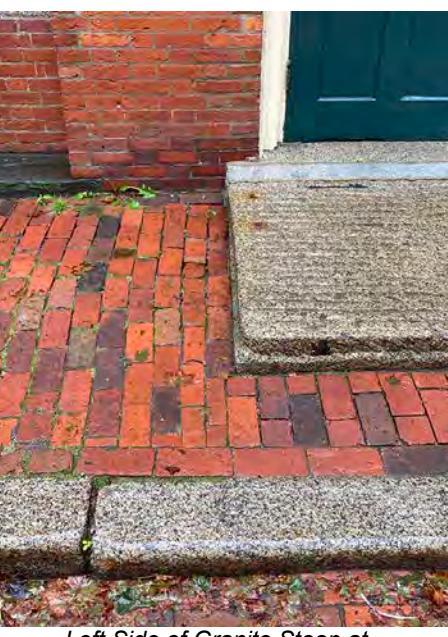
Left Side of Granite Stoop at Primary Entrance on North Facade

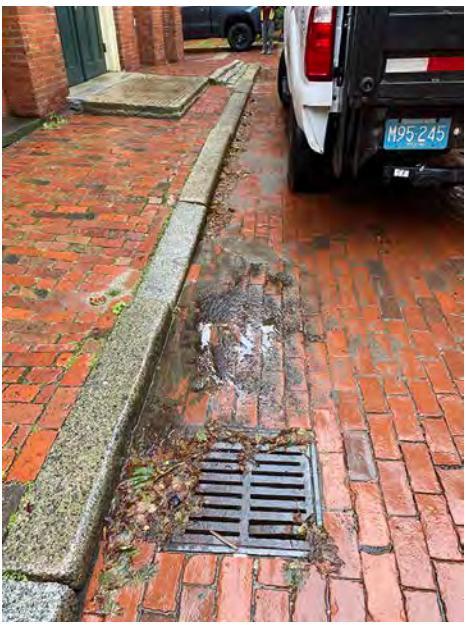
210805-IMG_9570.JPG

Catch Basin in Brick Paving Adjacent to Granite Curb and North Facade; Settlement of Curb Misaligned with Adjacent

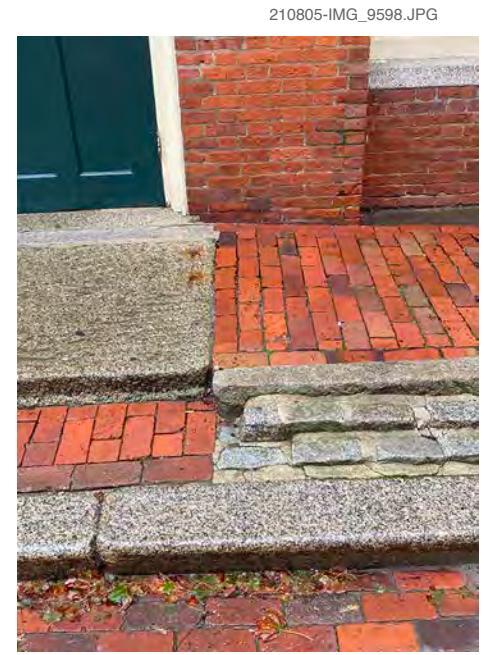
Right Side of Granite Stoop at Primary Entrance on North Facade; Terraced Cobbles at Edge of Accessible Walkway

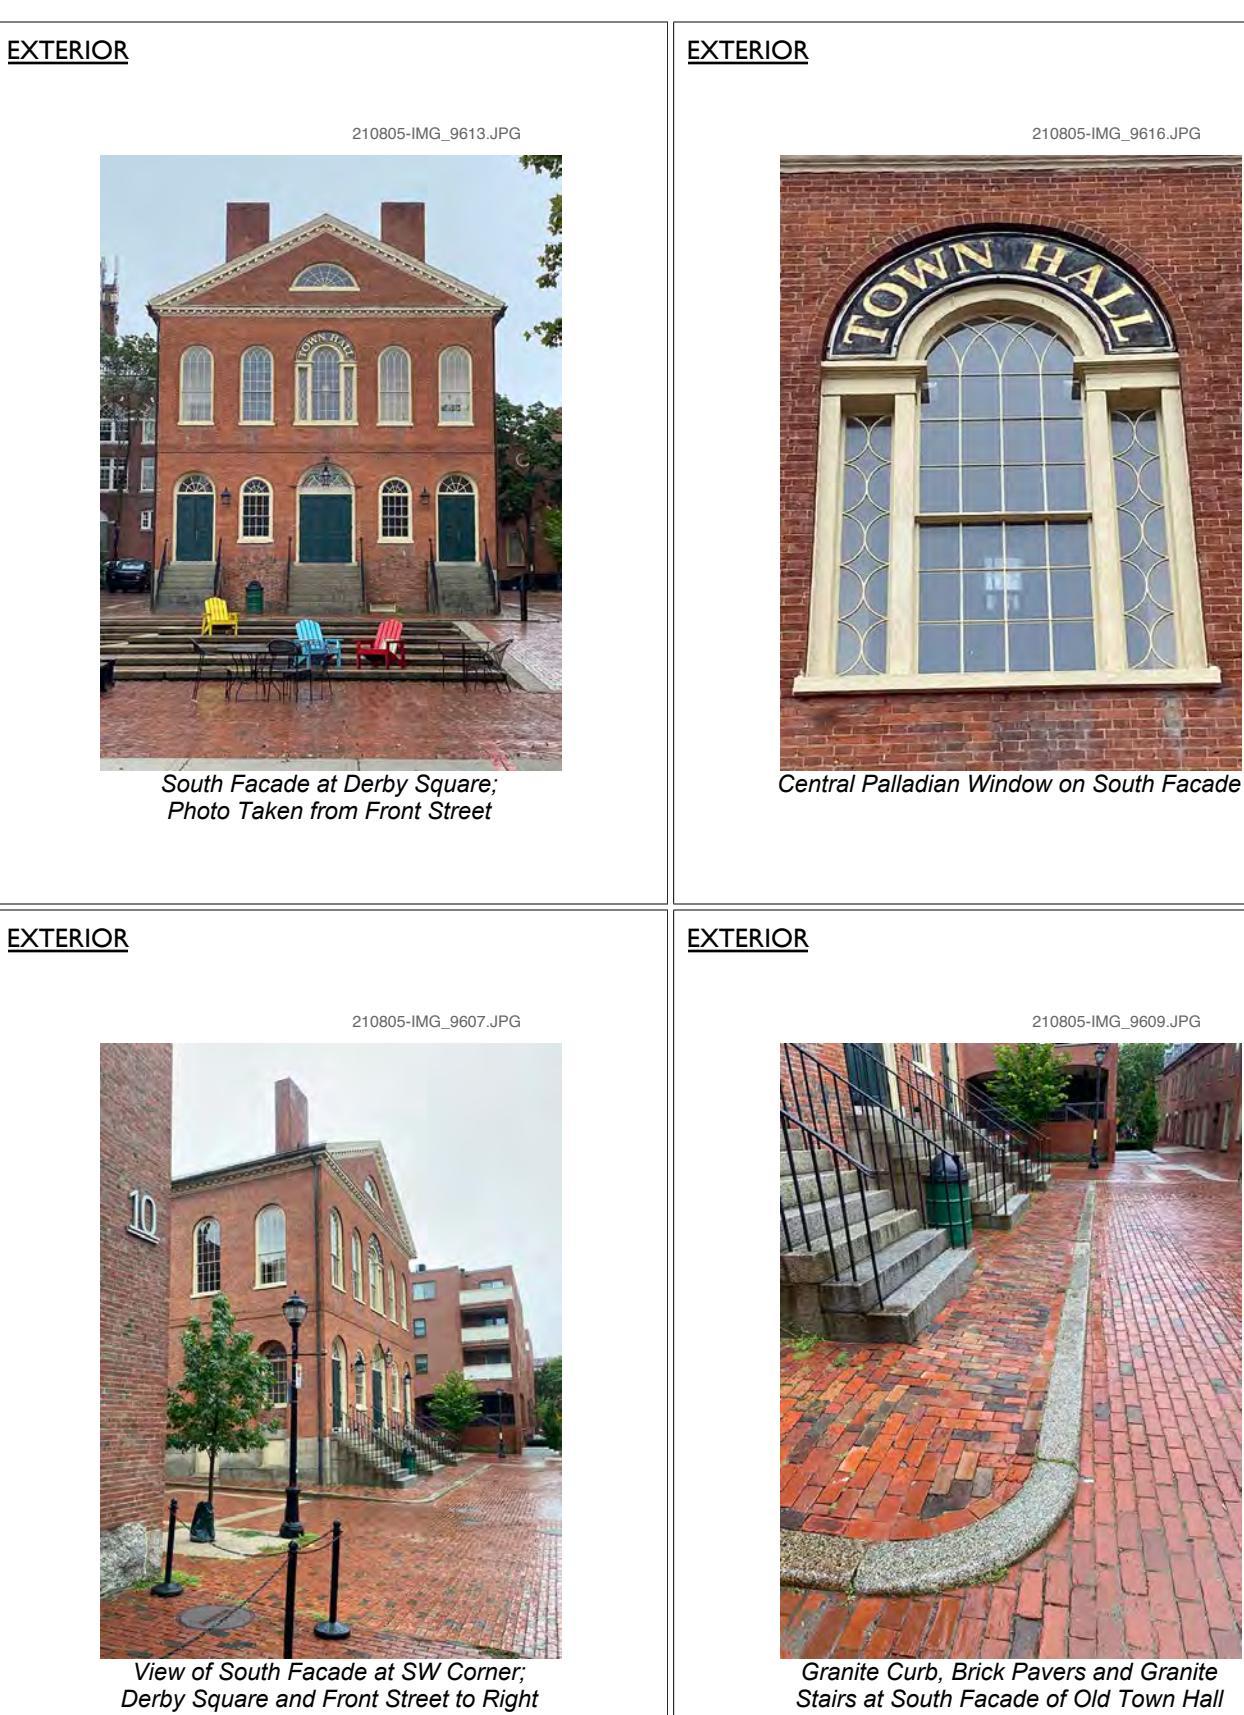
Granite Curb, Brick Pavers and Granite Stairs at South Facade of Old Town Hall

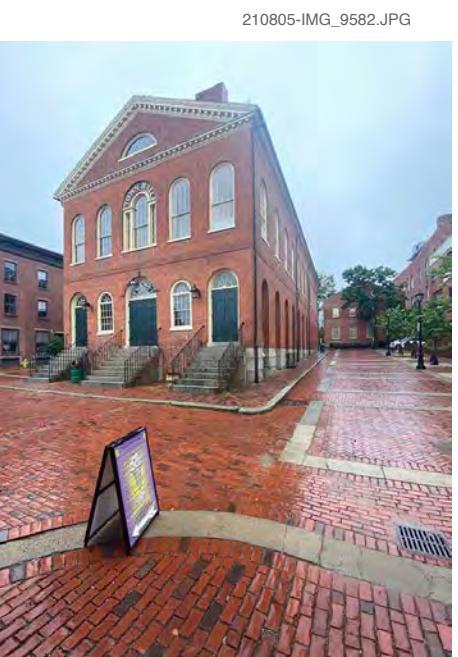
View of South Facade and East Side of Building Looking North Toward Essex Street

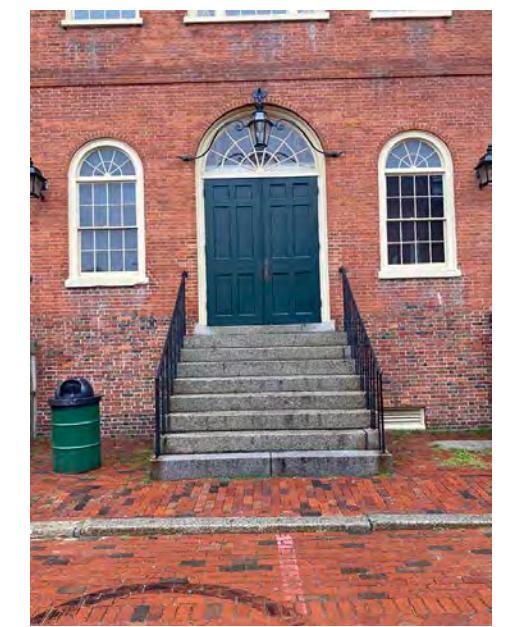
210805-IMG_9584.JPG

Central Stairs at South Facade with Brick Infill at Former Basement Entries at Each Side of Central Stair

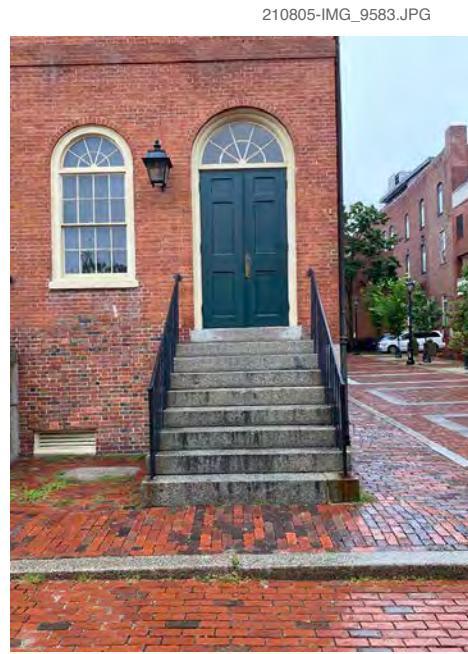
Granite Steps to Easterly Doors of South Facade Formerly Served Interior Stairway to Town Offices on Second Floor; Now Serves as Exit Only; Interior Stairs to Second Floor Still In Use

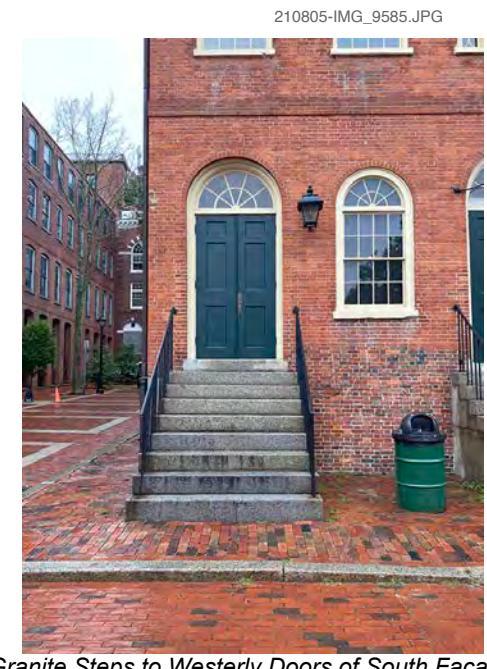
Granite Steps to Westerly Doors of South Facade Formerly Served Interior Stairway to Town Offices on Second Floor; Now Serves as Exit Only; Interior Stairs Removed for Elevator Installation

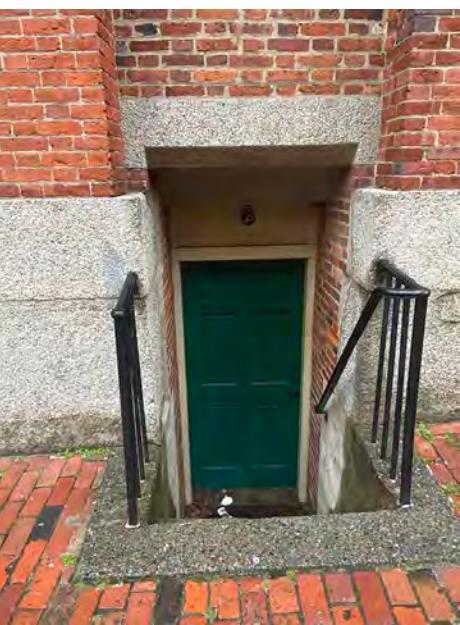
Basement Exit Door Well at East Facade; Guardrails with Handrail on Latch Side of Door

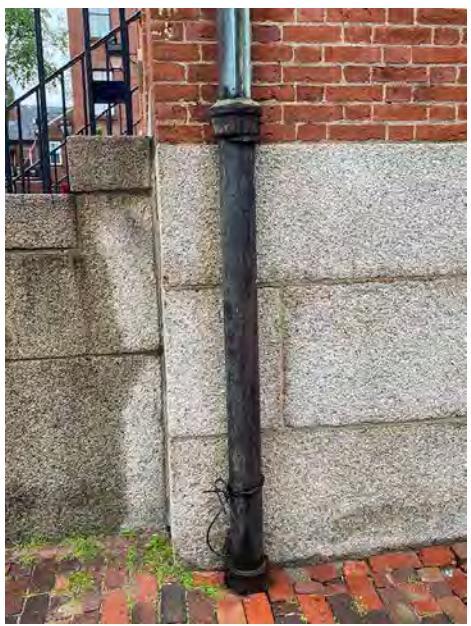
Cast Iron Boot to Copper Rain Leader at Southeast Corner; Granite Plinth at Basement Level with Brick Above

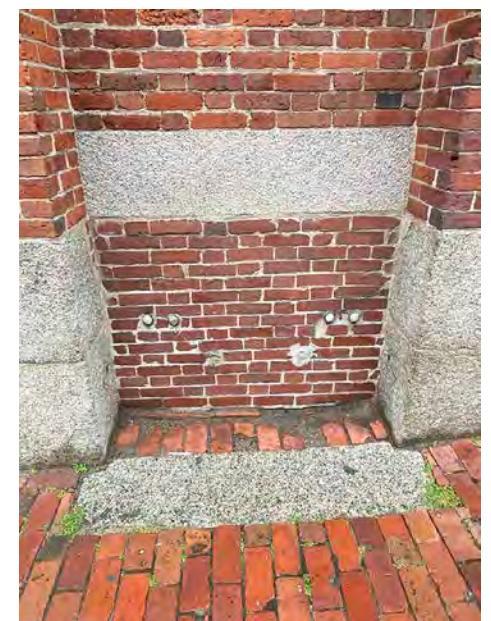
Typical Brick Infill at Former Basement Window; Former Pipes Served Former Interior Fuel Oil Tanks

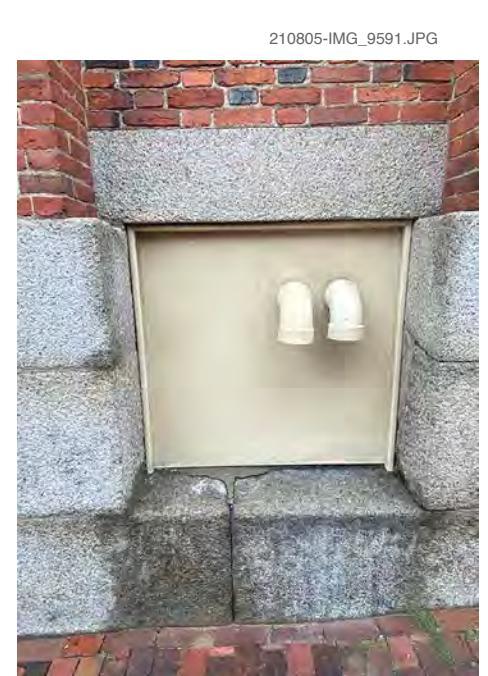
Basement Window Infill at East Facade with Exhaust Air Vents for Gas-Fired Condensing Boilers

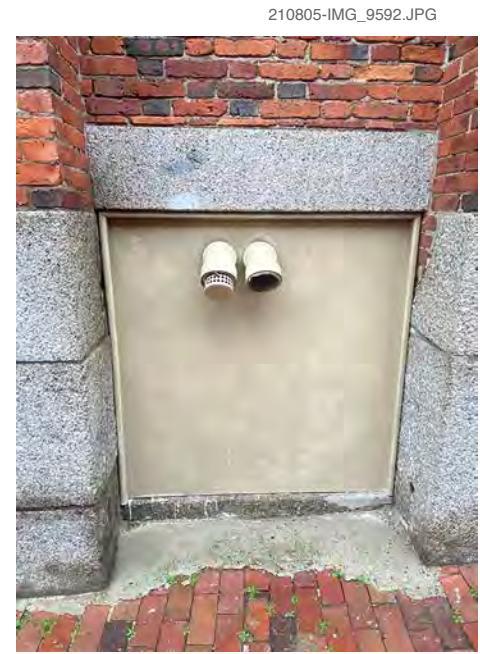
Basement Window Infill at East Facade with Intake Air Vents for Gas-Fired Condensing Boilers

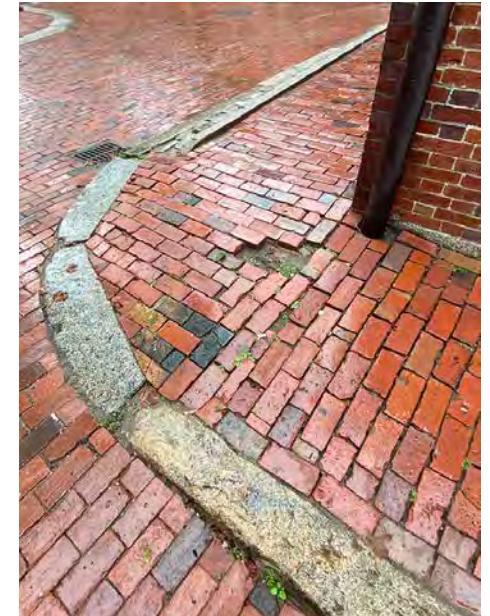
210805-IMG_9601.JPG

Void in Brick Pavers at NW Corner Sidewalk; Corner Curbing Set Flush to Sidewalk and Street to Serve Accessible Walkway Path to North Entry

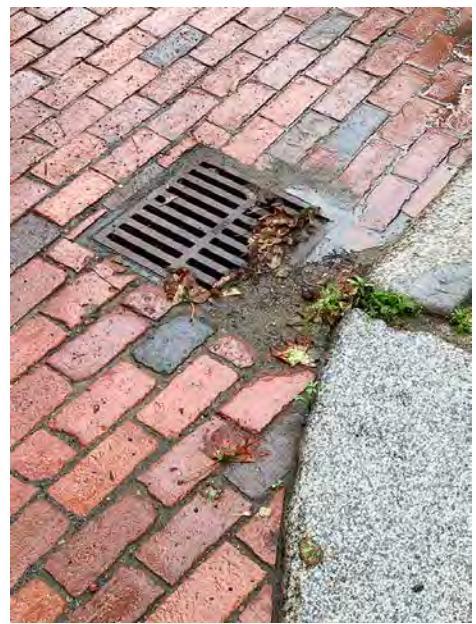
Storm Drain Grate at Curb by NW Corner

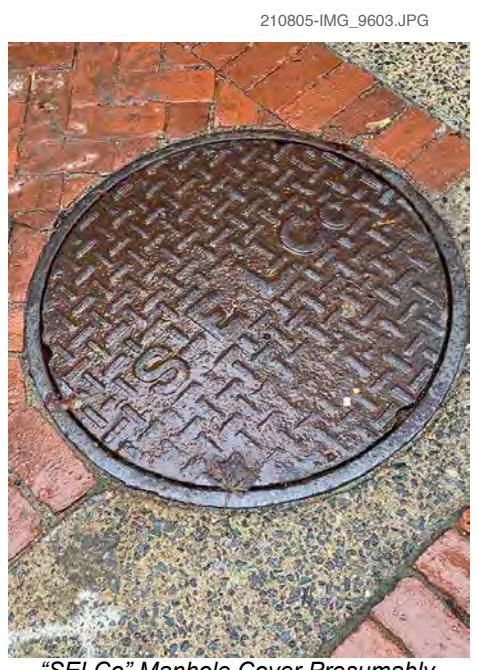
"SELCo" Manhole Cover Presumably Contains Electrical Utility Connections (Salem Electric Company)

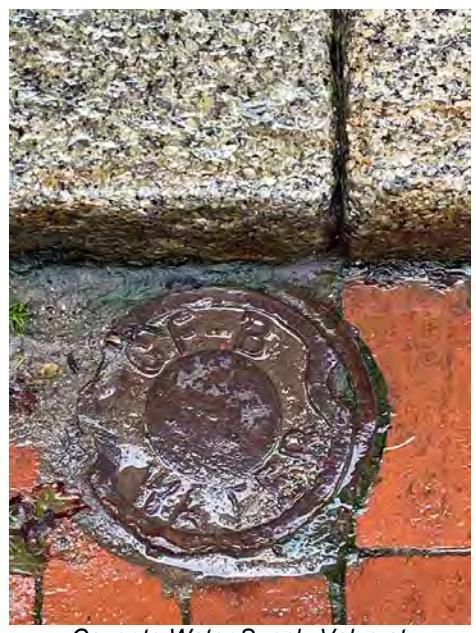
Cover to Water Supply Valve at West Side of Building Adjacent to Curb

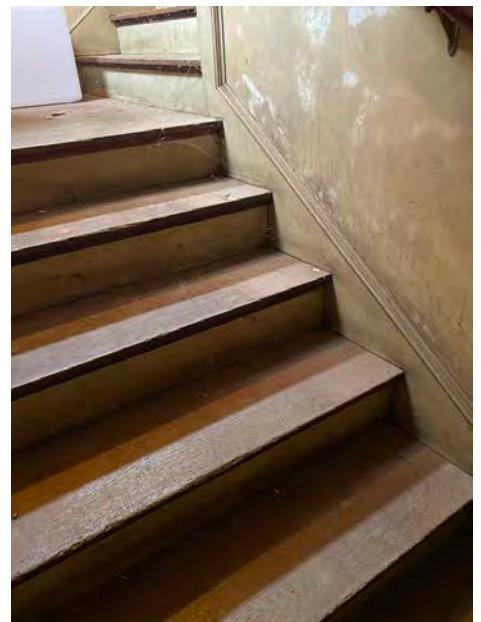
Basement Stairs at NE Corner of Building; Wood Framed Risers, Treads & Stringers; Crawl Space Below Adjacent to Vault

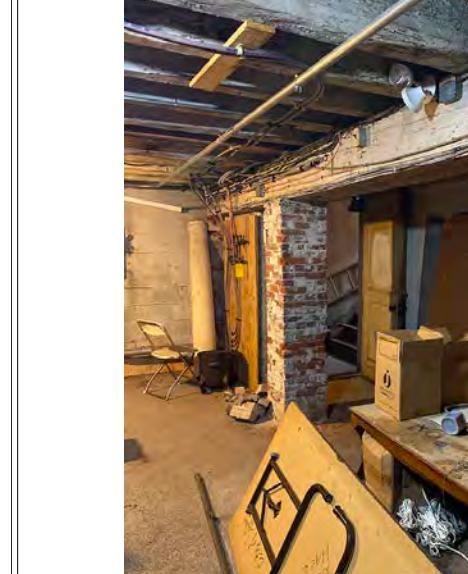
A central row of brick piers topped by a timber beam forms the original structure north of the area that was reconstructed in concrete at the boiler room. The brick piers are deteriorated in some locations and headroom below the central beam is only 75". This central north/south row of supports is not located below the columns on the first floor, so the colonnade columns bear upon east/west spanning timber transfer beams. This structural configuration has resulted in severe limitations of the occupant load for the upper floors, restricting the capacity of the building's use significantly.

Looking North to North End of Basement; Central Row of Brick Piers with N/S Timber Beam; Joists and Timber Transfer Beams Span E/W; Very Low Headroom at Beam (75")

- Remove the low headroom central beam and flush frame replacement beams above columns. Lower basement slab by 7" where structural changes are made.
- Remove the perimeter circa 1933 concrete block interior finish that conceals the original rubble stone foundation. Repoint stonework and insulate the exterior walls.

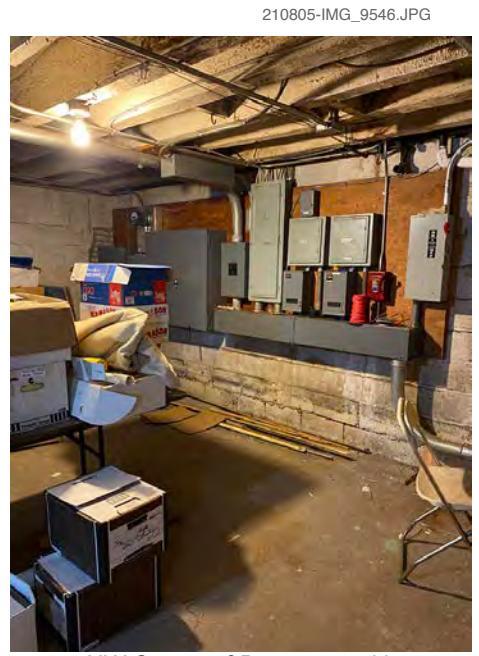
NW Corner of Basement with Electrical Service, Meter and Panels

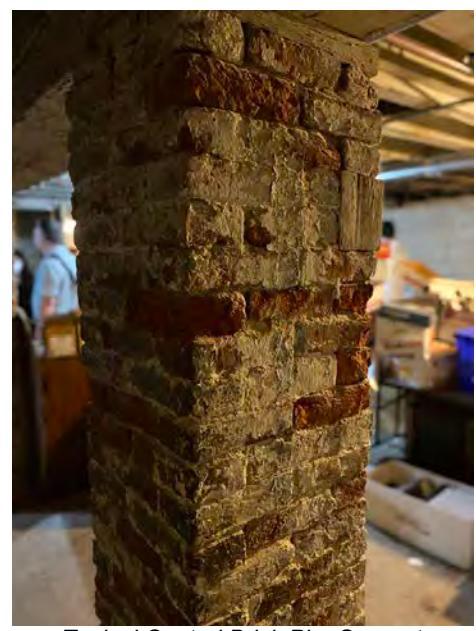
Typical Central Brick Pier Support

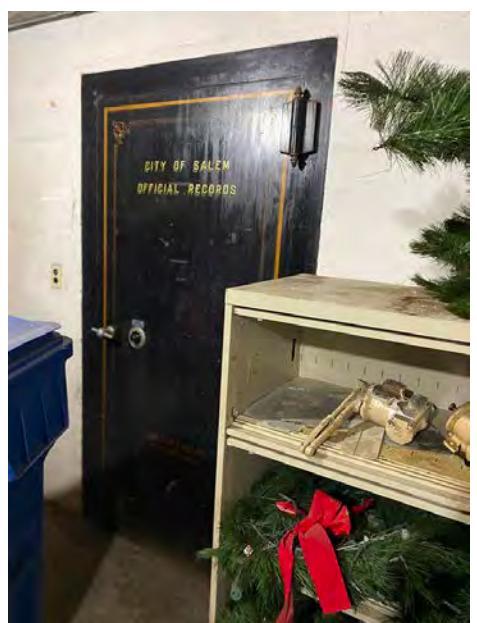
City Vault Door at North End of Building

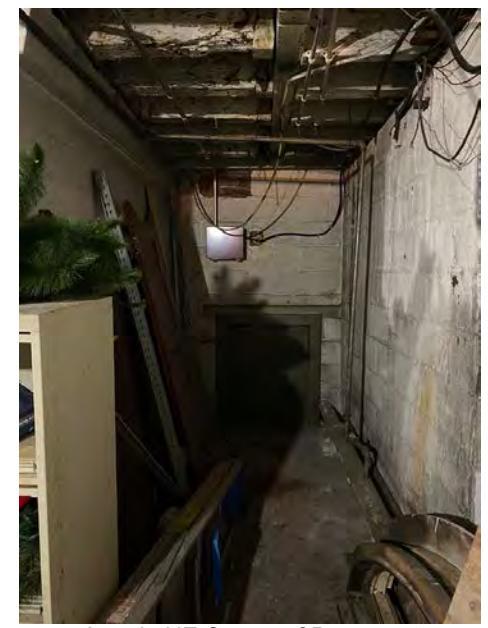
Area in NE Corner of Basement Between Vault (at left) and Exterior Walls (N+E); Crawl Space Below Stairs Via Hatch Door

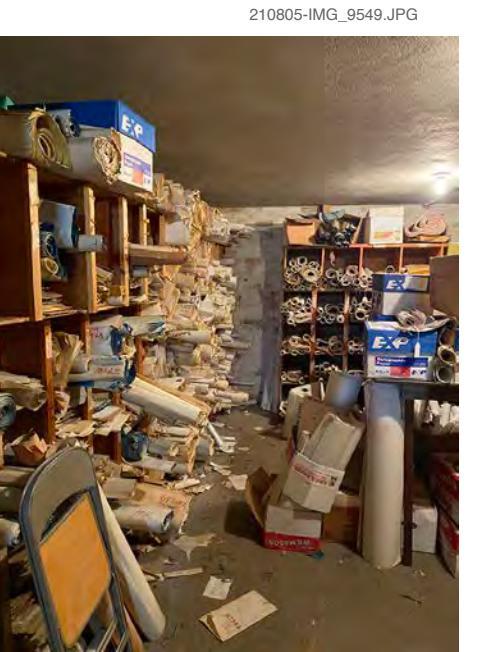
Records Storage Room on West Side of Basement; Looking South from Room Entrance; City Records to be Relocated from Old Town Hall

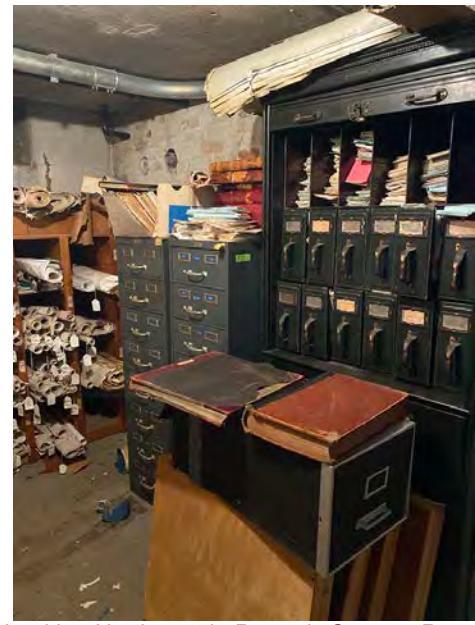
Looking Northwest in Records Storage Room

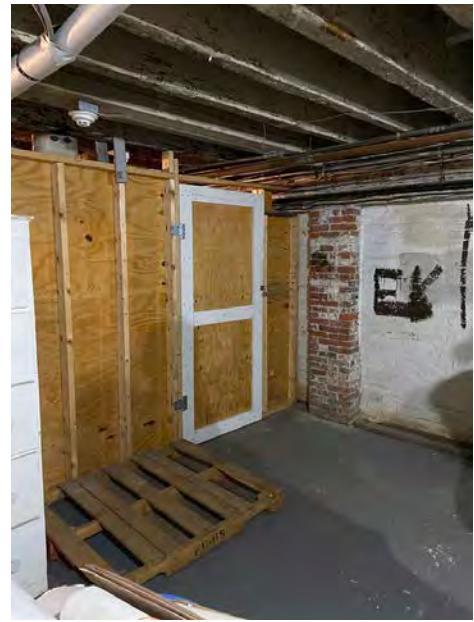
Plywood Partition Separating Two Sides of Basement Storage Areas

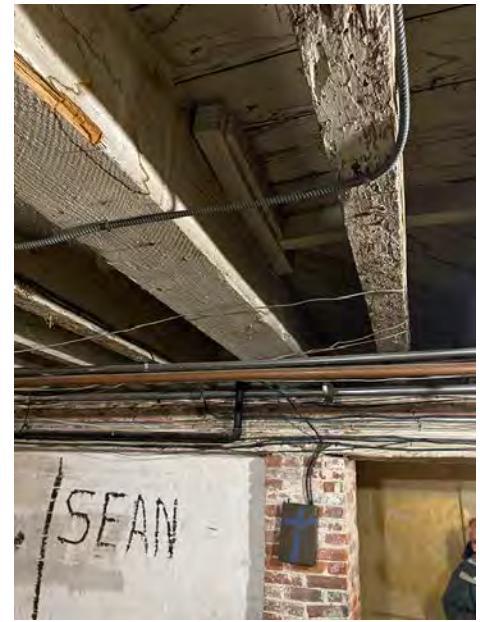
Timber Transfer Beam at Left Spans to Central Pier and Supports Column at First Floor Above

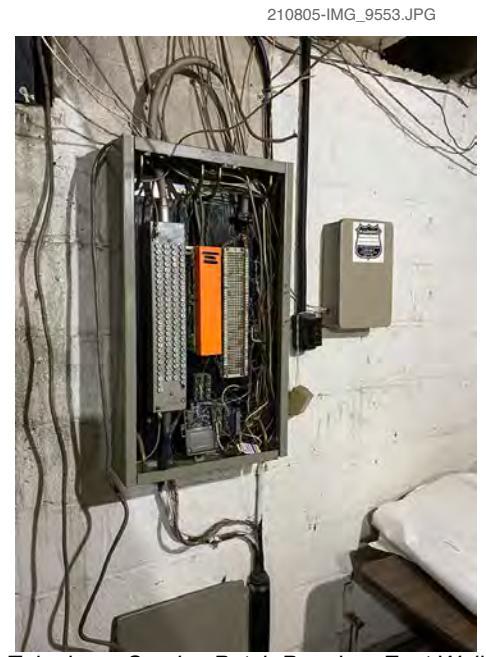
Telephone Service Patch Panel on East Wall

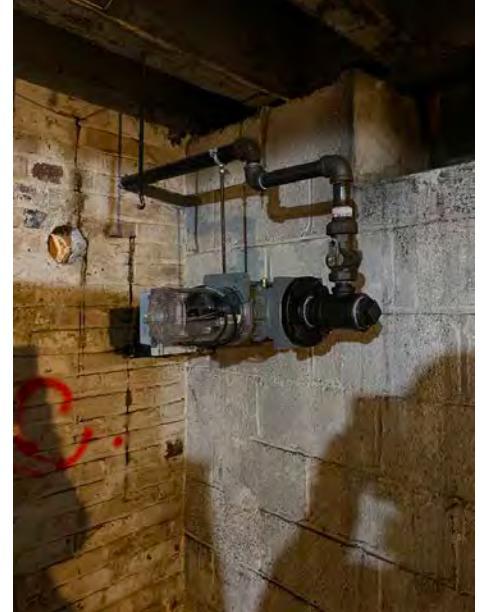
210805-IMG_9556.JPG

Natural Gas Meter on West Exterior Wall Adjacent to Records Storage Room; Natural Gas Fuels Pair of Condensing Boilers

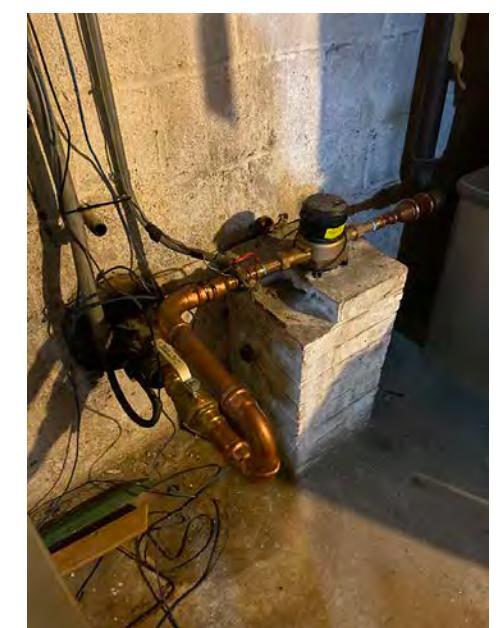
210805-IMG_9558.JPG

Potable Water Meter Adjacent to West Exterior Wall

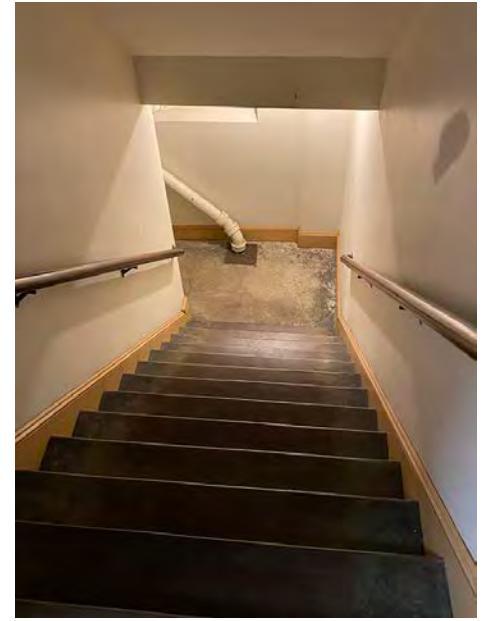
210805-IMG_9522.JPG

Stairs to Basement in SE Corner of Building Leading Down from South Foyer Area

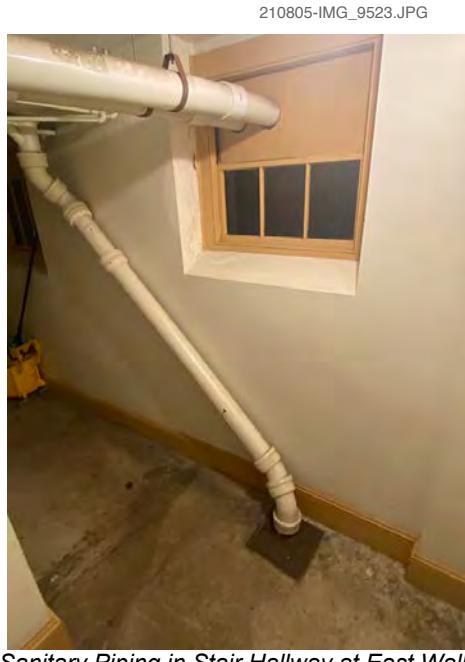
Sanitary Piping in Stair Hallway at East Wall; Air Vents for Condensing Boiler Overhead; Piping Serves Second Floor Single User Restroom

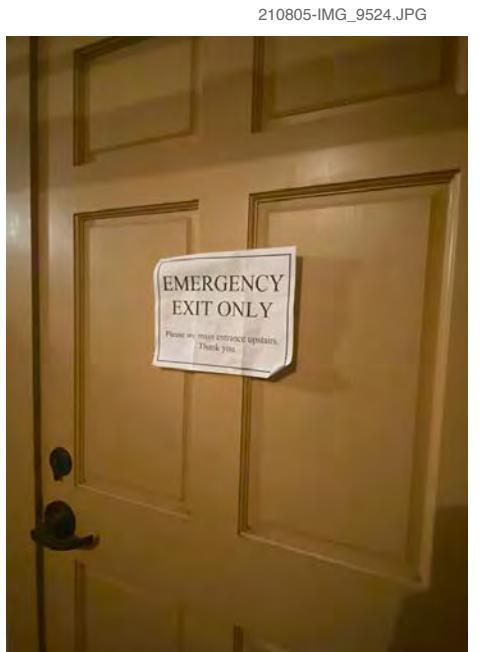
One of Two Side Exits from Transverse Hallway to East and West Door Wells at Exterior; Circa 1933 for Exterior Access to "Comfort Stations"

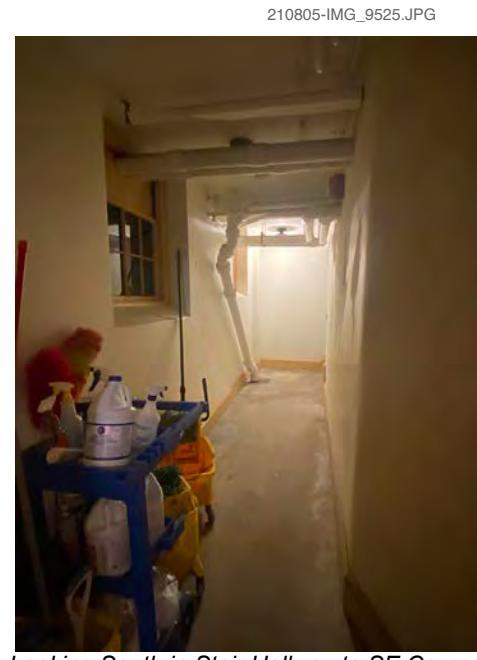
Looking South in Stair Hallway to SE Corner

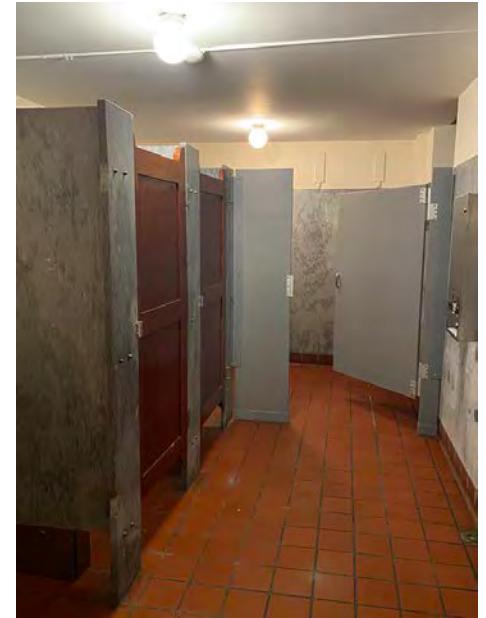
210805-IMG_9526.JPG

Looking North in Women's Restroom; Three Water Closets + One Lavatory

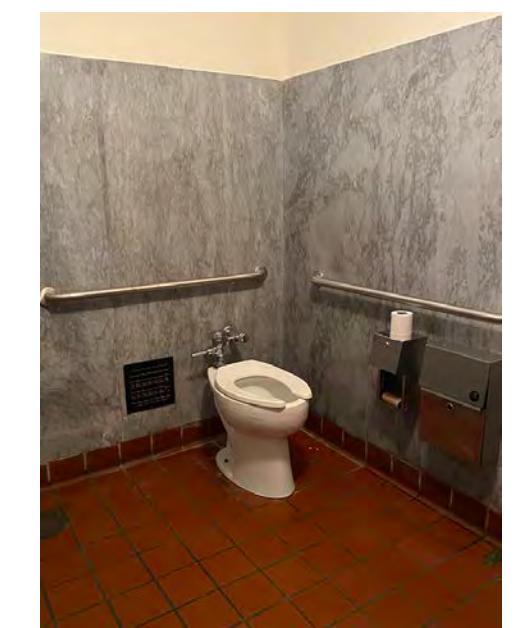
Accessible Stall in Women's Room; Low Exhaust Vent; Quarry Tile Floor, Marble Walls & Toilet Partitions

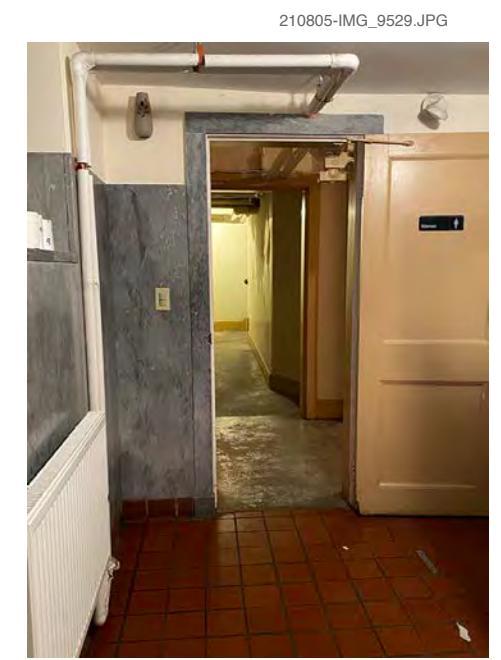
Looking South at Entrance to Women's Restroom

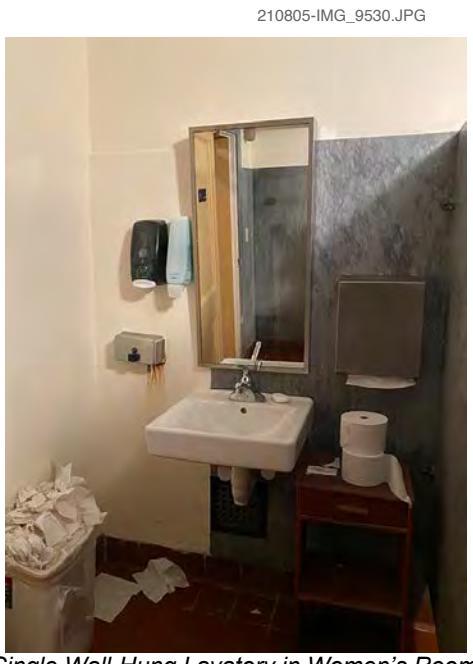
Single Wall-Hung Lavatory in Women's Room

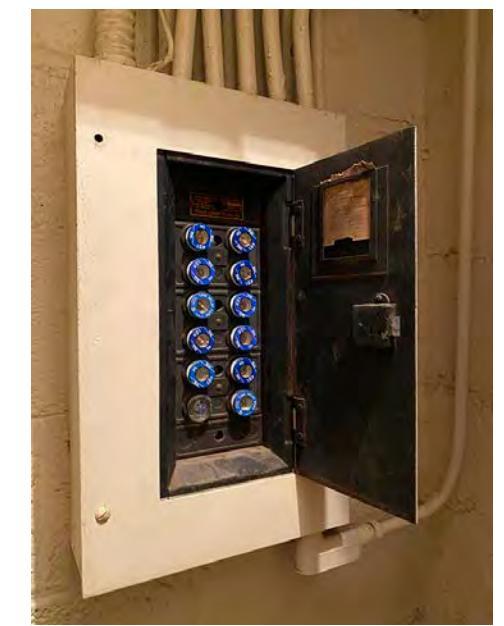
210805-IMG_9531.JPG

Surface-Mounted Screw-In Fuse Box in Hallway

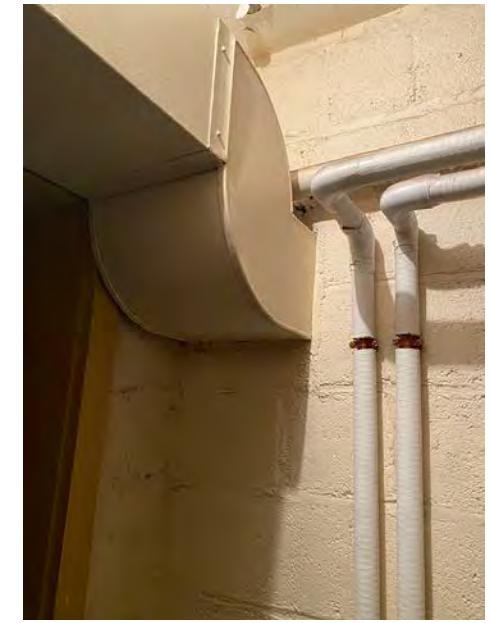
210805-IMG_9532.JPG

Exhaust Ductwork from Women's Room Chase Leads to Fan in Mechanical Room and Duct Discharges into Brick Chimney Flue to Roof

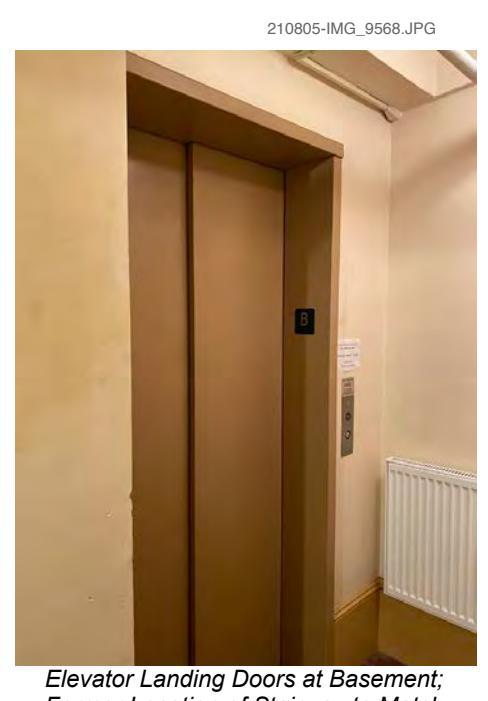
Elevator Landing Doors at Basement; Former Location of Stairway to Match Stairway in SE Corner of Building

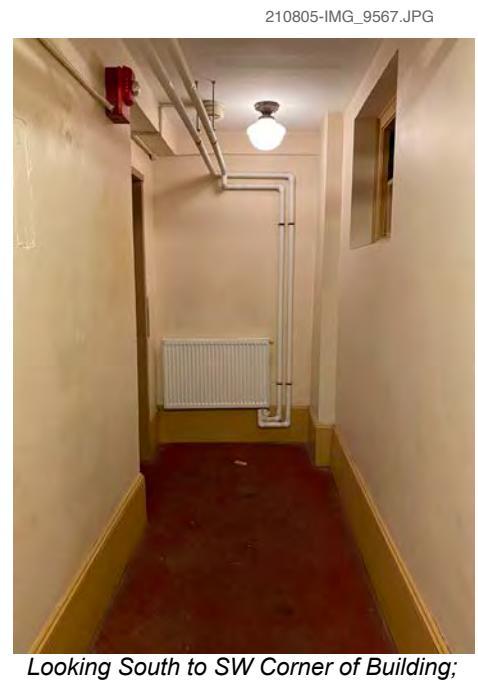
Looking South to SW Corner of Building; Elevator at End of Hallway on Left

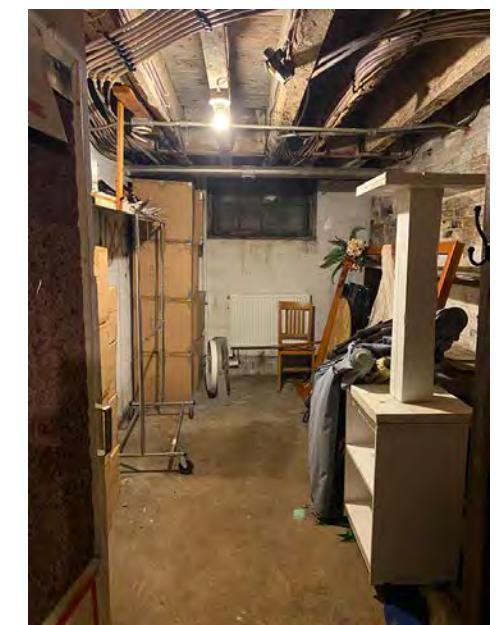
210805-IMG_9540.JPG

Looking West into Storage Room Located Between Men's Room (at left) and Records Storage (at right)

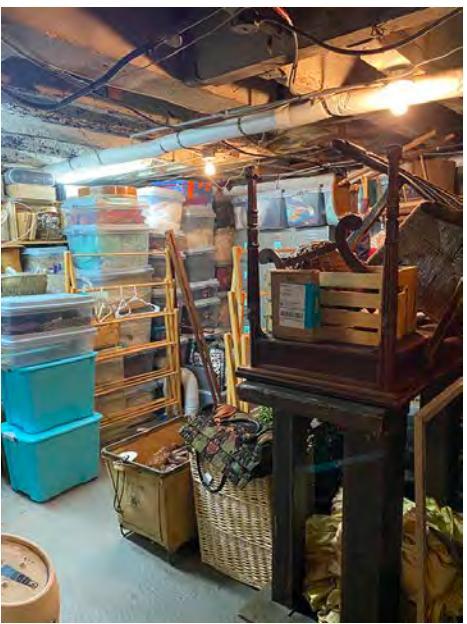
210805-IMG_9539.JPG

Storage Area at East Side of Basement to North of Women's Room

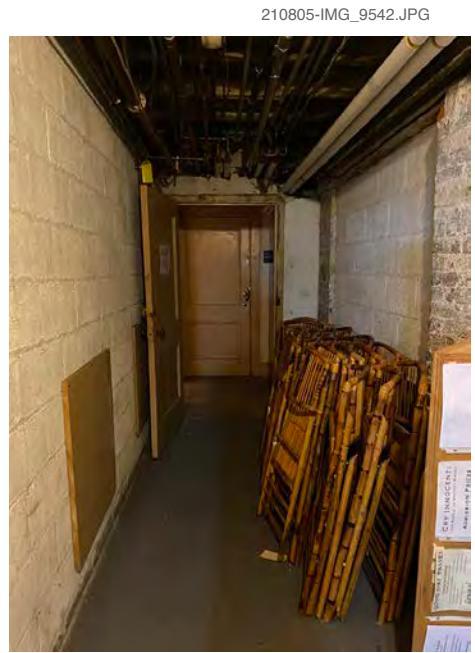
Looking South from Storage Area to Mechanical Room Door Beyond

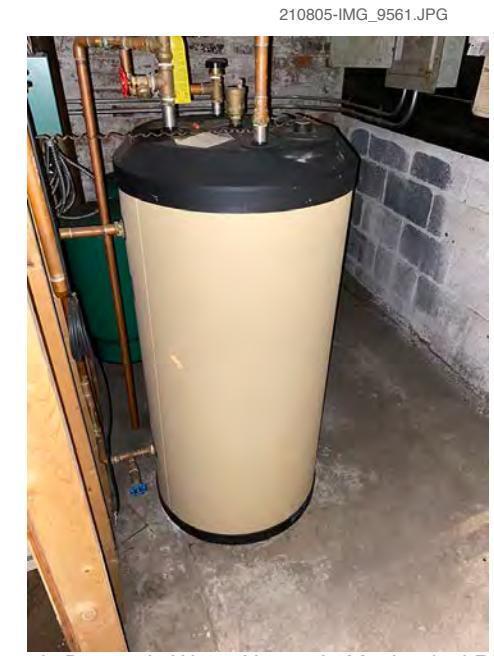
Electric Domestic Water Heater in Mechanical Room

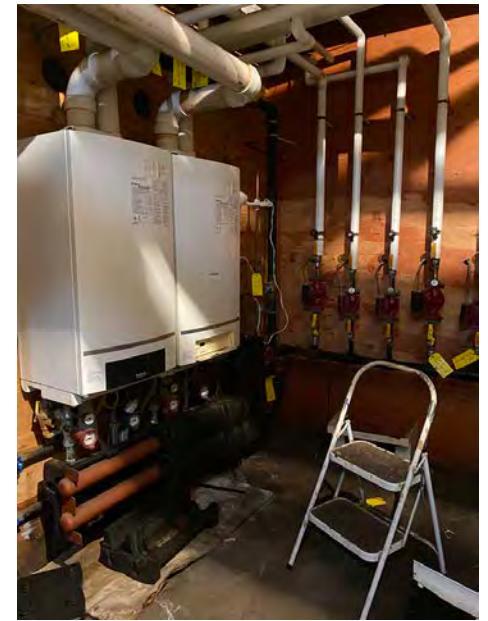
210805-IMG_9565.JPG

Pair of Gas-Fired Hydronic Condensing Boilers

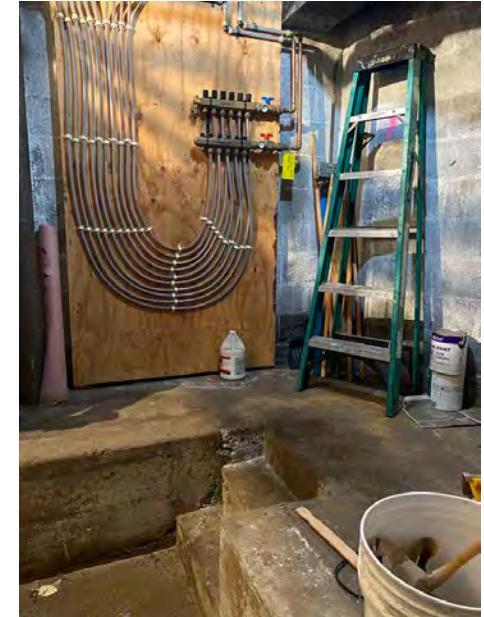
NE Corner of Utility Room with Sunken Floor Area; Concrete Block Walls; Heating Piping Array Mounted on Plywood at North Wall

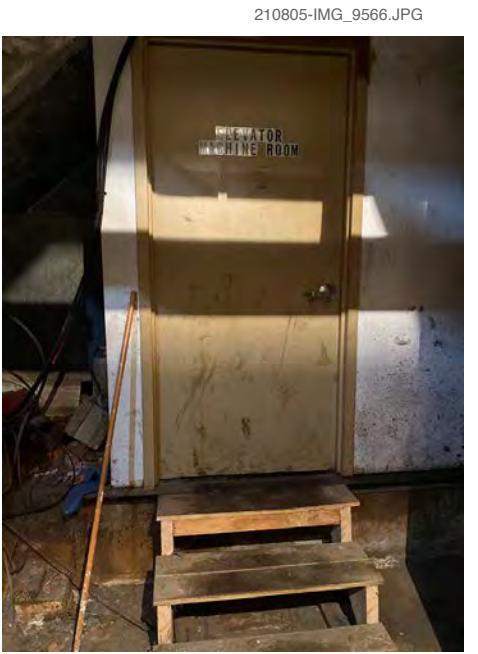
Steps Up to Elevator Machine Room Door Adjacent to Elevator Hoistway in Mechanical Room

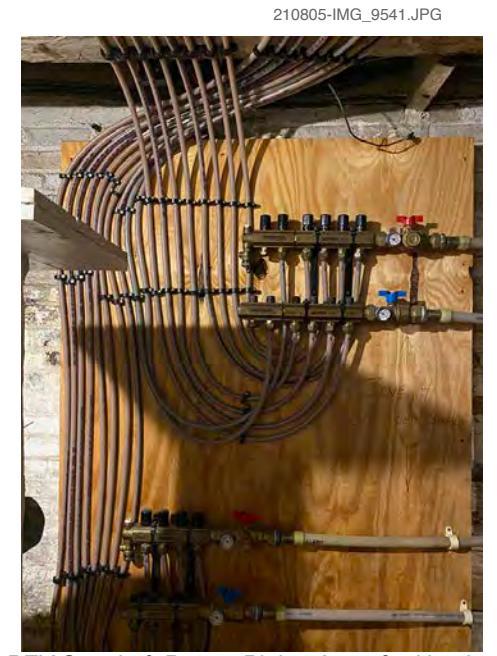
PEX Supply & Return Piping Array for Heating Mounted on Plywood in Storage Area

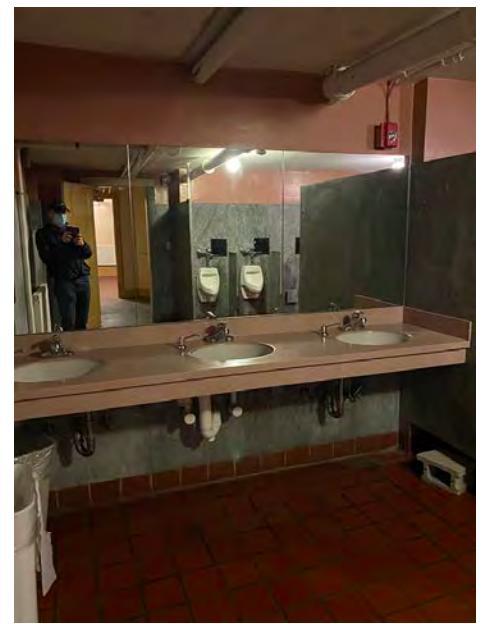
210805-IMG_9535.JPG

Three Lavatories in Men's Room at North Wall; Urinals at South Wall Reflected in Mirror

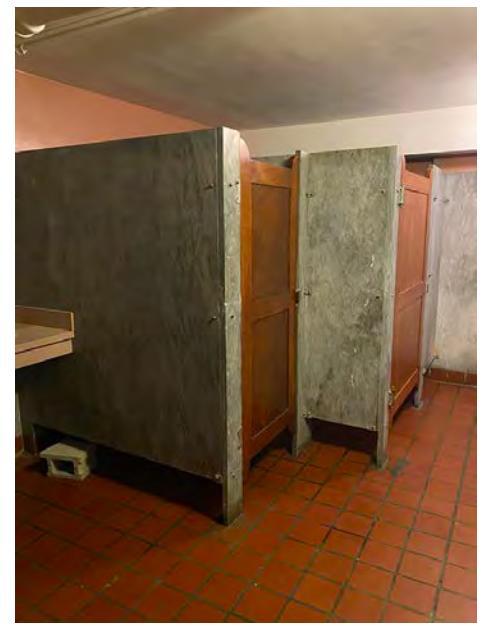
210805-IMG_9534.JPG

Two Water Closets in Men's Room; Quarry Tile Floor and Marble Toilet Partitions

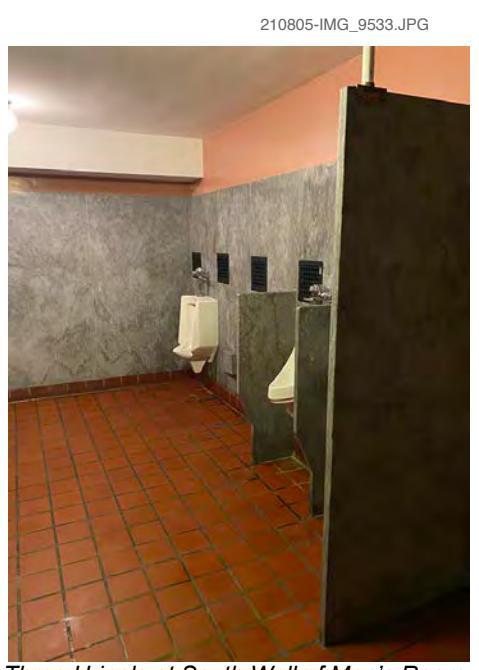
Three Urinals at South Wall of Men's Room; Marble Surfacing on Walls

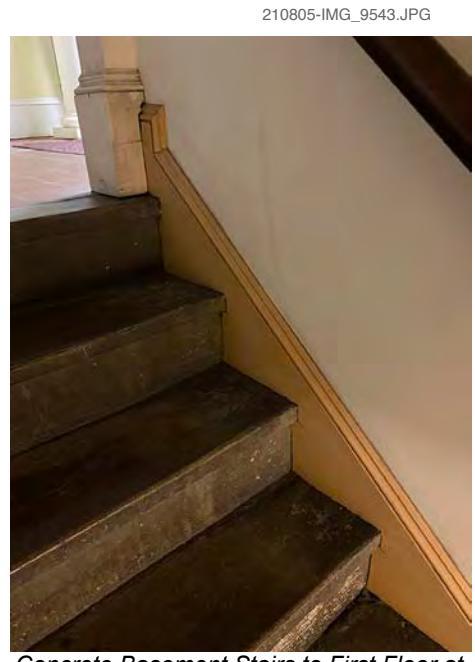
Concrete Basement Stairs to First Floor at South Foyer to Derby Square Exit
