EXECUTIVE SUMMARY

OLD TOWN HALL RENOVATIONS

32 Derby Square / Salem MA

PHOTOGRAPHS OF EXISTING CONDITIONS

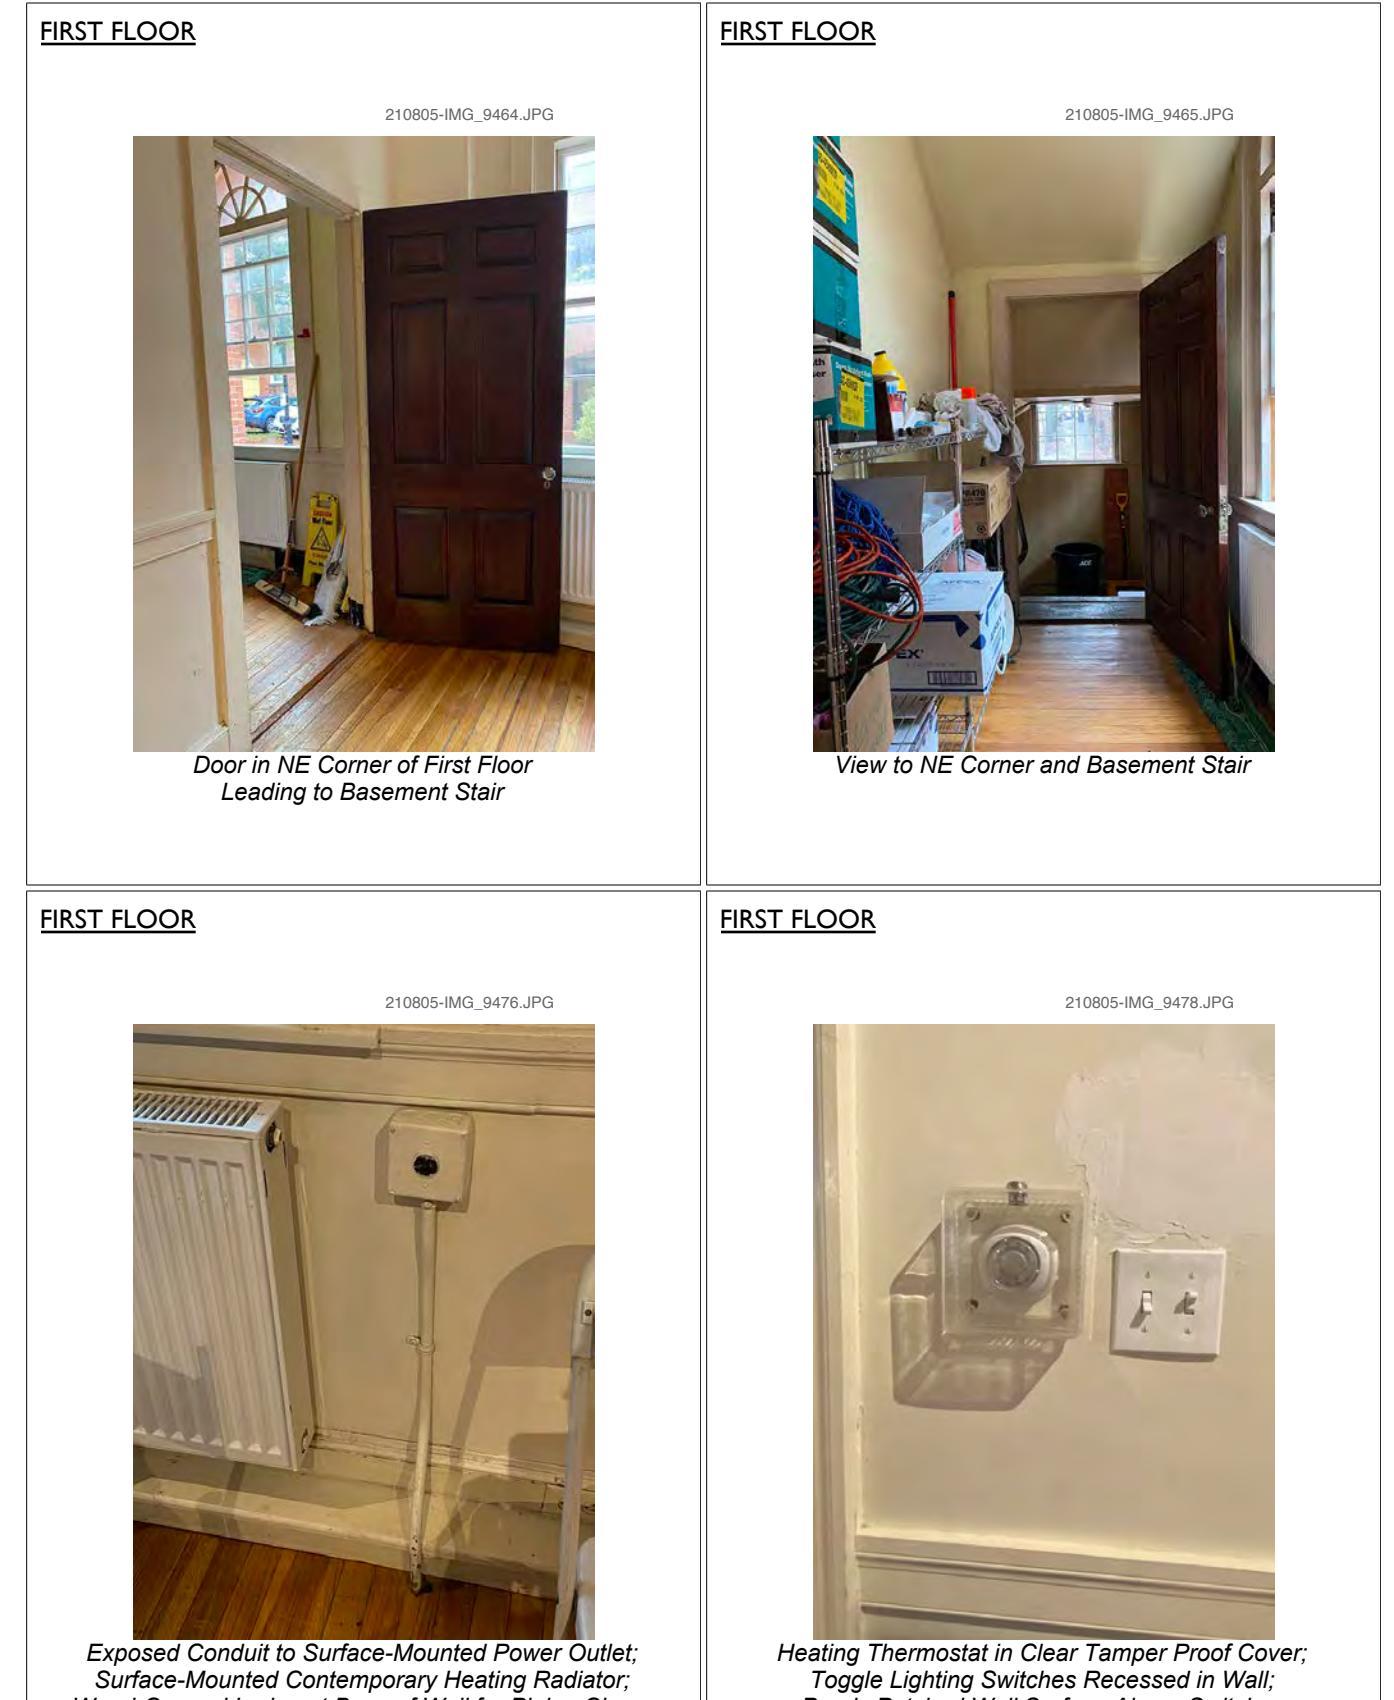
Heating Thermostat in Clear Tamper Proof Cover; Toggle Lighting Switches Recessed in Wall; Poorly Patched Wall Surface Above Switches

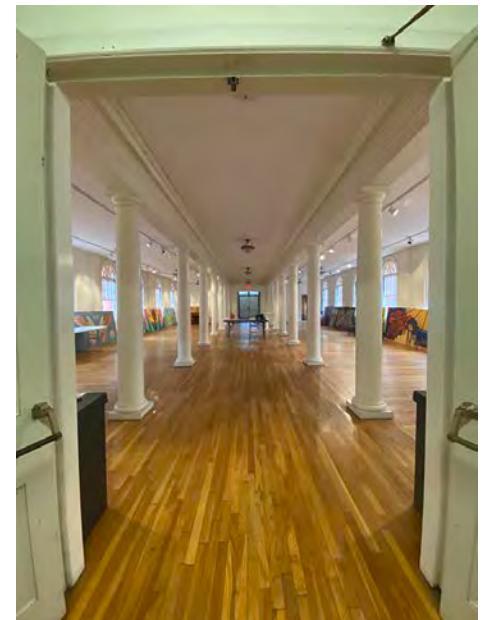
210805-IMG_9520.JPG

Looking North thru First Floor Colonnade; Columns Support Second Floor Framing Above and Bear Upon Timber Transfer Beams Below; Basement Support on Brick Piers in Center

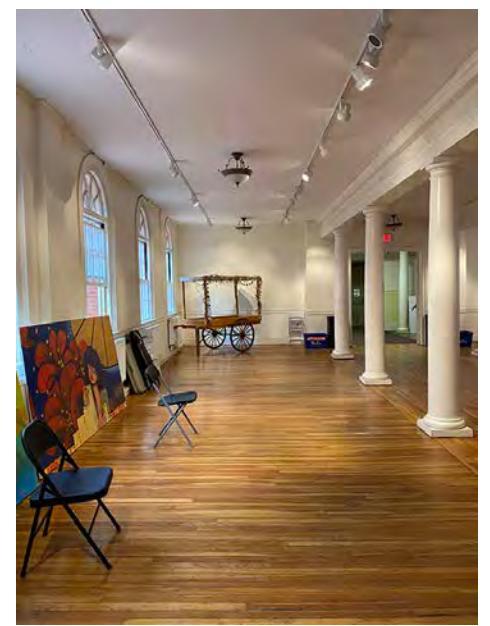
210805-IMG_9463.JPG

Looking South Along East Wall of First Floor

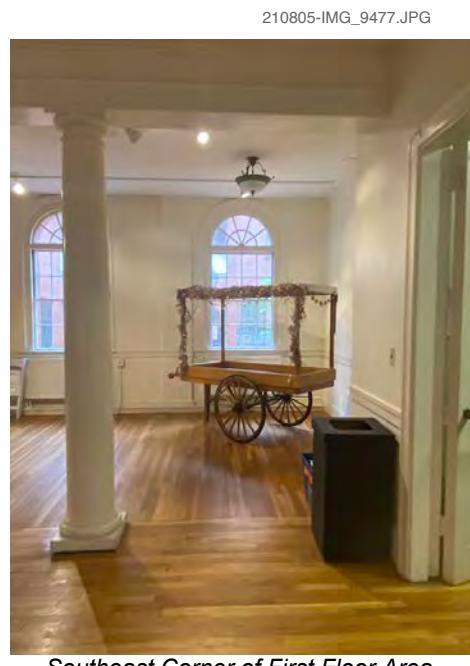
Southeast Corner of First Floor Area

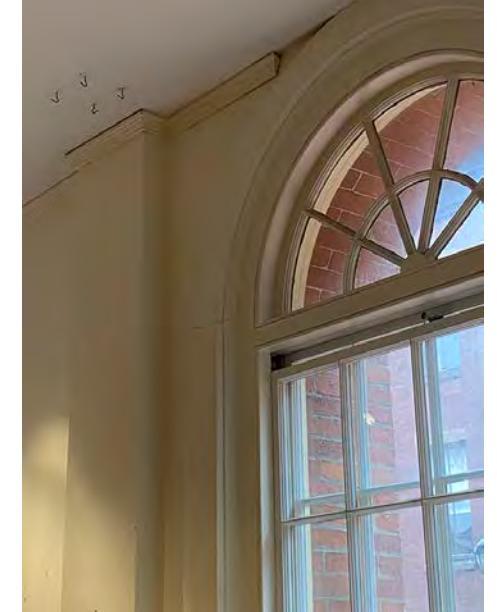
210805-IMG_9482.JPG

Typical Arched Window Casing Touches Ceiling and Interrupts Crown Moulding at Window Head; Integrated Pilaster Piping Chase in Exterior Wall

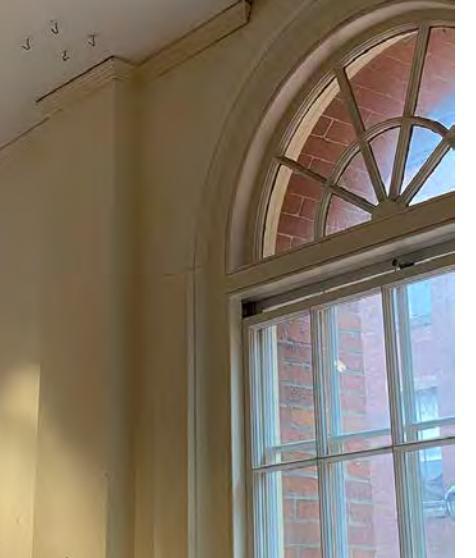
Lower Sash Open to Provide Ventilation; No Exterior Storms or Insect Screens; All Sash Glazed with Single Pane Clear Glass

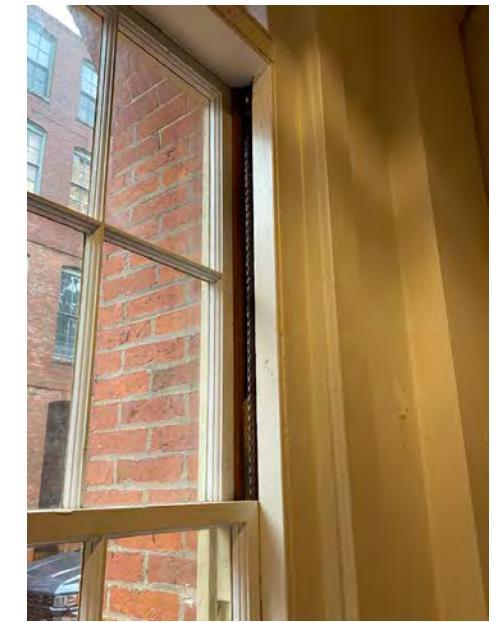
Chain and Pulley for Lower Sash Operation; Exterior Block Below Upper Sash Fixes Sash in Place; All Windows Recently Restored and Operable

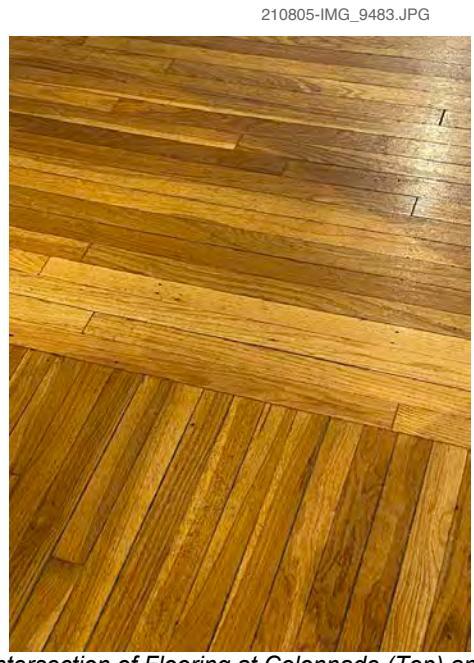
Intersection of Flooring at Colonnade (Top) and Former Market Stalls and Town Offices (Lower); Last Major Renovation in 1933

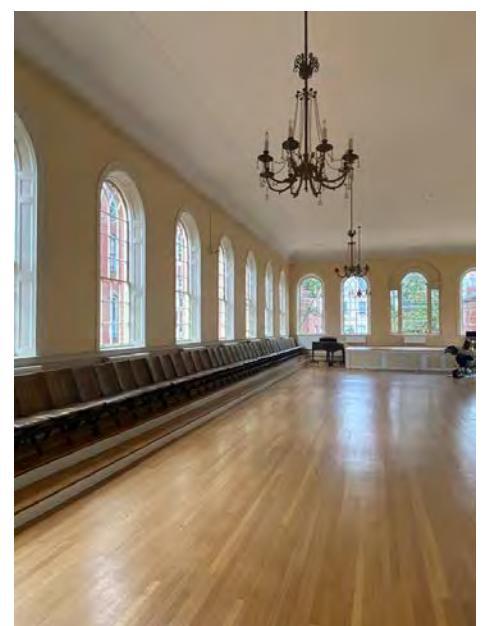
210805-IMG_9508.JPG

View to North Along West Wall of Great Hall

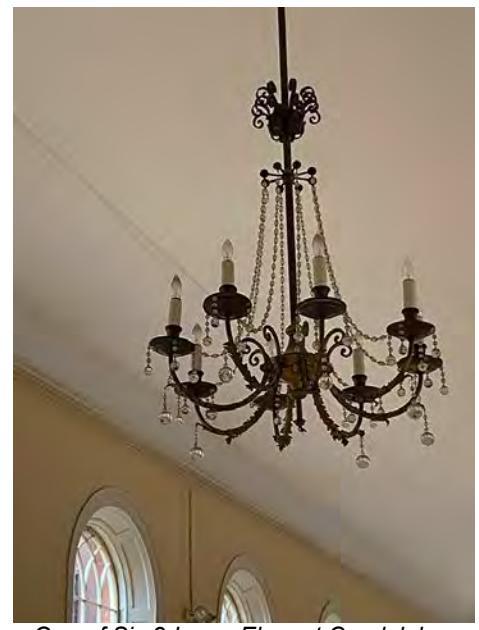
210805-IMG_9509.JPG

One of Six 8-Lamp Elegant Candelabra Chandeliers in the Great Hall Ceiling

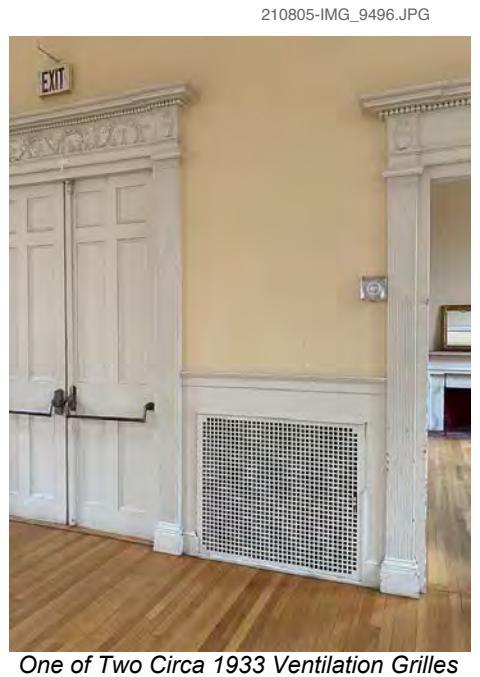
One of Two Circa 1933 Ventilation Grilles at Each Side of Central Exit to South Foyer

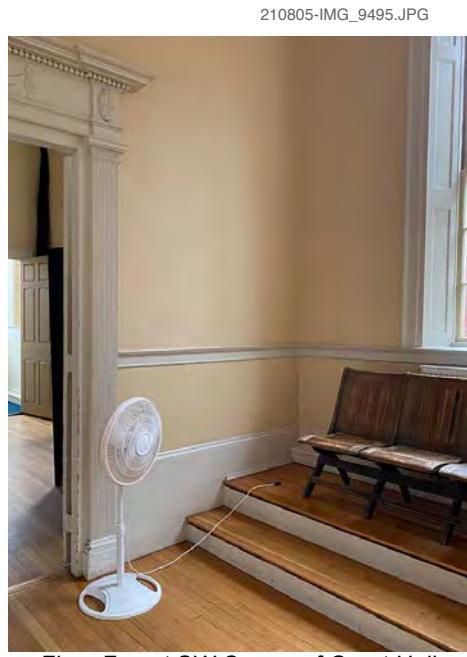
Floor Fan at SW Corner of Great Hall Illustrates Current Lack of Cooling

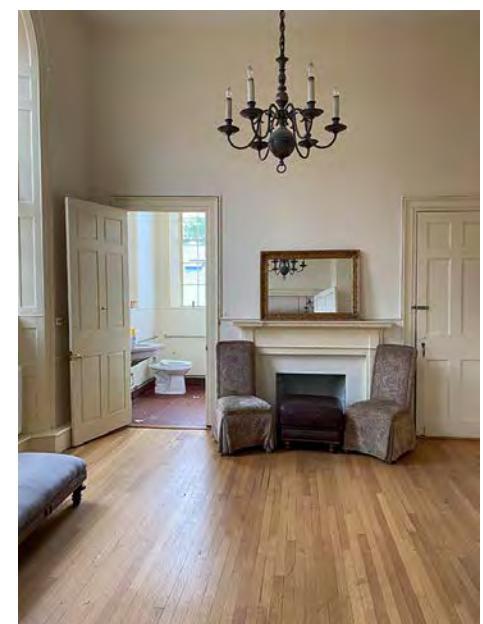
210805-IMG_9503.JPG

Looking North in Former Selectmen's Office; Painted Wood 6-Panel Doors and Suspended 6-Lamp Chandelier

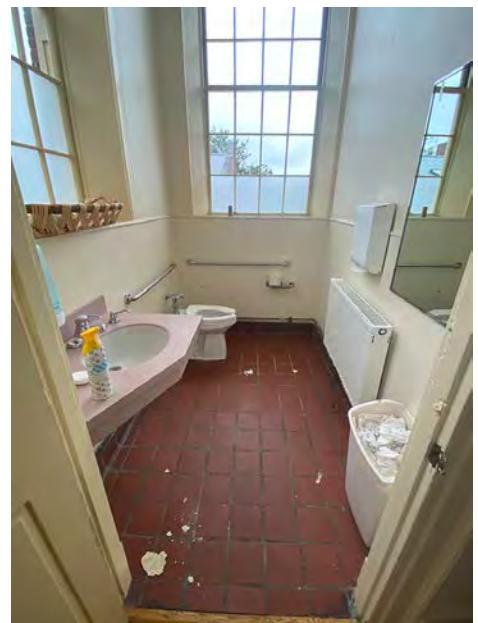
Single-User Restroom at SE Corner of Building Adjacent to Former Office

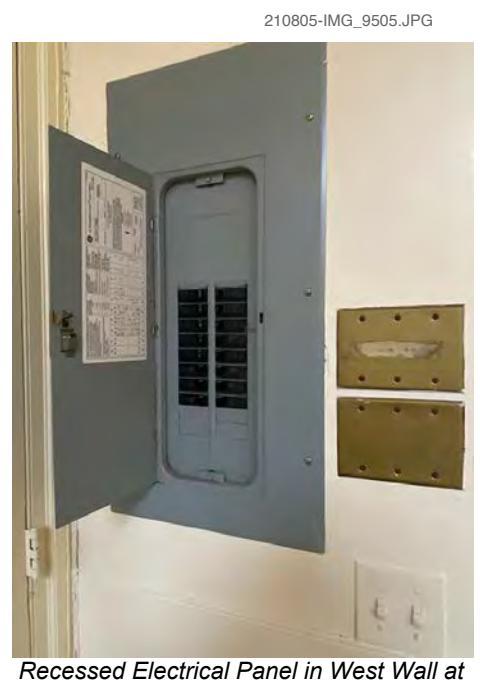
Recessed Electrical Panel in West Wall at SW Corner of Former Selectmen's Office

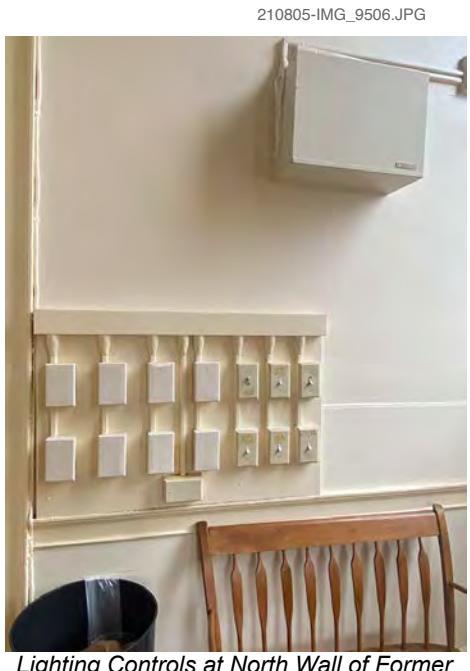
Lighting Controls at North Wall of Former Selectmen's Office; Battery Pack Above for Emergency Lighting System

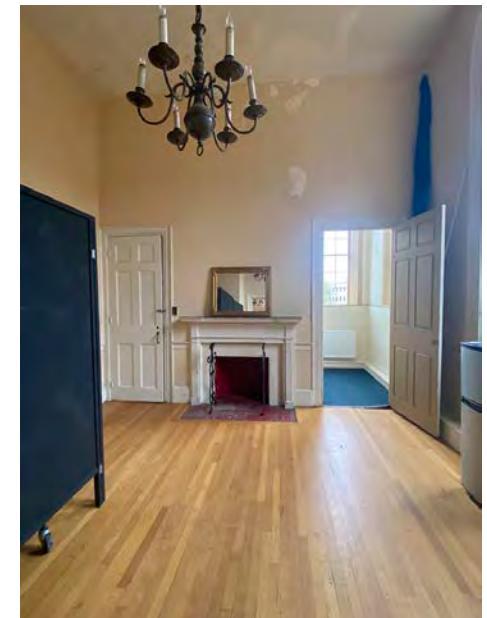
210805-IMG_9497.JPG

Looking North in Former Town Clerk's Office; Painted Wood 6-Panel Doors and Suspended 6-Lamp Chandelier

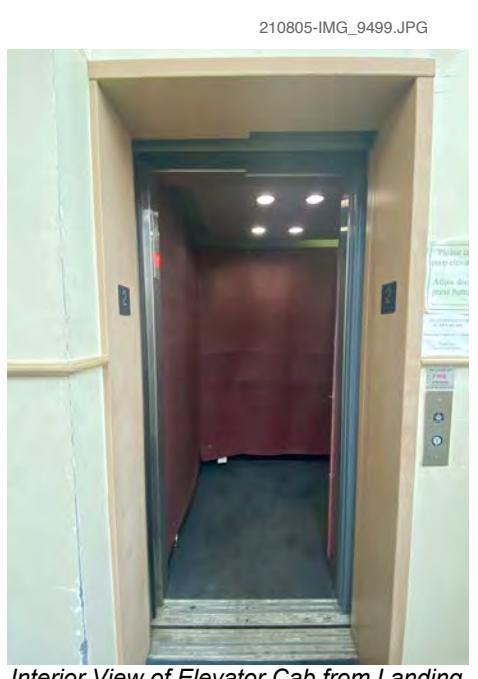
Interior View of Elevator Cab from Landing

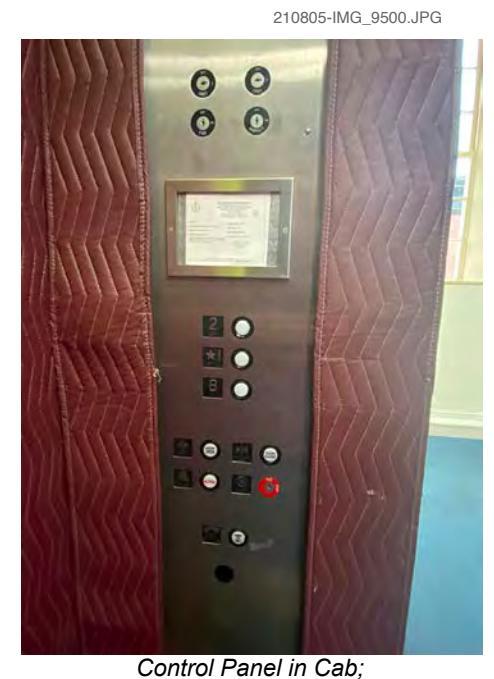
Control Panel in Cab; Protection Pads in Cab

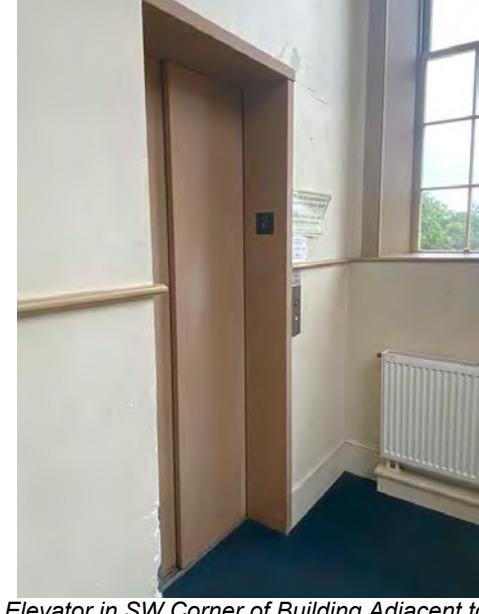
210805-IMG_9498.JPG

Elevator in SW Corner of Building Adjacent to Former Town Clerk's Office; Originally a Private Lavatory Adjacent to Stairs Below

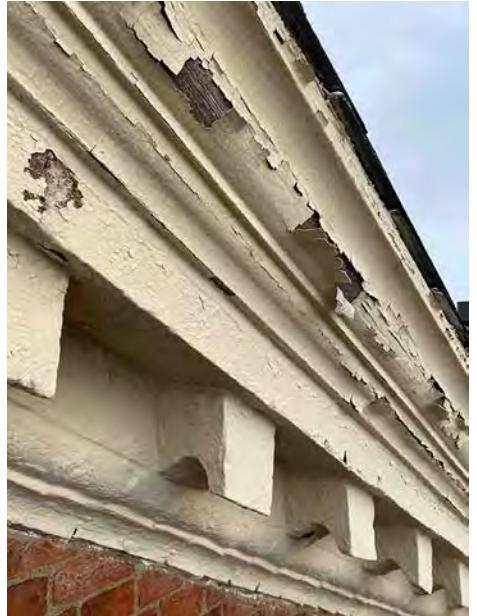
220119-IMG_0614.JPG

Detail of Rake at South Gable; Peeling Paint at Wood Crown Below Roof Slates; Painted Masonry Fascia, Modillions & Bed Moulding

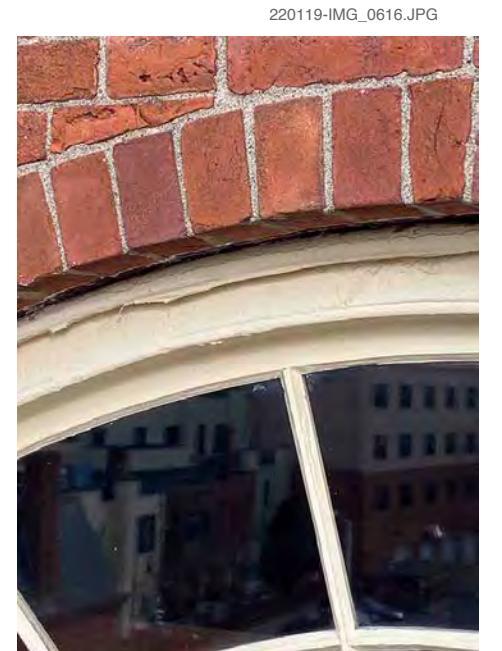
Open Head Joint Between Wood Brick Moulding and Brick Archway at South Facade Attic Window

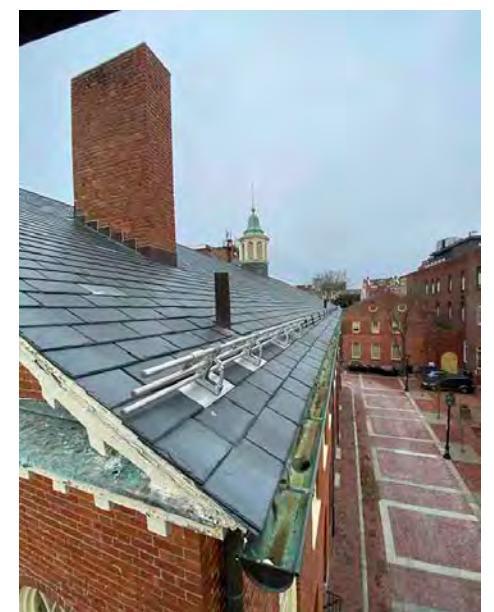
220119-IMG_0630.JPG

Looking North Along Eave from Southeast Corner

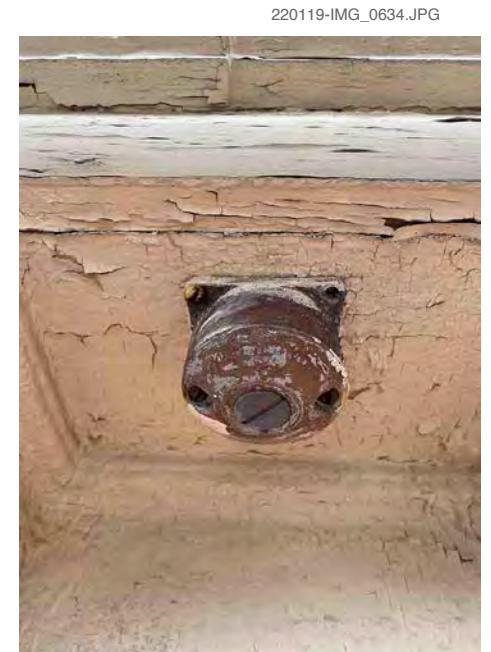
One of Several Intermittently Spaced Electrical Device; Appears to be Lamp Socket for Screwed-In Light Bulb; Installed Under Wood Soffits at East/West Facades; Installed on Face of Masonry Cornices at Gable Ends

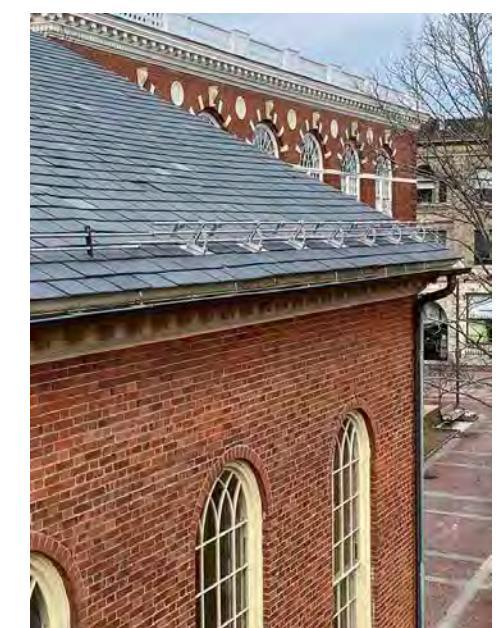
220119-IMG_0646.JPG

Transition from Older 2-Rail Snow Guard to Newer 3-Rail Snow Guard at Northeast Portion of Roof; Newer Guards Located at NE, NW and SE Eaves

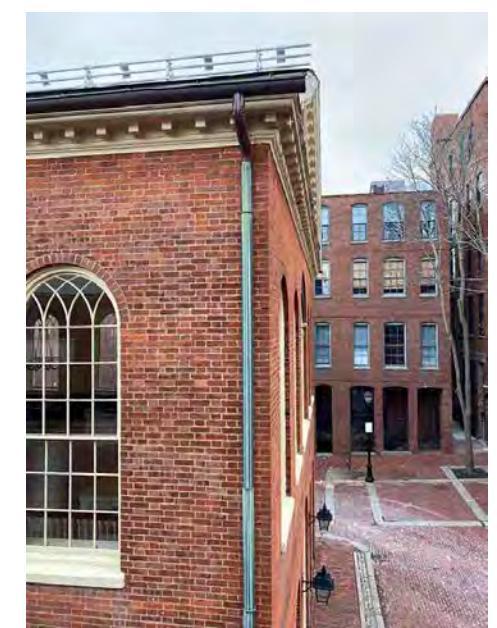
Northeast Corner of Upper Facade; Flemish Bond Brickwork; Copper Gutter & Downspout; 3-Rail Snow Guard with Ice Flags

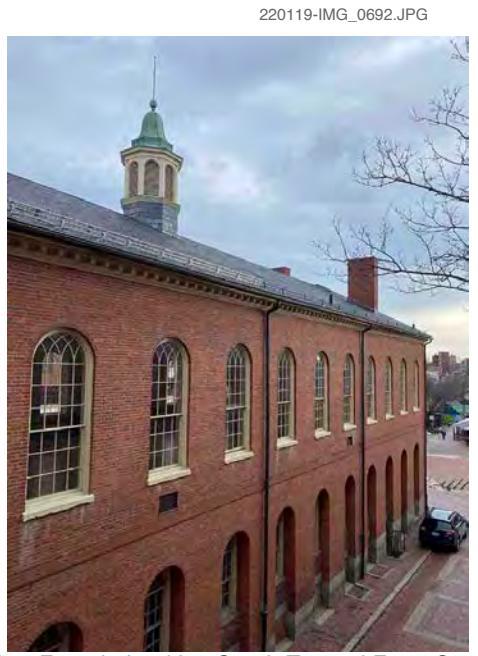
West Facade Looking South Toward Front Street

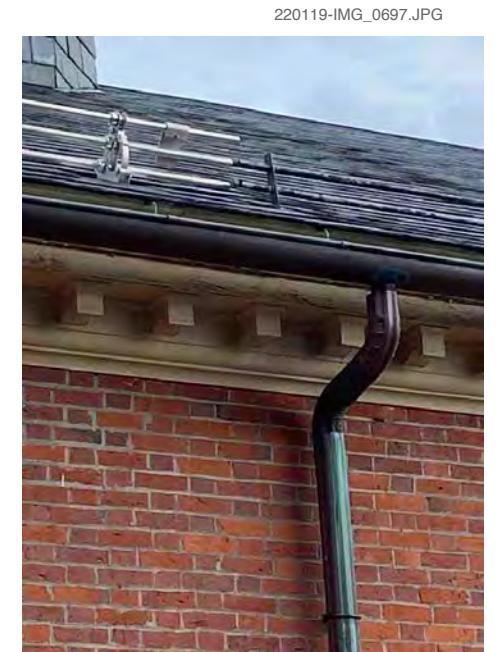
Detail at Eave of West Facade; Newer Copper at Downspout Elbows; Intersection of 3-Rail and 2-Rail Snow Guards; Overhangs at East/West Eaves are Painted Wood

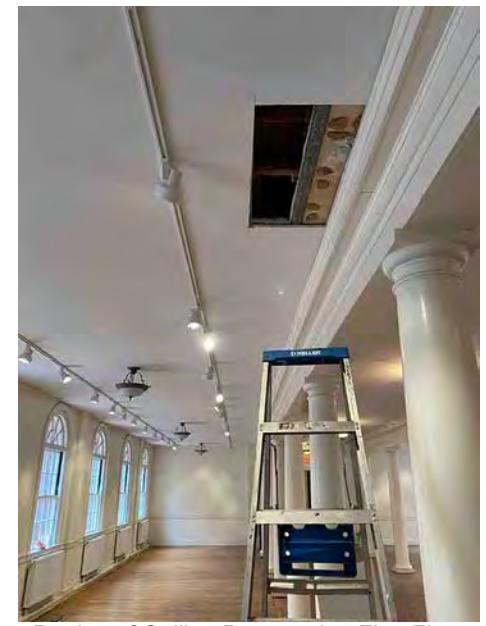
Portion of Ceiling Removed at First Floor Adjacent to North/South Beam of Colonnade

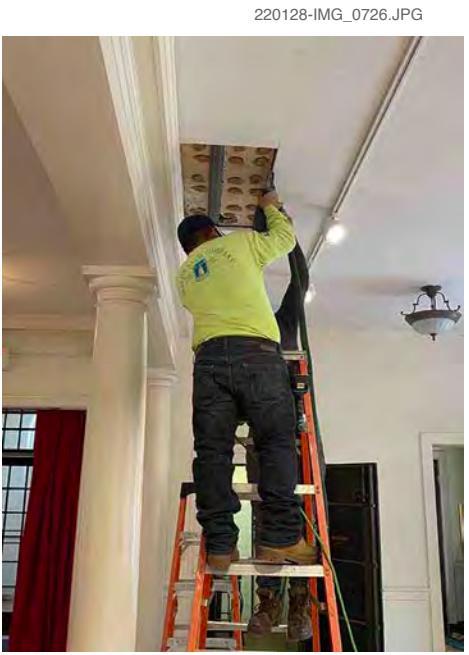
Ceiling Exploration in Process at First Floor

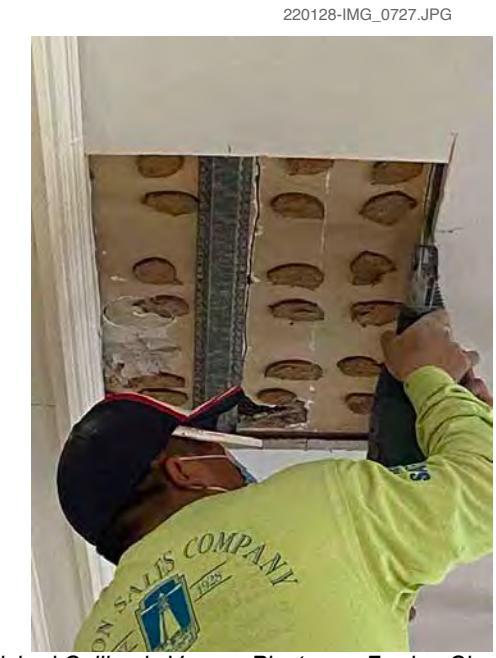
Finished Ceiling is Veneer Plaster on Furring Channels; Concealed Ceiling is Cement Plaster on Wire Lath

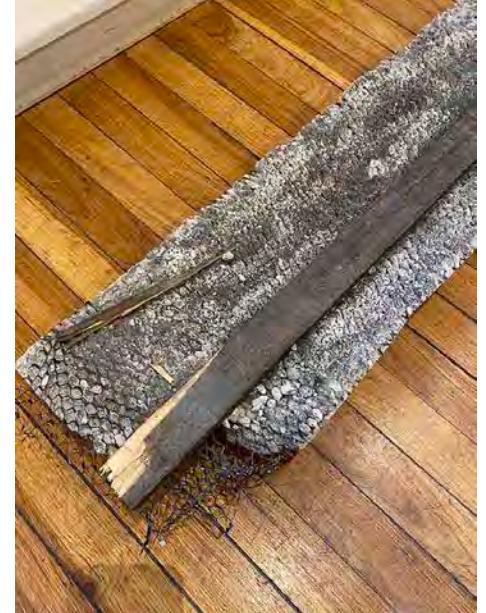
220128-IMG_0764.JPG

Portion of First Floor Ceiling Over Wire Lath Currently Concealed by Drywall on Furring

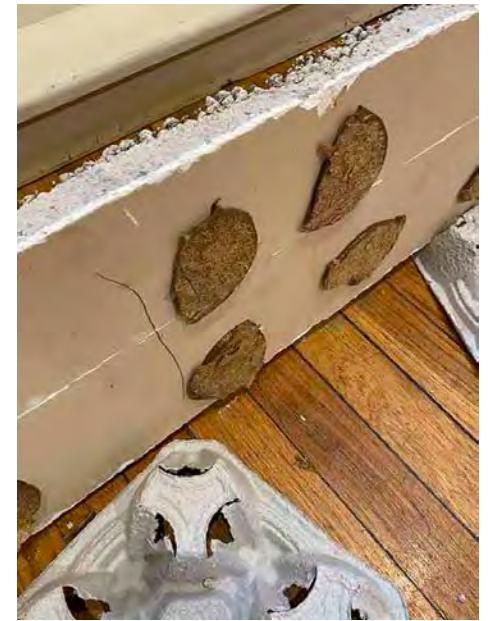
220128-IMG_0765.JPG

Adhesive Daubs on Concealed Plaster Assumed to Have Formerly Held 12" x 12" Perforated Tiles; Adhesive to be Tested for Asbestos

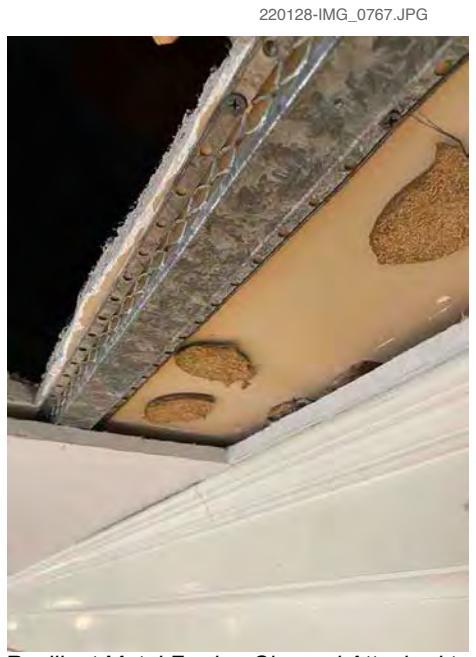
Resilient Metal Furring Channel Attached to Concealed Cement Plaster on Wire Lath Circa 1933; Contemporary Veneer Plaster Ceiling 1970s

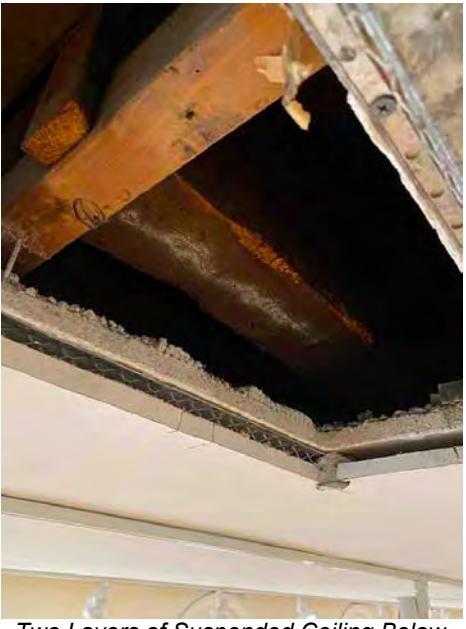
220128-IMG_0768.JPG

Two Layers of Suspended Ceiling Below Wood Joist Framing of Great Hall Above; Suspended Wood Framing Circa 1933

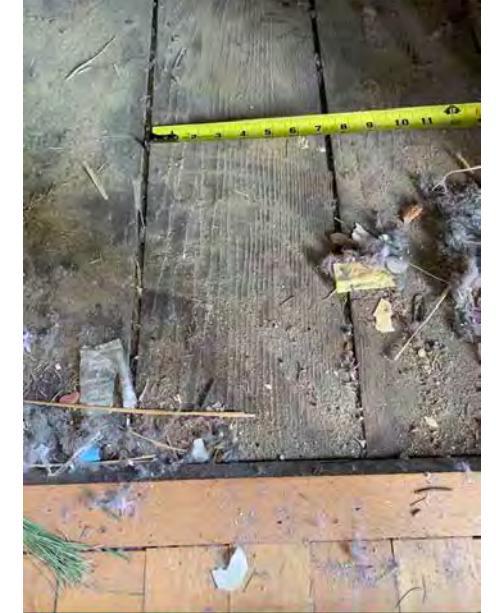
220118-IMG_0603.JPG

Original Wood Subfloor at Second Floor Below Great Hall Stage

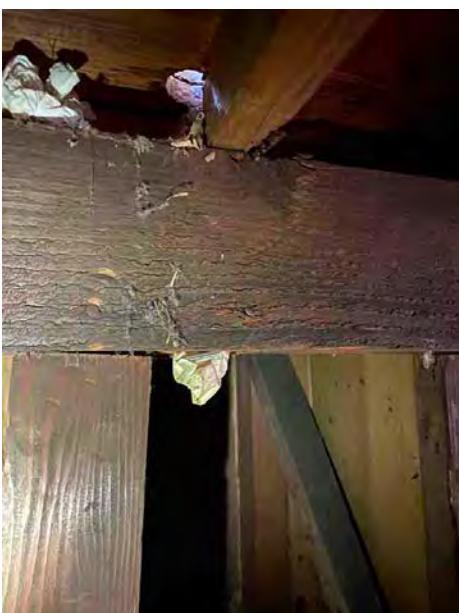
1933 Reframed Stage Lumber with Bore Hole for Posts in Stage Surface Above

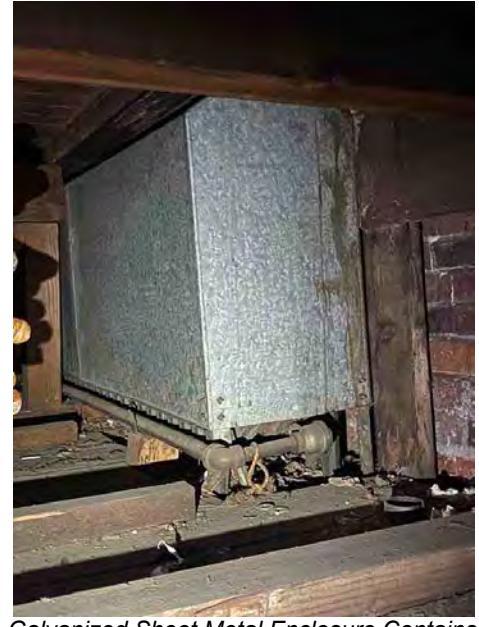
220118-IMG_0600.JPG

Galvanized Sheet Metal Enclosure Contains Abandoned Heating Radiator Below Stage; Exposed Brick at North Wall

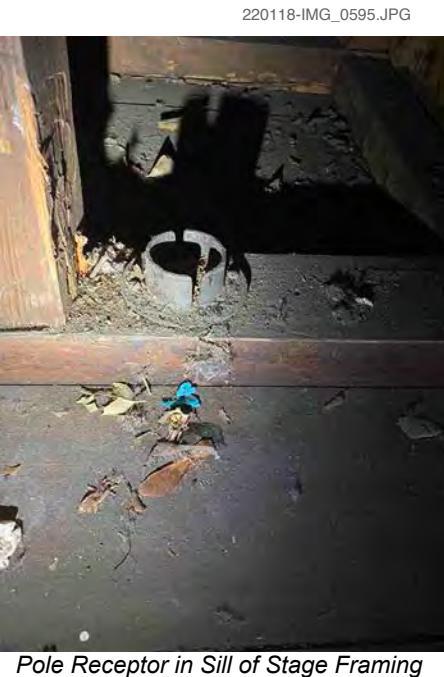
220118-IMG_0596.JPG

Pole Receptor in Sill of Stage Framing Aligns with Hole in Beam and Floor Above; Pole Used to Set Proscenium for Theater

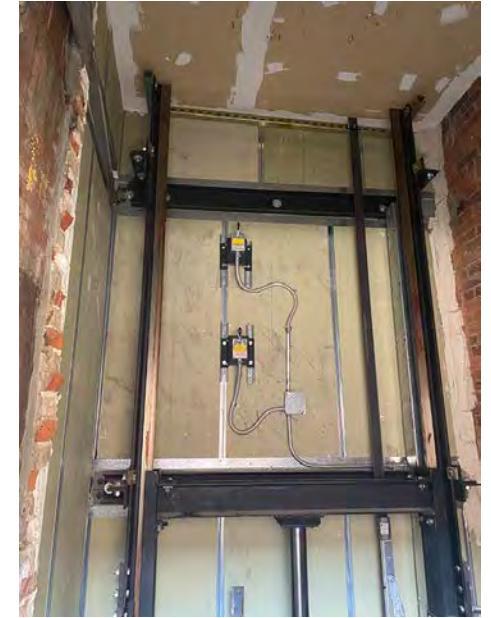
220714-IMG_1703.JPG

View of Rear Cantilever Frame from Hoistway

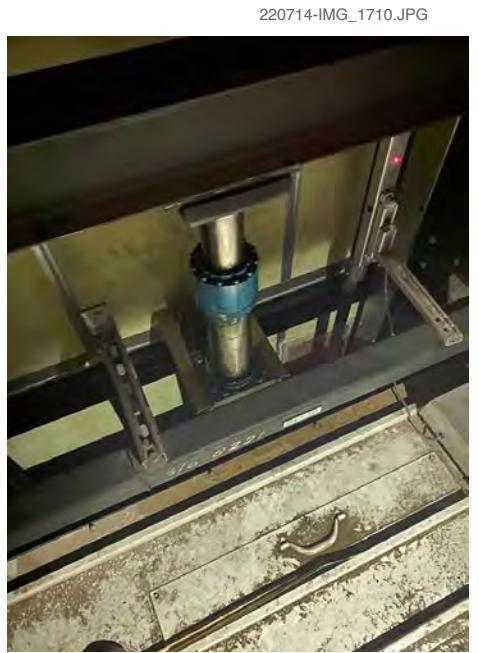
View of Holeless Hydraulic from Top of Elevator Cab

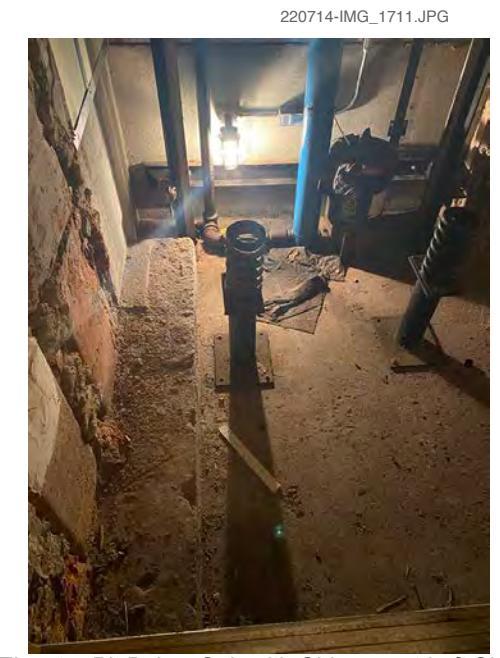
Elevator Pit Below Cab with Chimney at Left Side

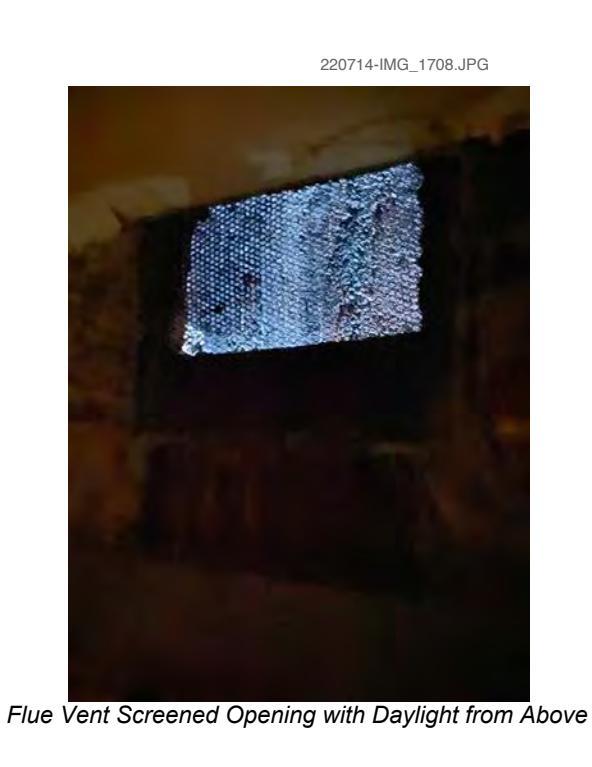
Vent Opening at Top of Hoistway into Terracotta Flue Liner; Chimney Opening Reinforced with Steel Strap

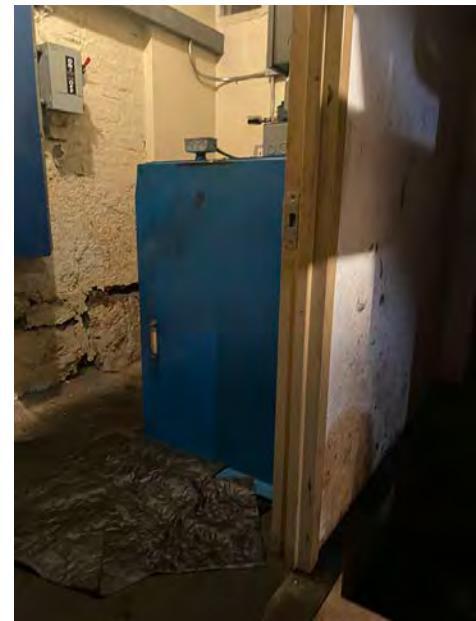
220714-IMG_1697.JPG

Elevator Machine at Back Side of Hoistway Accessed via Mechanical Room

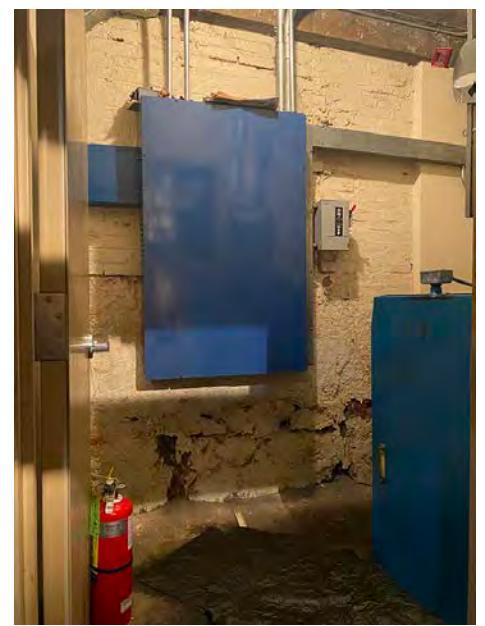
220714-IMG_1696.JPG

Elevator Controller in Machine Room

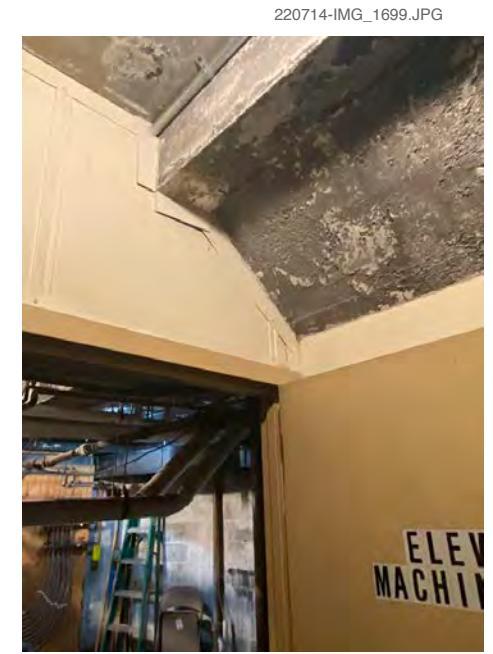
Machine Room Partition Intersection to Concrete Basement Stairs from First Floor Foyer

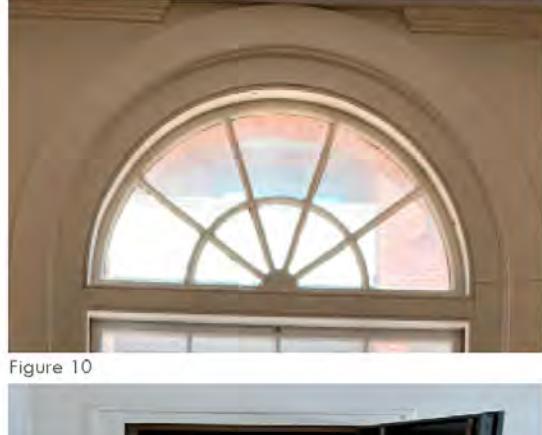
Figure 9

Figure 9: Hard wood floor on the Colonnade Hall Figure 10: Arch Window from the interior Figure 11 Vault / Storage for the City

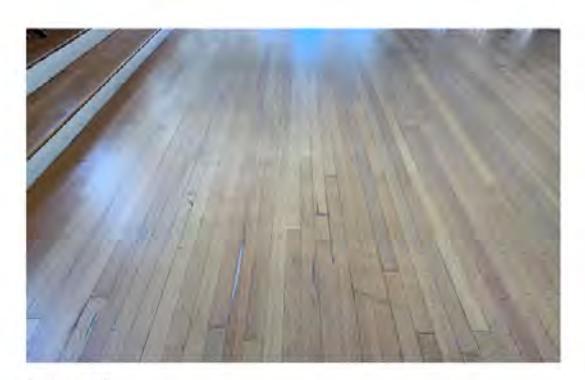
Figure 13

Figure 13: Hard wood floor on the Great Hall Figure 14: Window on the South wall from the interior Figure 15: Attic access door Figure 16: View of the single bathroom on the second floor

- Refinish the hard wood floor at the Great Hall if possible. Otherwise replace with new flooring.
- 20. Fix cracks on the North wall behind the folding chairs
- 21. Repair crack molding around the window on the West elevation

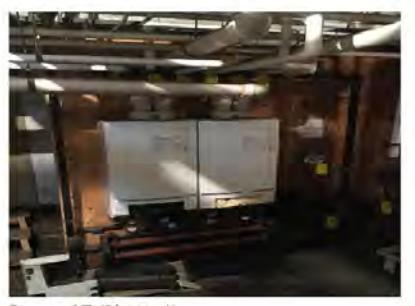
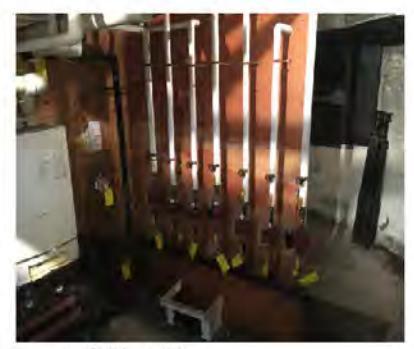
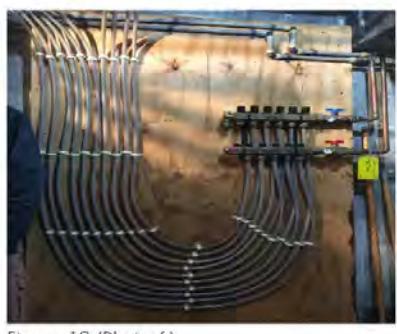
- The building heating system consists of condensing gas boilers, heating hot water pumps and piping serving radiators throughout the building. The heating system is approximately 10 years old and appears to be in good condition. (Figures 17, 18, 19)

Figure 17: Condensing gos boilers Figure 18: Heating hot water pump Figure 19: Radiators piping Figure 20: Hot water system zoning

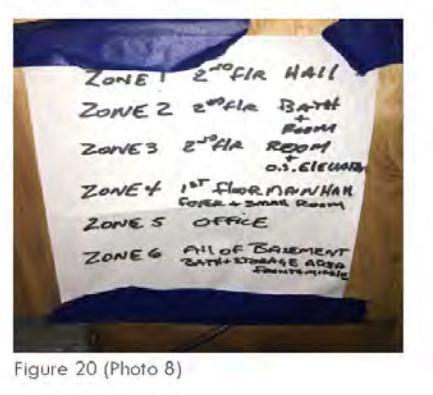
- Pipe and equipment labeling is very minimal. A handwritten note is provided to indicate hot water system zoning. (See Figure 20)
- Ducted toilet exhaust fans are provided for each bathroom on the lower level. The fans were functional but appear to be past their useful life. The fans were intended to be interlocked with the bathroom light switches, however, at least one fan was wired to the exterior lights, not the bathroom lights. Recommend to be fixed.

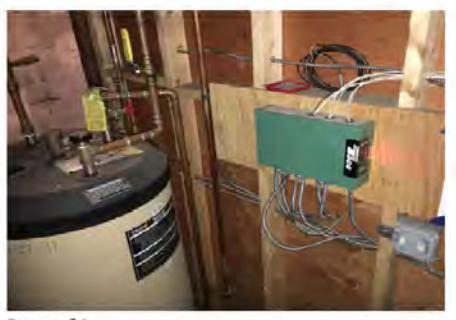
Figure 21

- An indirect domestic water heater (gas) is provided and was installed at the same time as the heating hot water system. A taco controller is provided to control the boiler system. (Figure 21)
- Sanitary piping was observed in fair condition. The hub and spigot type cast iron piping suggests that the piping is at least 50 years old. (Figure 24)
- Water and gas meters appear to have been replaced recently. (Figures 22, 23)
- Plumbing fixtures appeared to be in good condition.
 Facilities staff indicated that most fixtures has been replaced approximately 10 years ago.

Figure 21: Taco Controller to control boilers

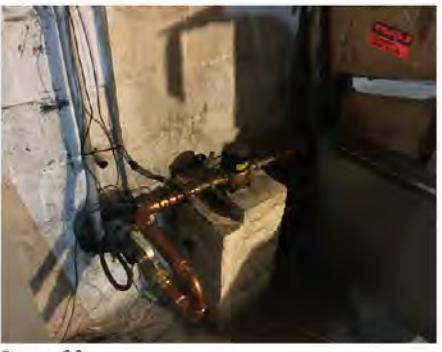
Figure 22

Figure 22: Water meter

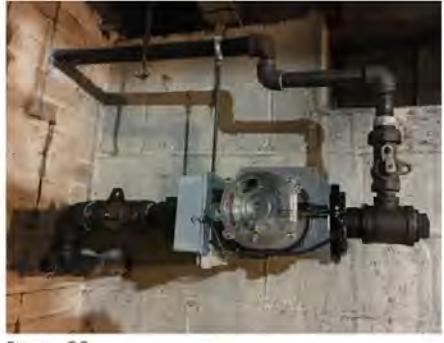
Figure 23

Figure 23: Gas meter

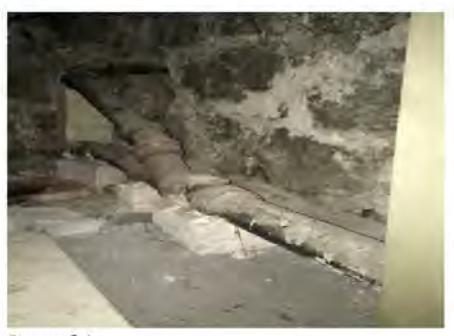
Figure 24

Figure 24: Cast Iron sewer pipe in the basement

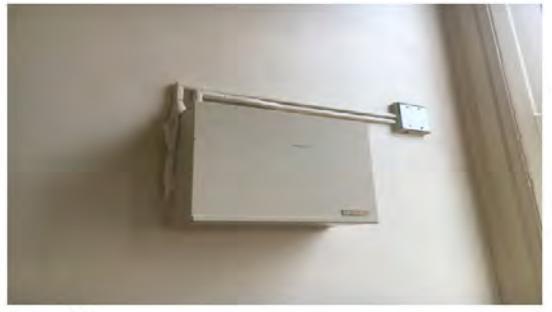
Figure 25

The fire alarm system appeared to be in functional condition and was installed in the 1990's. This system should be tested for verification. No sprinkler system was observed throughout the building (Figure 25)

Figures 25& 26: Battery Box for emergency lighting Figure 27: Lighting Control Figure 28: 600 A Main Panel Figure 29: Distribution Panels Figure 30: Fuse Breaker System Figure 31: Main Circuit Breaker

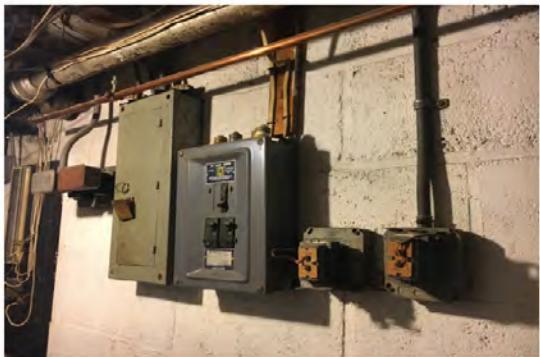
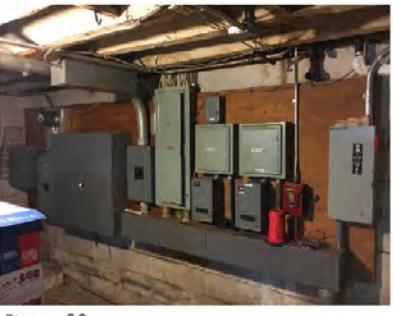
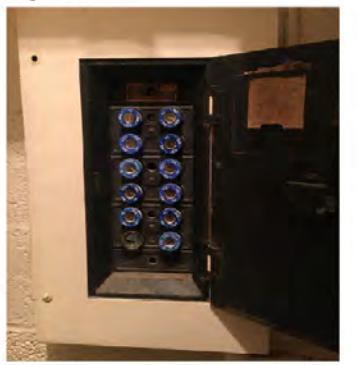
- The electrical infrastructure consists of a 600A main panel and numerous distribution panels of various ages. This building had an old electrical system setup with fuse breaker panel boards. The panel boards have been added onto over the years. Old panels should be considered to be replaced. (Figures 28, 29, 30, 31). In order to determine if the system is able to handle any future upgrades we recommend a load assessment is done.
- Battery boxes are provided for emergency lighting.
 Facilities staff indicated that the batteries require replacement. Recommend a battery maintenance routine. (Figures 25, 26)
- Lighting controls consist of basic switches and dimming dials that appear old and outdated.
- There is no backup generator at the facility
